**AIRCRAFT ACCIDENT INVESTIGATION BUREAU**

**INVESTIGATION REPORT ON**

**ACCIDENT TO THE B737-MAX8 REG. ET-AVJ OPERATED**

Report No. AI-01/19

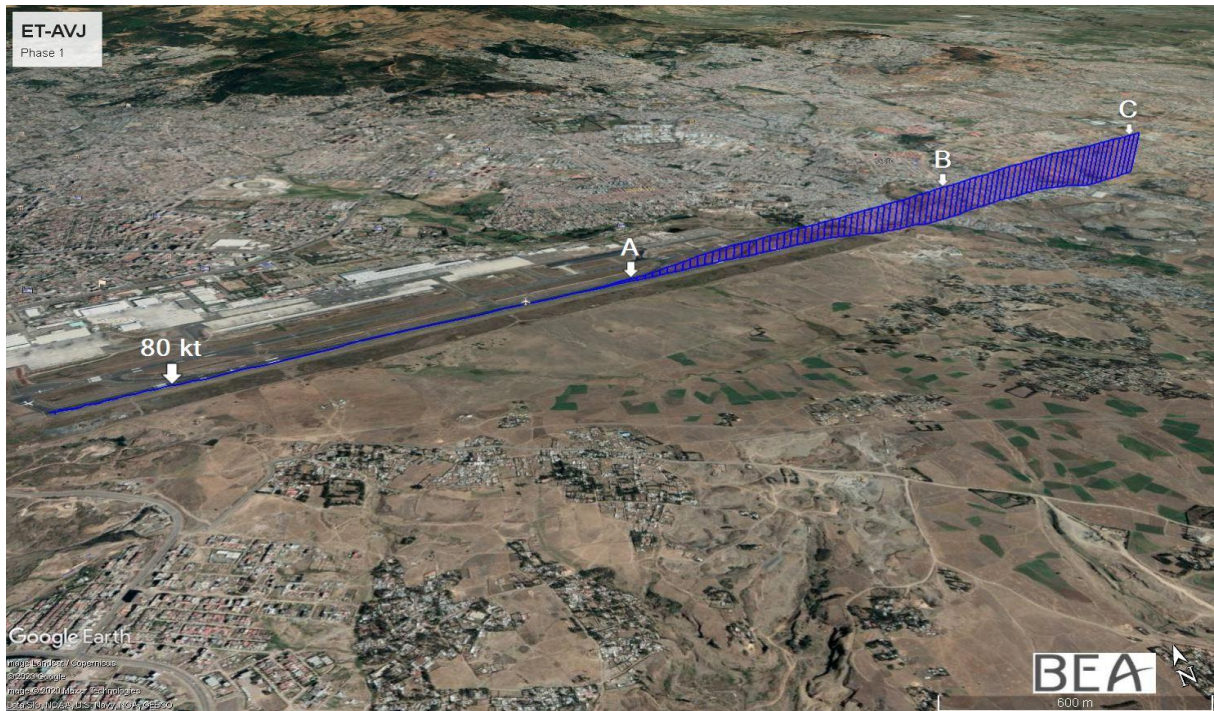
FIGURE 1: PHASE1 FROM TAKEOFF TO AUTOPILOT ENGAGEMENT

Before CMD A engaged, the stabilizer trim position was around 5.6 units, with elevator positions around 4° (consistent with the elevator neutral position for the stabilized flight condition).

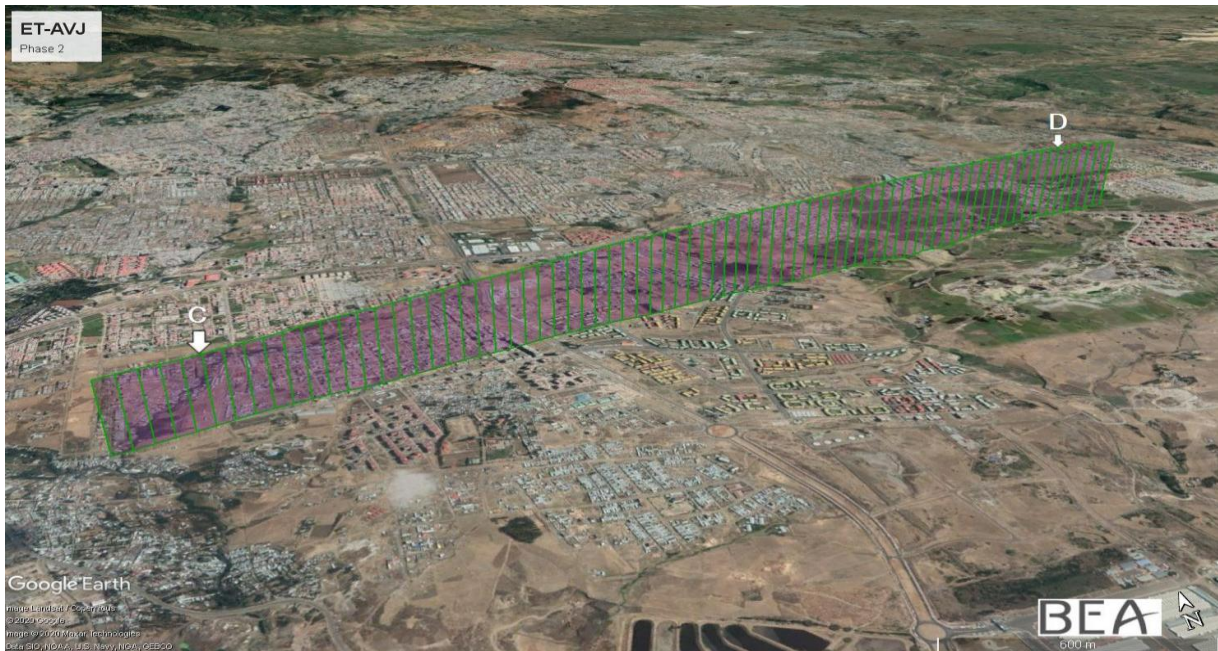
FIGURE 2: PHASE 2 DURING AUTOPILOT CONTROL

At the end of this phase, the pitch angle was around 1°, the stabilizer was at 4.6 units and the vertical speed was around -1,400 ft/min Flaps were still moving up.

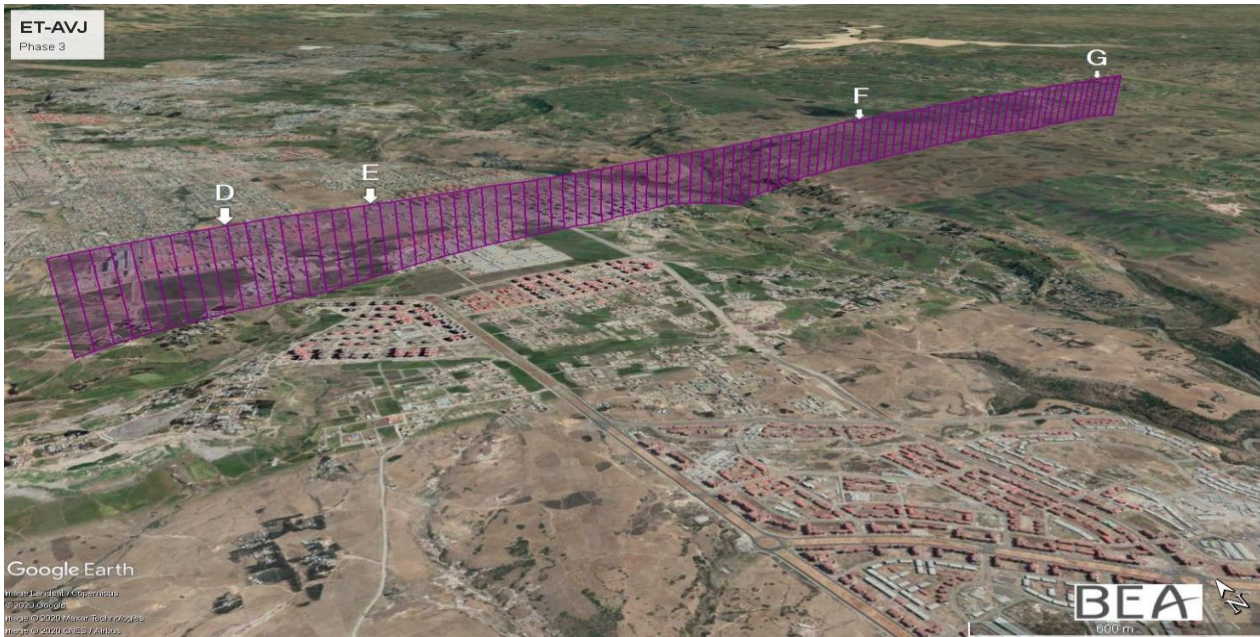
FIGURE3: PHASE 3 FROM A/P DISCONNECT TO STABILIZER TRIM CUTOUT

As a result of the erroneous LH AOA value and the increasing airspeed, SMYDC 1 computed LH minimum operational speed and LH stick shaker speed greater than VMO (340Kt) without any alert or invalidity detection.

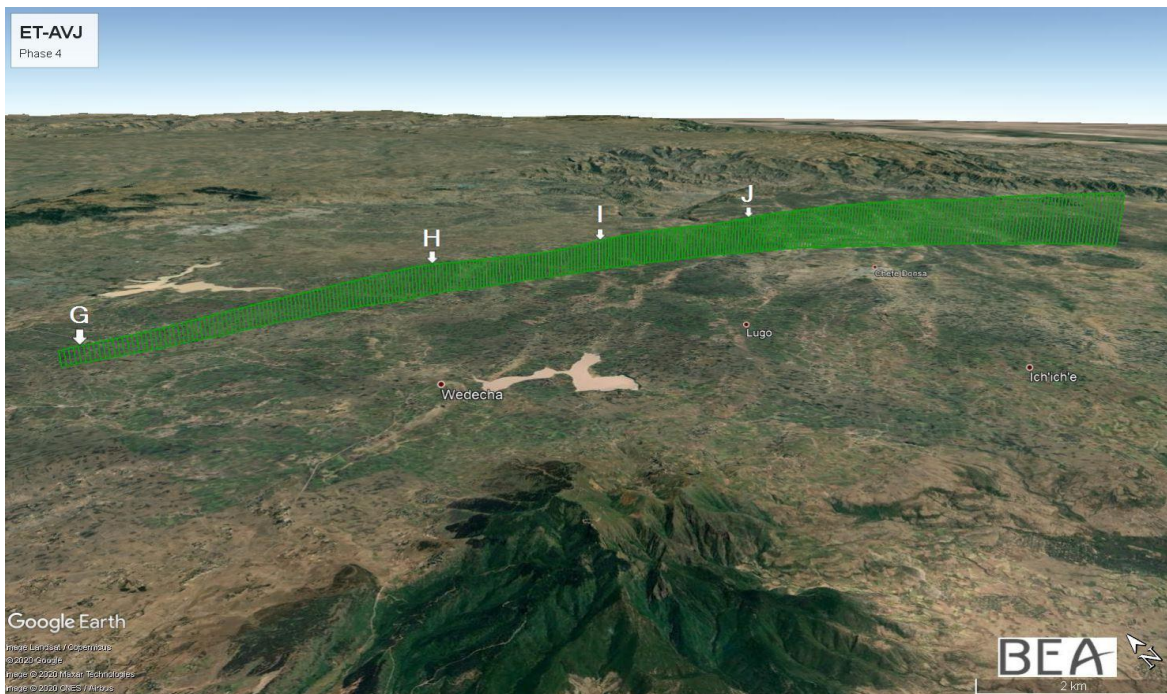
**FIGURE 4: PHASE 4 FLIGHT WHILE THE STAB TRIM CUTOUT SWITCHES WERE IN THE CUTOUT POSITION**

- The Airplane was at an altitude of 6,200 ft above the airfield elevation (computed from the RH pressure altitude). LH altitude values were 1,250 ft lower.
- Computed airspeed was around 367Kt (RH value), LH erroneous value was 344 Kt.
- The pitch angle of the Airplane was lower than 1°
- The vertical speed was around + 125 ft/min and decreasing
- The bank angle was around 21° right, with a slight trend to increase.

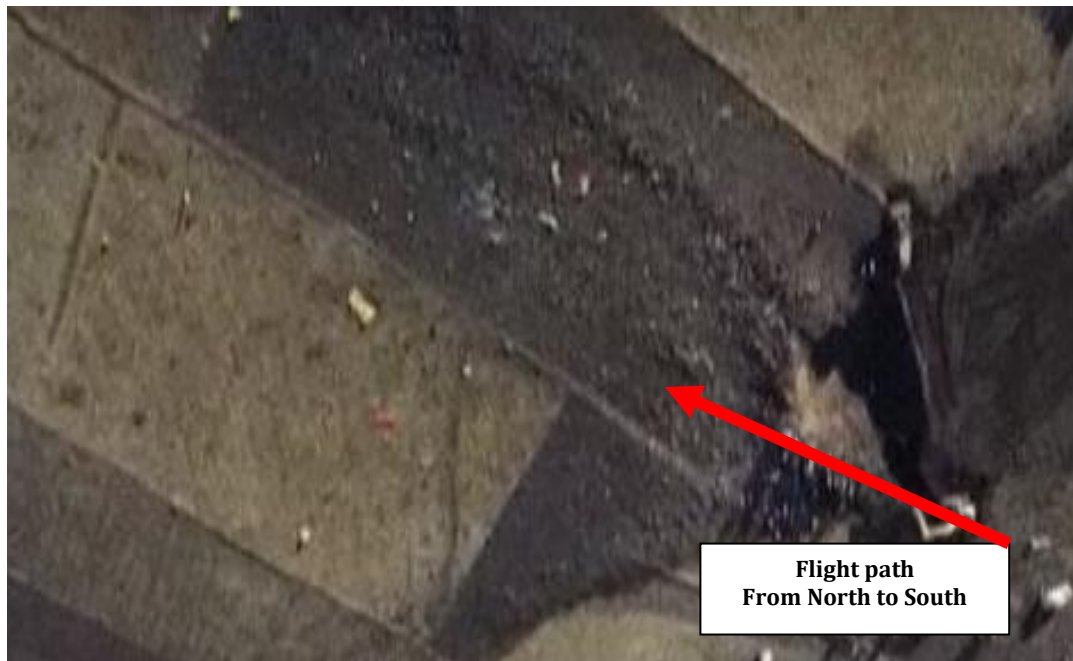
FIGURE 40: TOP VIEW OF THE CRATER

The Airplane impacted terrain at a farm field and created a crater approximately 10 meters deep (last Airplane part found) with a hole of about 28 meters width and 40 meters length. Most of the wreckage was found buried in the ground; small fragments of the Airplane were found scattered around the site in an area about 200 meters wide and 300 meters long. Damages to the Airplane were consistent with a high energy impact.

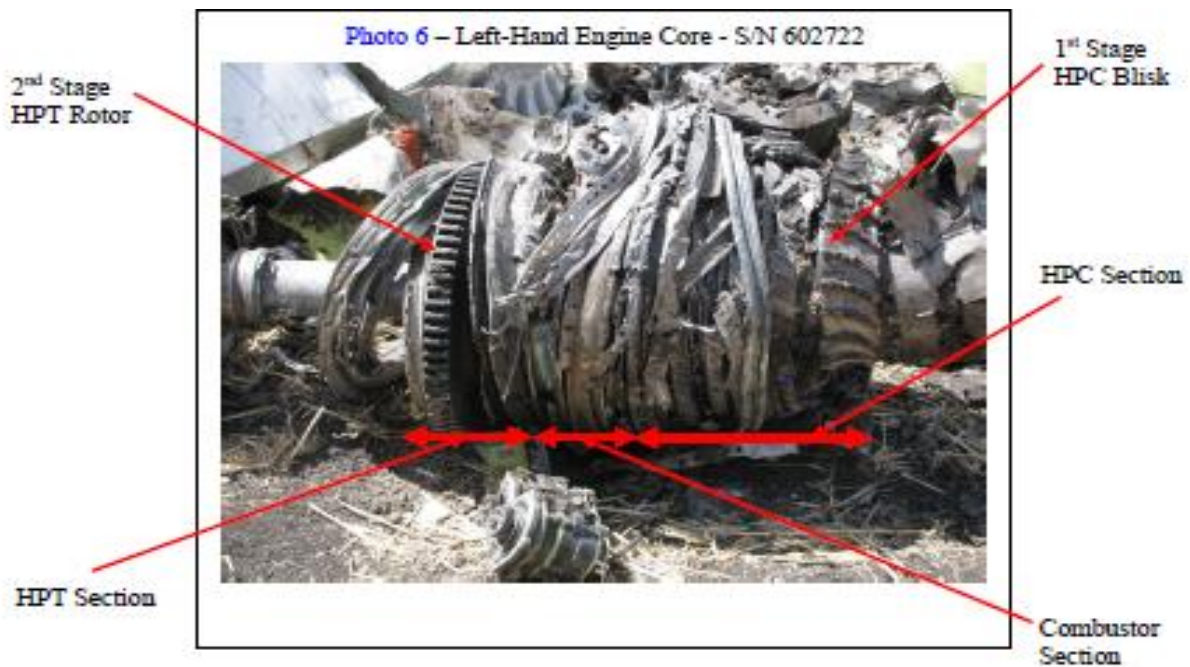
FIGURE 43: LEFT HAND ENGINE SECTION

The left engine core was recovered from the site and examined by the group. The engine was reportedly recovered at a depth of approximately 10 to 15 meters depth on the left side of the excavation site. The predominant feature of the deformation of the entire remaining core was axial deformation.

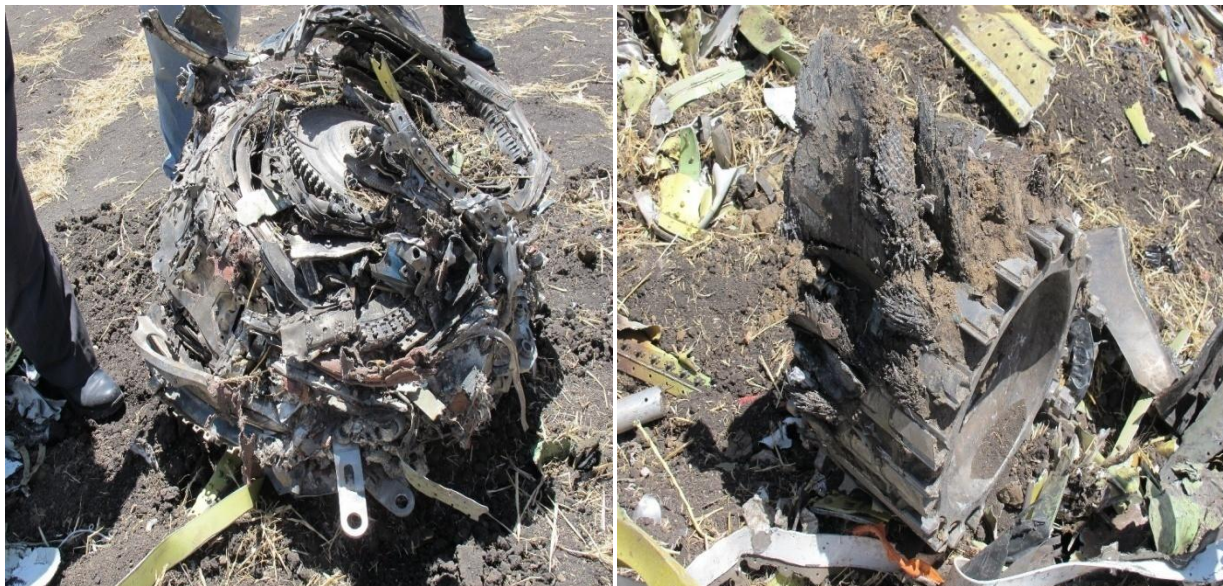
FIGURE 44: R/H ENGINE - S/N 602695 - CORE    FIGURE 45: - R/H ENGINE - S/N 602695 - FAN DISK

The predominant feature of the deformation of the entire remaining core was axial deformation.

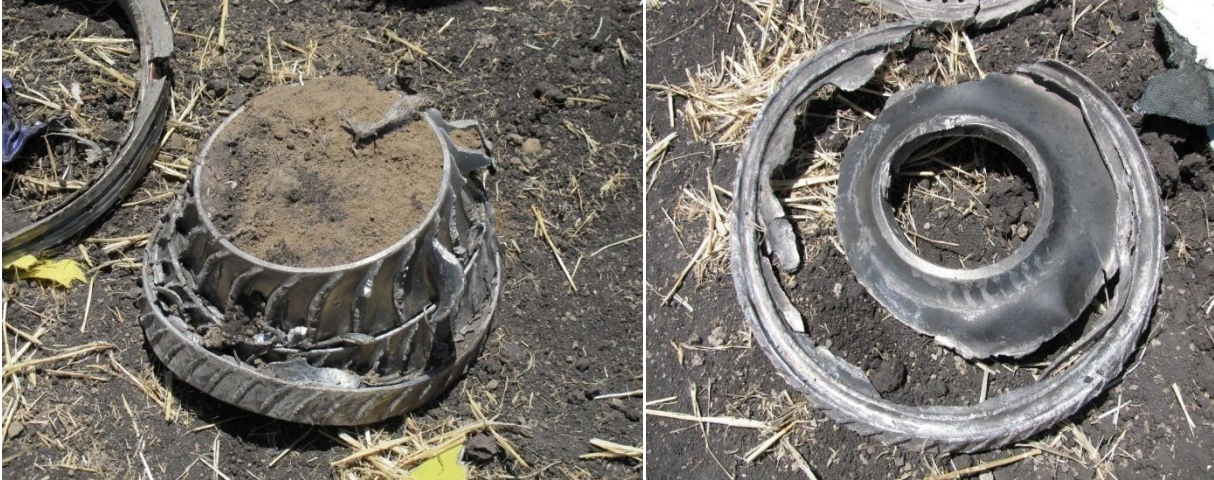
FIGURE 48: - R/H ENGINE - S/N 602695 - HPC STAGES 1 TO 3 FIGURES 49:- R/H ENGINE - S/N 602695 - HPC STAGE 7

6<sup>th</sup>, and the 8<sup>th</sup> to 10<sup>th</sup> stages were not found. The 5<sup>th</sup> stage was found separately, and it was also missing its airfoils. The 7<sup>th</sup> stage web was fractured circumferentially. The stator sections could not be identified.

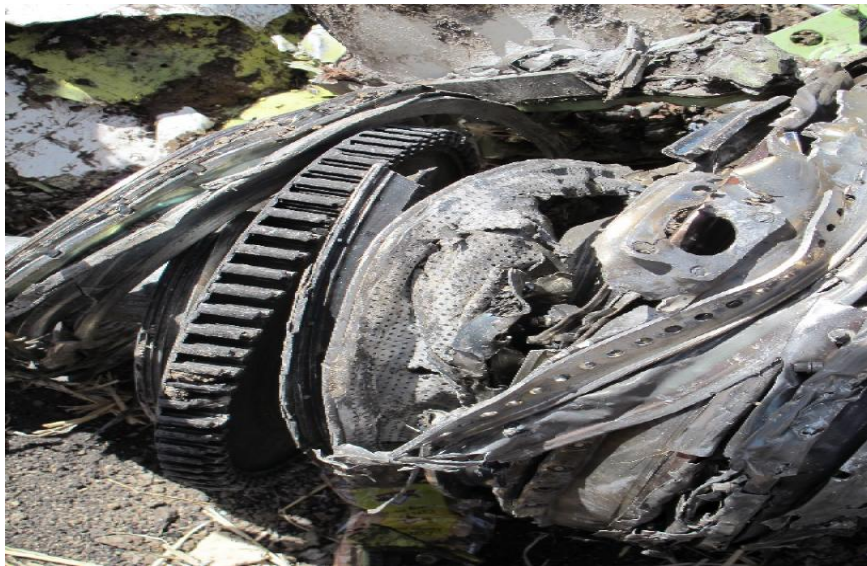
The combustor was severely crushed and most of it was missing into pieces.

FIGURE 50: COMBUSTOR CRASHED

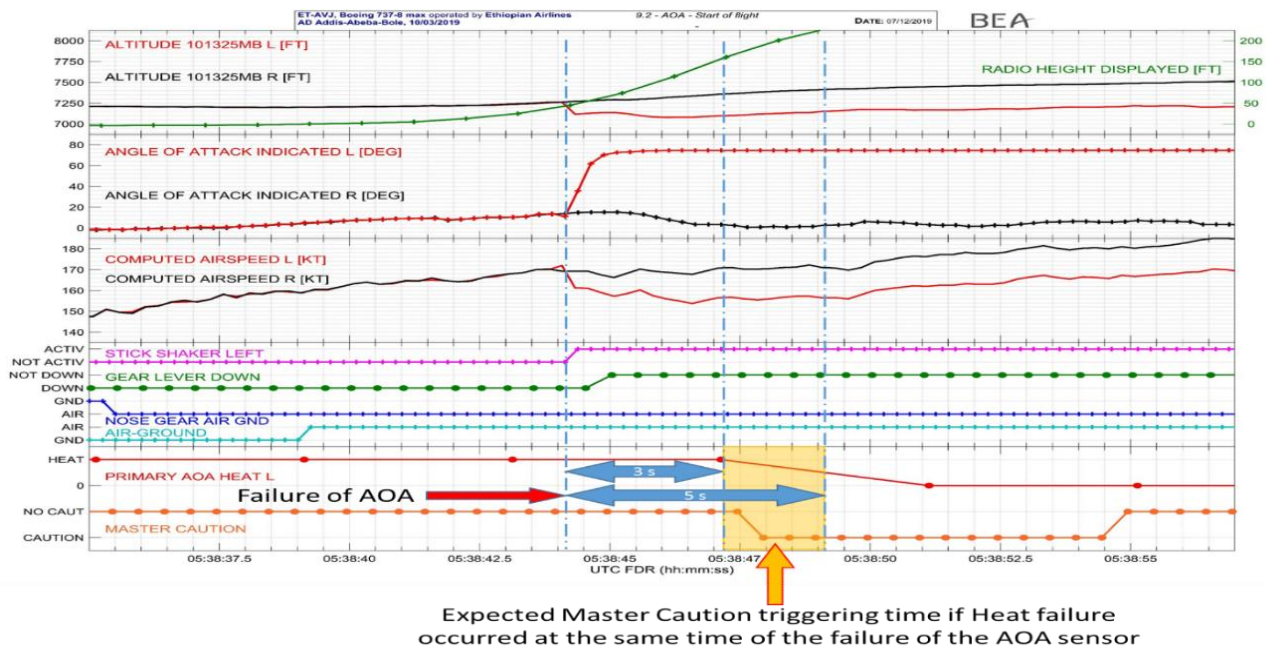
FIGURE 67: AOA VALUES DURING THE BEGINNING OF THE FLIGHT

From the CVR transcript, at 5 h 42 min 48 s, the Captain requested the recall of the master caution. At that time, master caution had only triggered once. Following the master caution recall, the crew exchanged “Master Caution Anti Ice” and “Left Alpha Vane”.

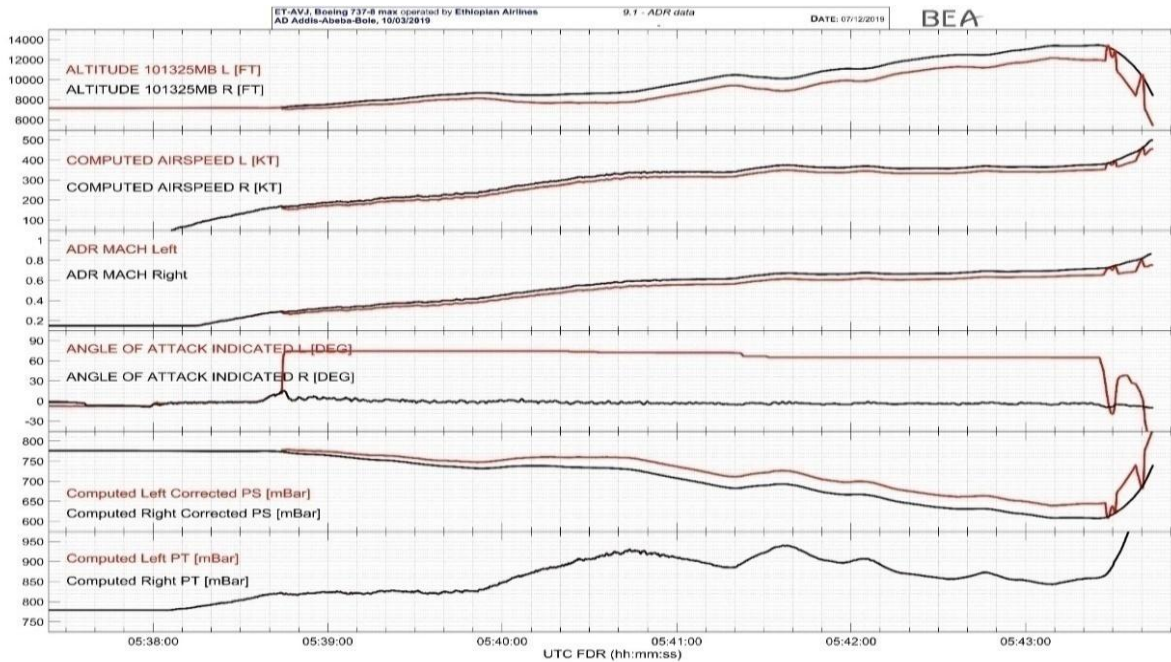
FIGURE 68: AIR DATA PARAMETERS

During the flight of the event, the left and right recorded altitude values, the recorded CAS values and the recorded Mach numbers diverged after LH and RH AOA values divergence.

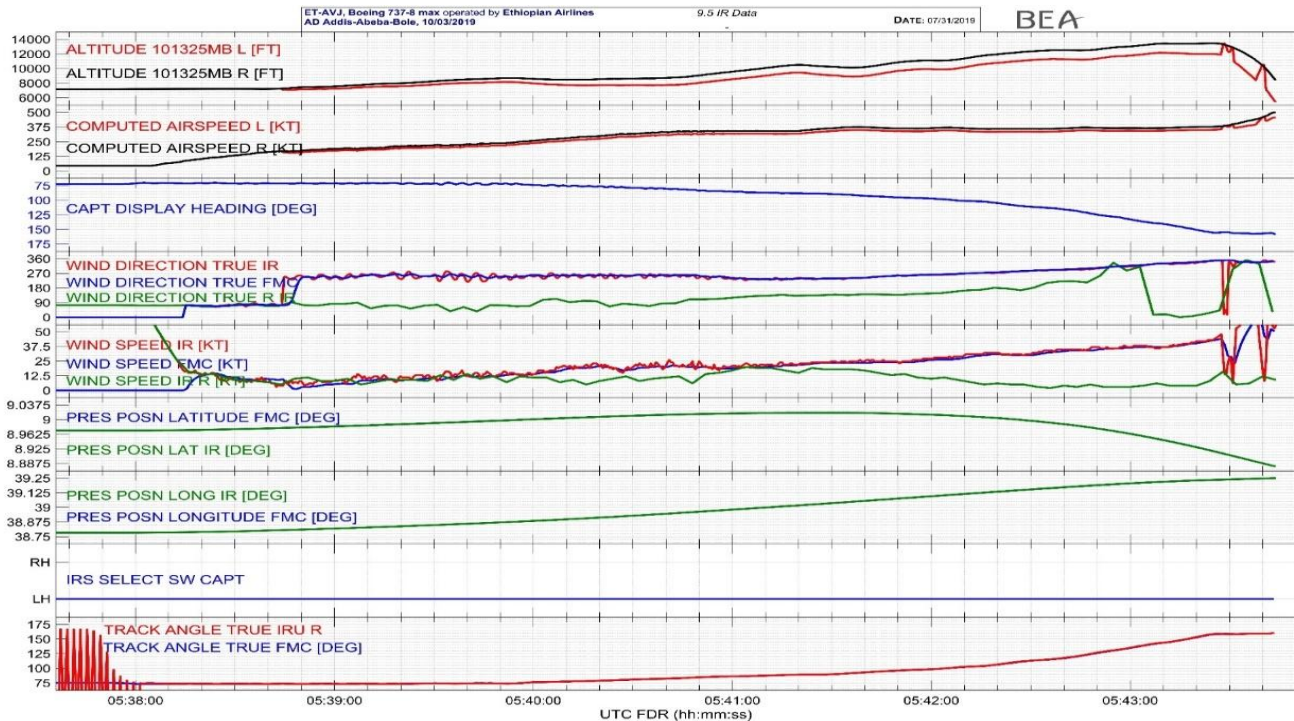
FIGURE70: IMPACT OF AOA FAILURE ON THE WIND COMPUTED VALUES

Most of the recorded IRS parameters did not show any variation following the AOA failure. On the contrary, the computed wind, on the left side, was clearly affected by that failure.

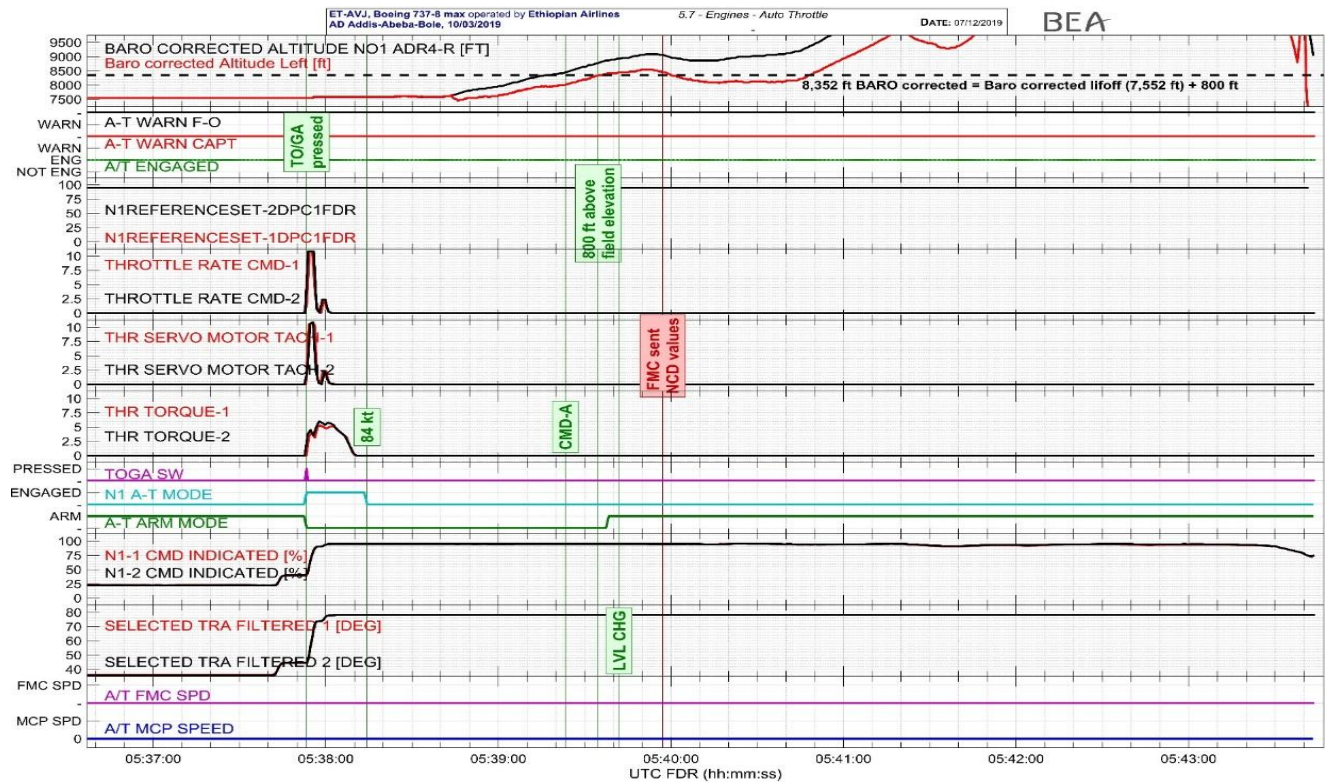
FIGURE 73: AUTO THROTTLE BEHAVIOR DURING THE FLIGHT OF THE EVENT

automatic reduction to climb thrust did not occur because the LH and RH TAS diverged by more than 25Kt before the FMC sensed that the Airplane had reached the thrust reduction altitude.

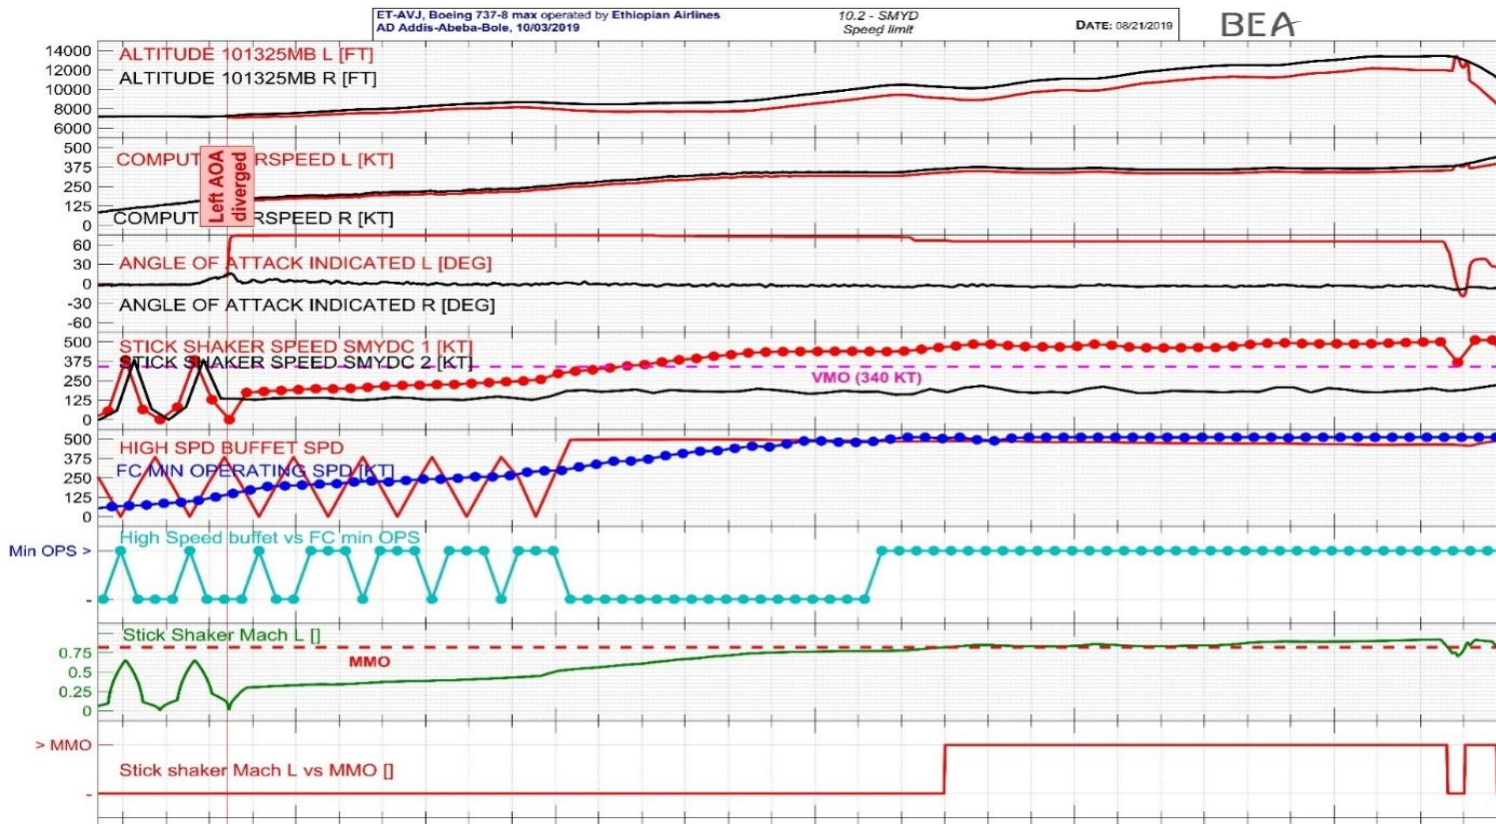
FIGURE 75: SMYD COMPUTED SPEEDS LIMITS

At 5 h 41 min 17 s, SMYDC1 computed FC minimum operational speed values greater than High speed buffet speed values. Both values were computed by the same computer SMYDC 1.

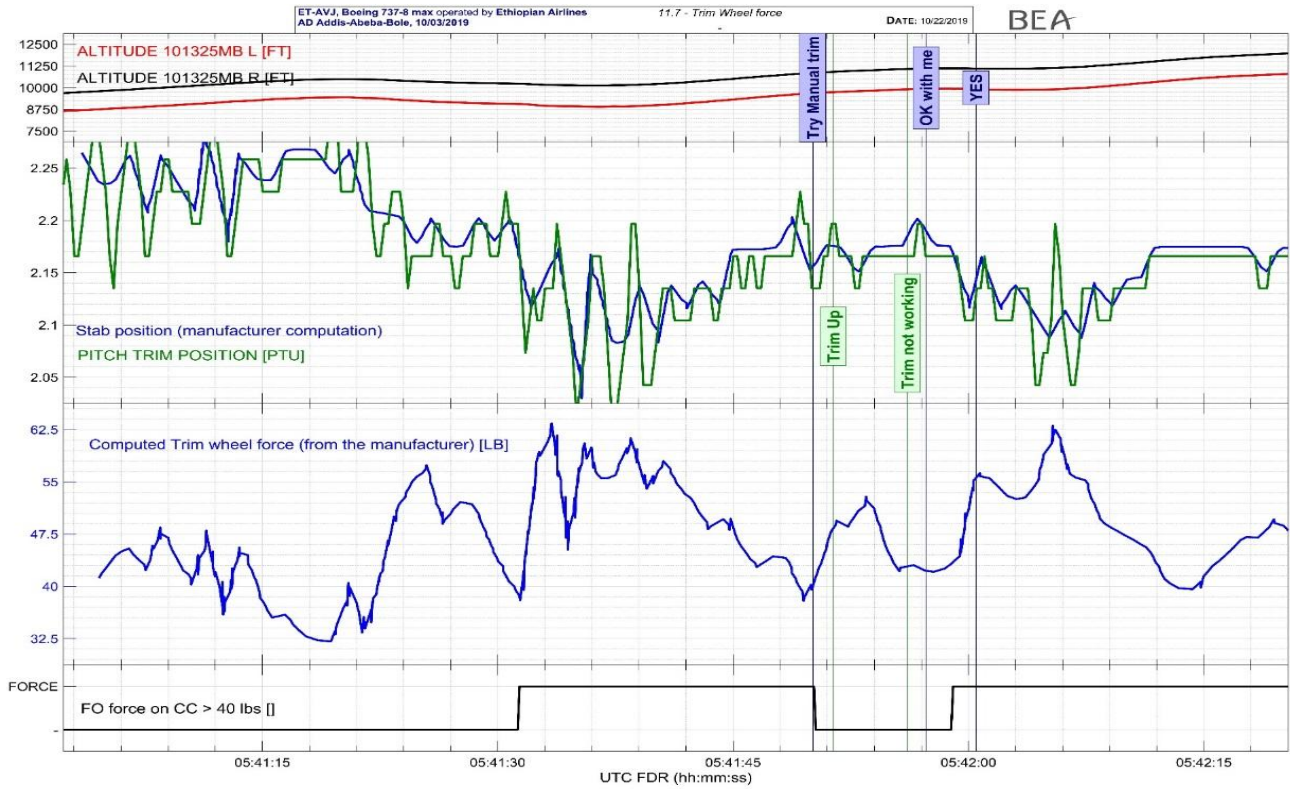
FIGURE 77: FORCE NEEDED TO MOVE THE TRIM WHEEL

The time during which the F/O tried to manually move the trim was then between 5 h 41 min 51 s and 5 h 41 min 56 s.

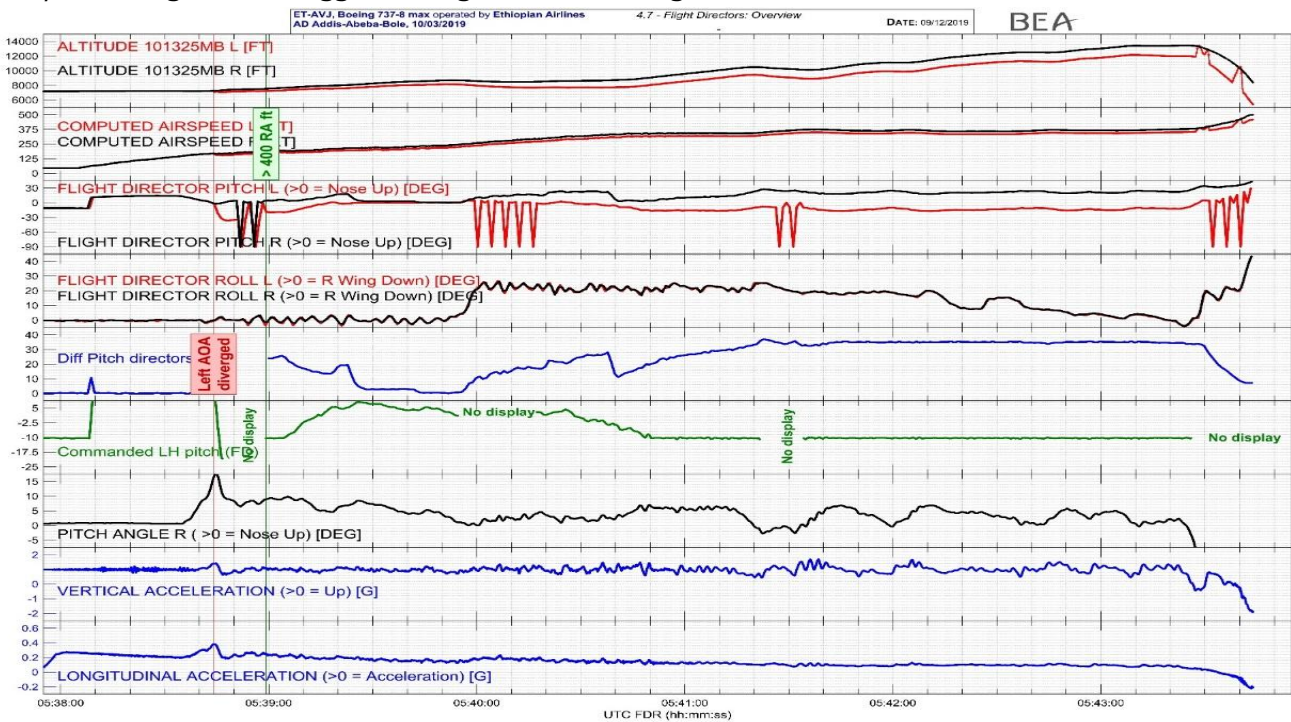
FIGURE 80: FLIGHT DIRECTOR DURING FLIGHT

Each time the LH or the RH invalidity pattern was recorded, the recorded invalidity code (NCD - No Computed Data) indicates that the pitch F/D bar was removed from the PFD (biased out of view or BOV). The F/D fail flag did not trigger during the accident flight.

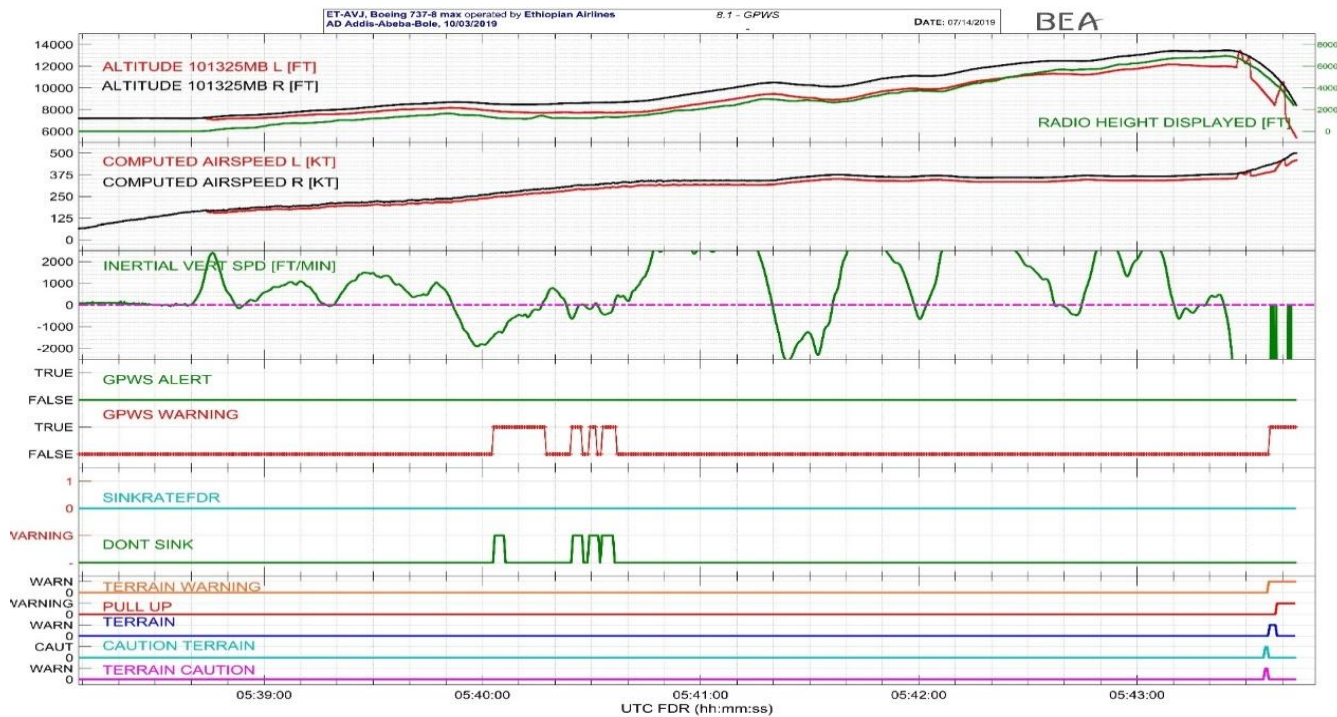
FIGURE87: GPWS ALERTS

At the end of the flight, the combination of the vertical speed and the height of the Airplane made the terrain and pull up warning trigger.

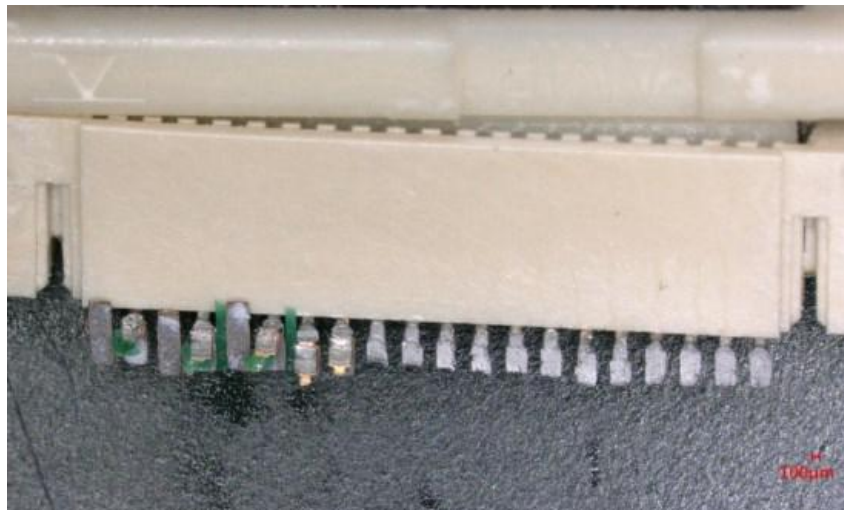
Figure5: Pads and pieces of PCB material on the connector pins

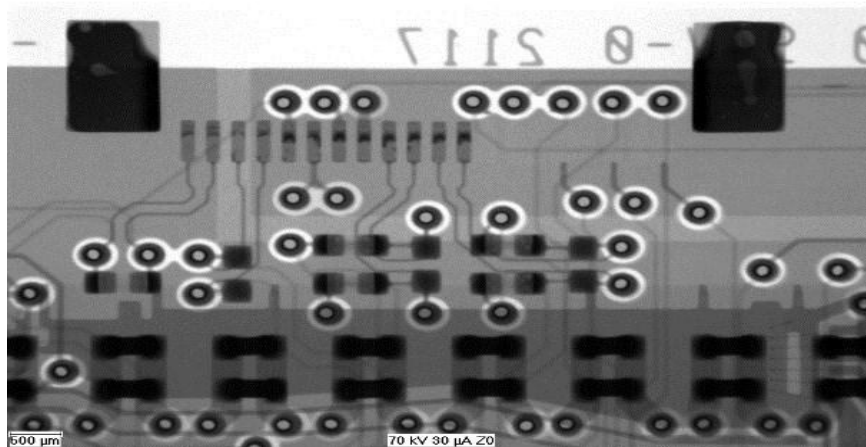
FIGURE 6: X-RAY EXAMINATION OF THE FDR MEMORY BOARD SHOWING THE 8 MISSING PADS
