Interference From a Hand Held Radiofrequency Remote Control Causing Discharge of an Implantable Defibrillator

MAN, K.C., ET AL.: Interference From a Hand Held Radiofrequency Remote Control Causing Discharge of an Implantable Defibrillator. A 46-year-old man with a history of sustained monomorphic ventricular tachycardia underwent an implantation of a third generation multiprogrammable implantable cardioverter defibrillator. One year post implant, while manipulating a remote control to a radiofrequency modulated toy car, the patient experienced a defibrillator discharge not preceded by an arrhythmia prodrome. Subsequent interrogation of the defibrillator revealed that a 34-joule shock had been delivered and had been preceded by RR intervals ranging from 141–406 msec, consistent with sensing lead noise. The remote control utilizes a 12-volt battery and has a carrier frequency of 75.95 MHz and a modulating frequency of 50 Hz. Evaluation of the remote control and defibrillator interaction revealed that the remote control was able to trigger tachyarrhythmia sensing and reproduce the clinical episode. Interference was present only when the remote control was within 8 cm of the pulse gen

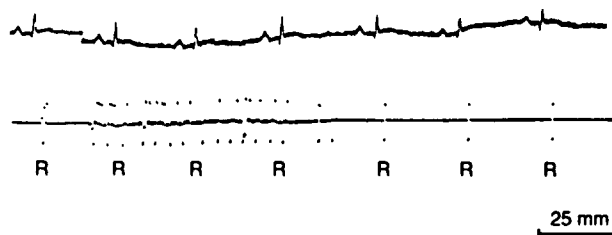
When the remote control was turned on and placed next to the pulse generator in the left upper quadrant of the abdomen, oversensing occurred (Fig. 2). This oversensing was dependent on the

**Figure 2.** ECG tracing of sinus rhythm (top). Sensing markers (bottom) demonstrating the detection of intrinsic QRS complexes (R) and noise interference during sinus rhythm after the remote control was turned on (bottom).

distance between the remote control and the device, the orientation of the remote control in the frontal plane, and the length of the remote control antenna. Oversensing occurred only when the remote control was within 8 cm of the ICD. Interference was observed only when the antenna was angled between 60–120° in the frontal plane and when the antenna was extended > 45 cm. Noise detection was eliminated when a ground wire was attached to the antenna and when the antenna was detached from the remote control. The various features of the remote control transmitter such as the steering and speed did not affect the level of signal interference. Finally, no signal interference was detected when an aluminium shield was placed between the pulse generator and the remote control.
