**REPORT ON A MID-TO-LATE NINETEENTH-CENTURY WOODEN SHIPWRECK
IN THE EAST CHANNEL OF THE MOBILE RIVER SUGGESTED AS A CANDIDATE
FOR THE 1855 SCHOONER *CLOTILDA*,
BALDWIN COUNTY, ALABAMA**

JULY 2018

JAMES P. DELGADO, PHD, RPA, KYLE LENT, MA, RPA, JOSEPH GRINNAN, MA, RPA,
DAVID W. MORGAN, PHD, STACYE HATHORN, MA, AND DAVID CONLIN, PHD

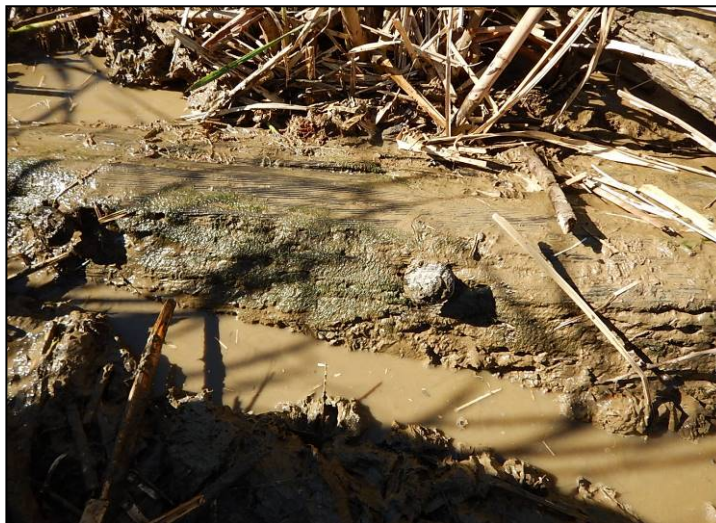
The same timbers that comprise the stem are present on both articulated and disarticulated sections, including the stem and apron. Additional timbers extant on only the articulated section include the stemson, which runs aft atop the keelson. The articulated and disarticulated sections of the stem comprise the length of the stem as fitted to the vessel, implying that the forward section of the bow was intact when the vessel was abandoned. The stem has been exposed to river current for some period of time, as evidenced by wear on the timbers exposing drift bolt heads several centimeters beyond the existing timber surface (Figure 26). Hand excavation inside the disarticulated portion of the stem suggests that the erosional wearing took place before the stem detached.

Figure 26. Erosional wear on the fallen stem piece; visible after hand excavation.

Originally, the bolt heads would have been flush with the timber, indicating that moving water and sediment over time wore away the surface of the stem. In addition, the repeated drying and rewetting process likely added to the wood warping process. In essence, the stem was weakened over time by numerous factors including erosion, marine borer damage, and probable dry rot. The stem likely detached from the hull as the result of higher water pulling on the structure or from a strike by a snag. The stem piece attached to the hull is partially wrenched free of the apron, and is angled to starboard, suggesting that a significant force was required to displace the upper portions of the stem (Figure 27).

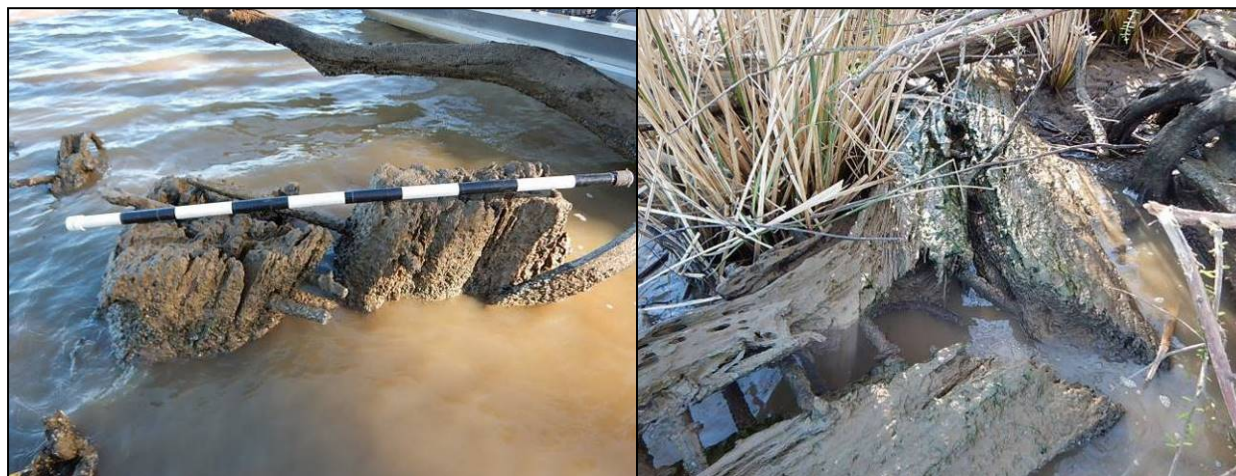
Figure 27. Left: The stem attached to the hull (note bobstays), looking aft and along the starboard side. Right: The upper stem, laying off the starboard bow.

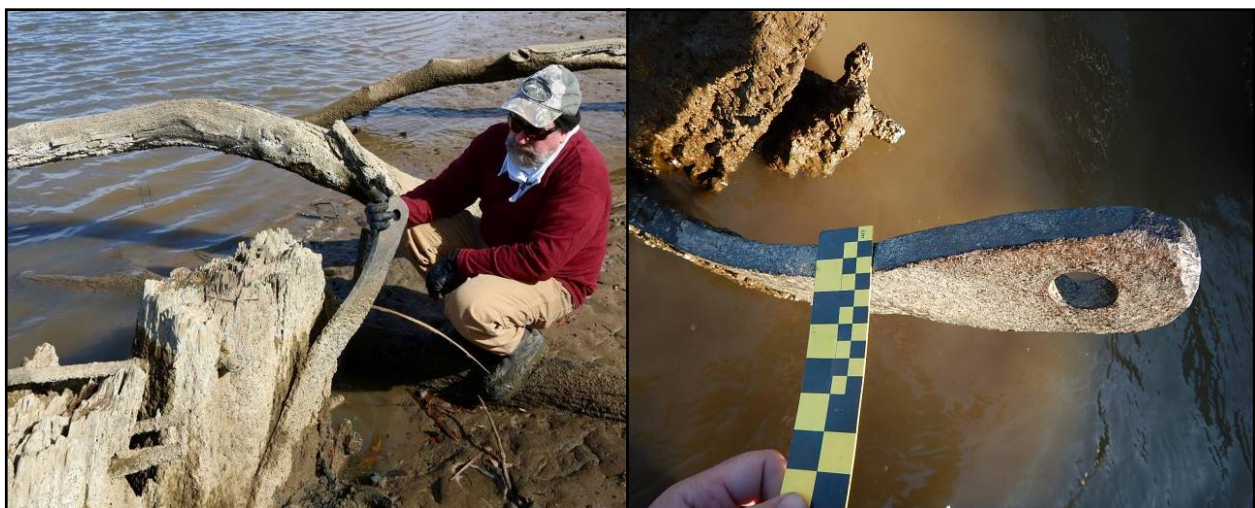
Figure 29. Iron strap for securing bobstays on the starboard side of the stem, as exposed in January 2018 (left) and March 2018 (right).

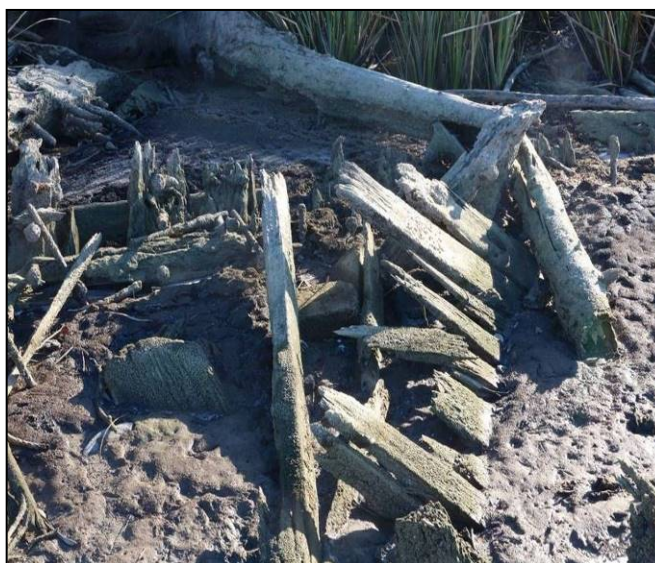
Cant frames are visible on the Twelvemile Island Wreck (1BA694). Cant frames are any of several frames bracketed aft of the bow of a ship and delineate the full form of the bow. The cant frames at the Twelvemile Island Wreck (1BA694) are heavily eroded and show evidence of marine borer infestation. The infestation is indicative of the height of the surviving vessel remains above the keel, and demonstrates that the hull has survived to at least the level of the original waterline at the bow. The cant frames and the bow timbers, as observed in January 2018, are fitted into the stem and delineate a sharp, flared bow (Figure 31).

Figure 31. Collapsed upper hull inside the bow. Source: Raines 2018.

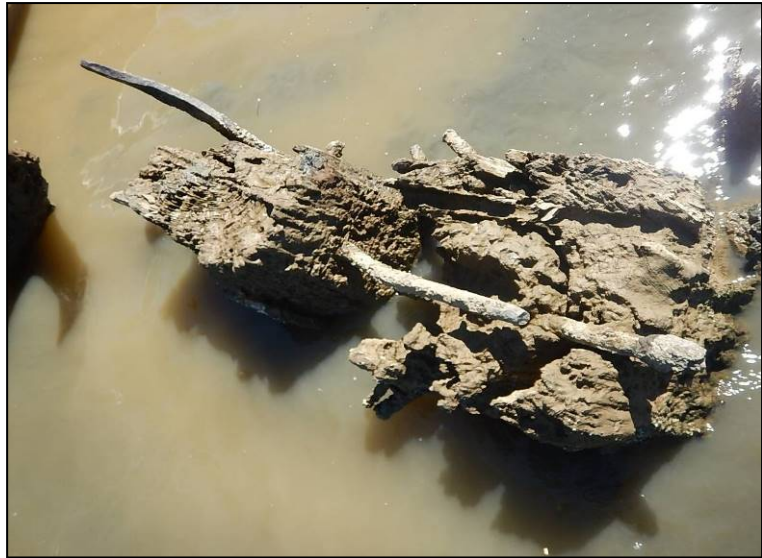
One distinctive feature of the wreck at the bow is a section of fallen hull from the juncture of the hull above the waterline where the flare of the bow meets the full body of the vessel. This portion of the vessel is comprised of a section of frames sandwiched between the exterior hull and ceiling planking. The exposed portion was subjected to attack and partial consumption by marine organisms. It is no longer in its original orientation and lies more or less athwart or across the breadth of the bow with broken and eroded planks rising out of the mud at an acute angle (Figure 32).

Figure 32. The partial separation of the stem and apron timbers still attached to the wreck, with the stem twisted to starboard and toward shore.

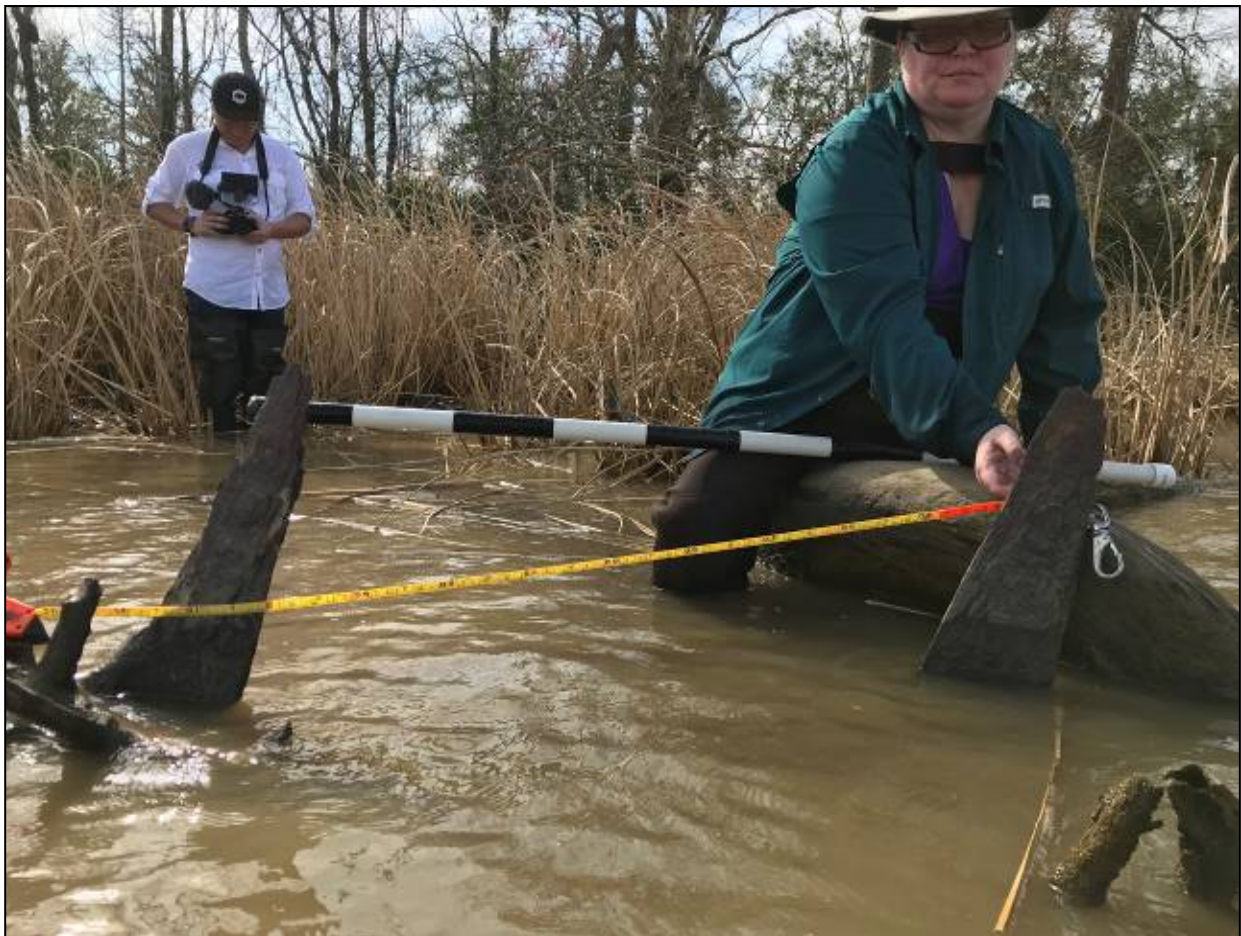
A second section of upper hull has detached and fallen into the inner hull of the vessel. This section of the structure is located on the starboard side of the vessel. This piece, upside-down from its original orientation, has two iron straps attached to it. Initially thought to be strap iron chainplates for rigging the foremast, they may be, based on their dimensions, iron or steel reinforcing straps (Figure 35). By the early twentieth century, "arch strapping" replaced mid-nineteenth-century diagonal strapping with iron. This essentially tied together a wooden hull that would carry heavy weight, usually early ocean steamers, or warships with multiple gun decks, to keep them from working apart in heavy seas. By the mid-nineteenth century, American shipyards built wooden vessels whose size "exceeded the ability of wood to support the weight of the hull" (Thiesen 2006:61). The solution for strengthening larger wooden sailing vessels was the adoption of iron reinforcing after 1850.

Figure 36. Archaeologist Stacye Hathorn measuring steel reinforcing straps along the starboard side of the vessel.

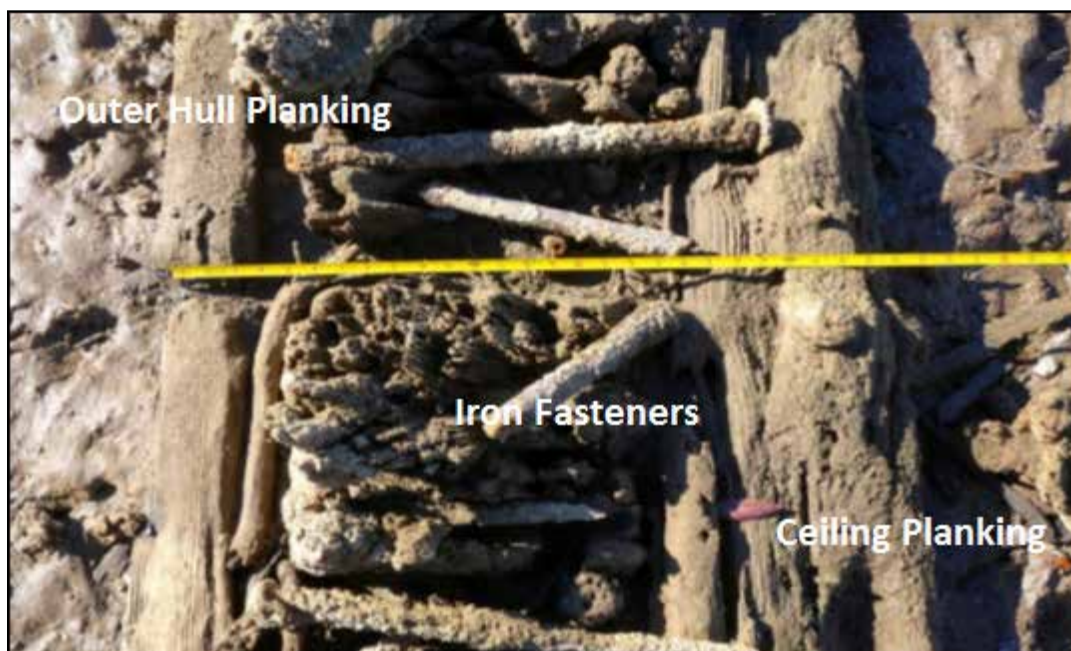
The higher water conditions of the March 2018 investigation of the wreck precluded visual inspection and measurement of the exposed frame ends, outer hull, and ceiling planking; however, much of the framework was visible and photographed during the January 2018 site visit. The hull of the vessel is heavily built. It is fastened with through bolts and iron or steel fasteners, with spikes, and with outer hull and ceiling planking midships that are 3.0 inches (7.6 centimeters) thick. The frames are double-sawn, a method employed from the mid-nineteenth through the early twentieth century, with large frame dimensions of 14 inches (36 centimeters) molded, and 10 inches (25 centimeters) sided. Ceiling planking is the timber inside the hull (on the right side of the image in **Figure 39** and **Figure 40**) with the thicker wale or strake that is believed to be a hold-beam shelf for the support of a hold or 'tween deck.

Figure 39. UWF measurement of a section of midships hull showing outer hull planking, the butt-ends of frames, likely at the third or fourth frame futtock level, and ceiling planking with the likely hold-beam shelf. Source: Raines 2018.

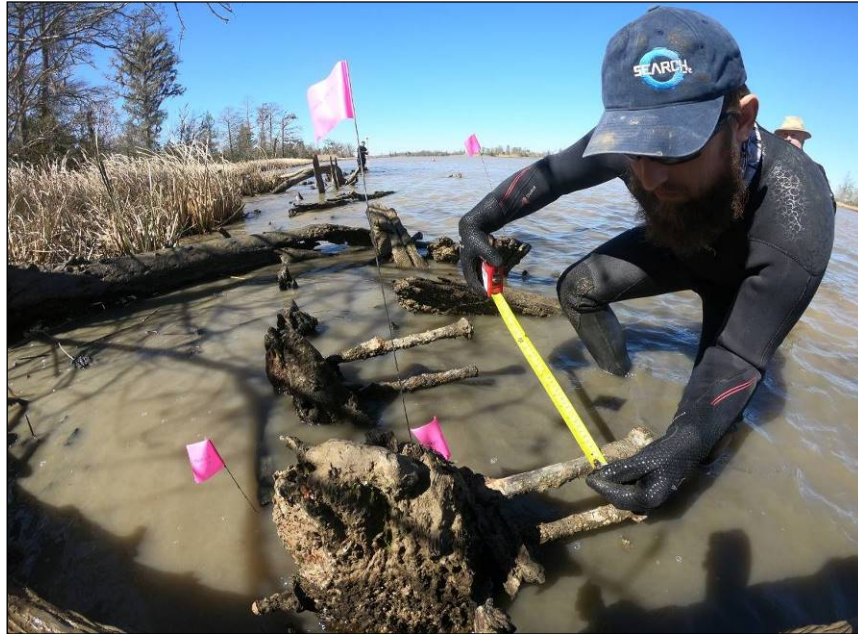
Figure 46. View of Twelvemile Island Wreck (1BA694) site from forward cant frames down starboard side; Joe Grinnan measuring drift bolt fastener; David W. Morgan in background with stadia rod; image facing west.

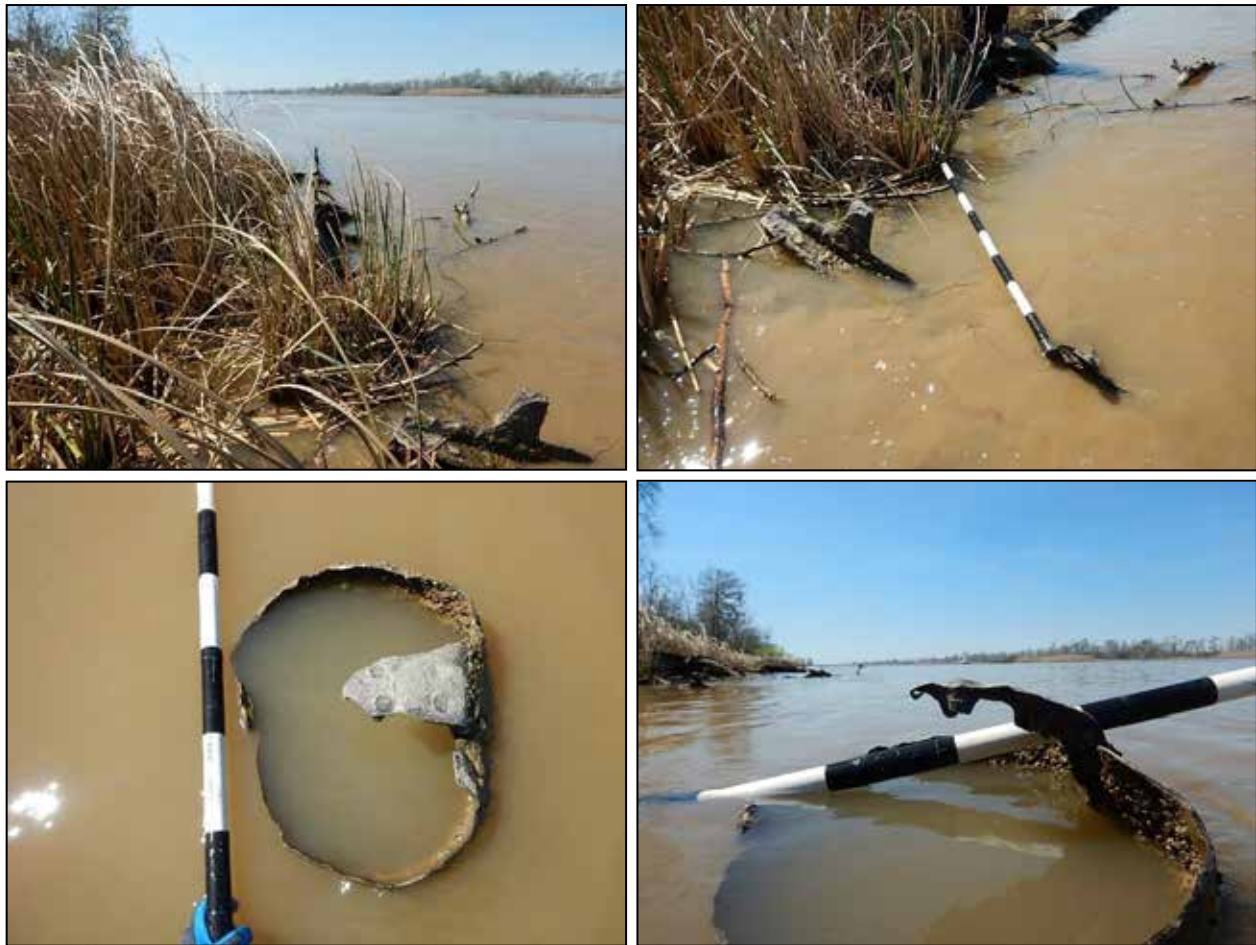
Figure 61. Photographs of the Dobbs Site. Top Left: Southeast corner, facing west. Top Right: Southeast corner, facing southwest. Bottom Left: Vent shaft, plan view. Bottom Right: Vent shaft in profile view, facing west.

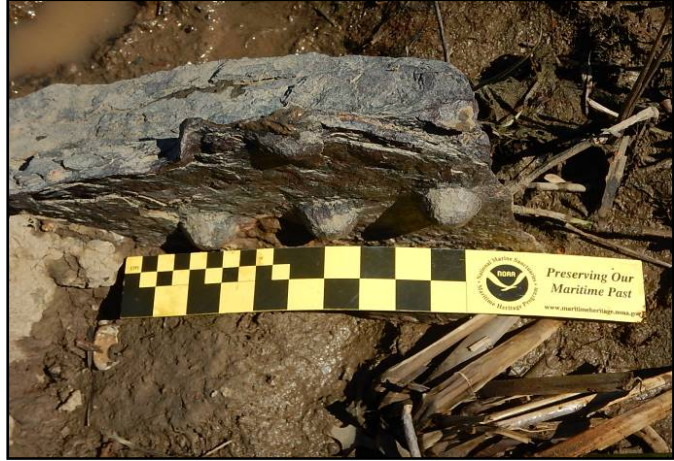
Figure 66. Close-up image of barge push-point feature at the Kennedy site showing rivets.

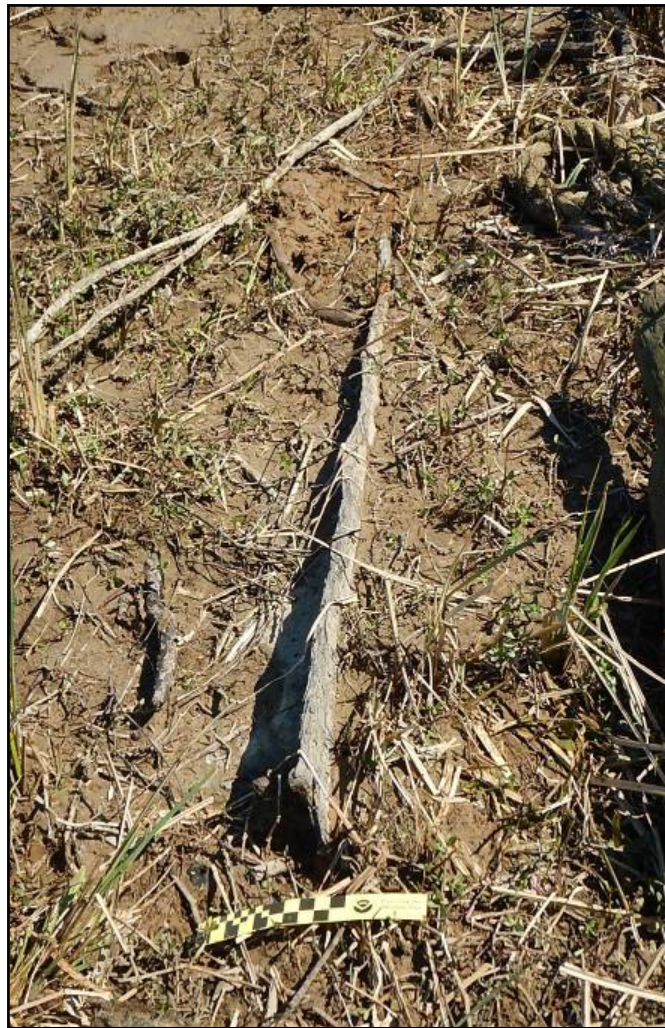
Figure 67. Southern edge of barge at the Kennedy site, facing northeast.
