DELTA VEHICLE FLIGHT FAILURE REPORT LAUNCH 33

OCTOBER 1966

GODDARD SPACE FLIGHT CENTER
Greenbel , Maryland

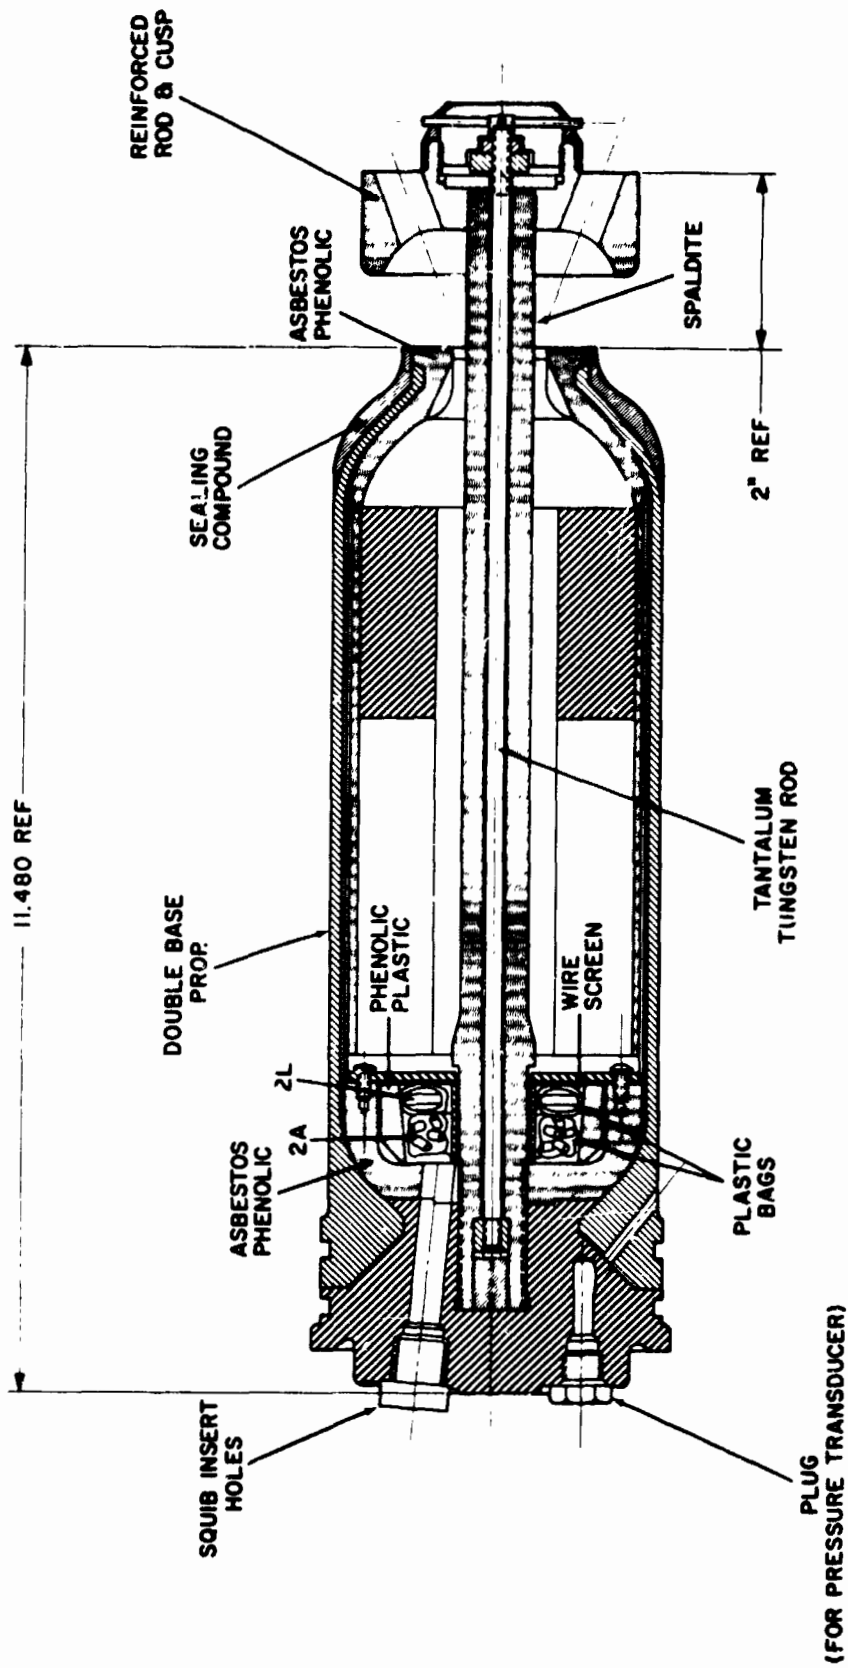
Figure 1

The pyrogen igniter used in Delta 33 (shown in Figure 1) was modified after the Delta 32 flight. This modification was made because a marginal ignition condition between the SD60AO squib and the BKNO_3 pellets, housed in the head cap of the igniter. This condition was discovered in a test firing at AEDC where an attempt to ignite the X-258 motor, with one squib instead of the customary two squibs, failed. The investigation of this failure revealed that the squib had discharged into the pellet chamber but the BKNO_3 pellets failed to ignite. The modifications made to the igniter to correct this marginal ignition condition were:

- a. The use of two pellet bags in place of one. The bag material was 1 mil non-conducting polyethylene in lieu of the former 4 mil conducting polyethylene bag.
- b. Each bag contained different size pellets to improve the ignition characteristic. Pellet sizes 2A and 2L were used where only 2L was used in the past.
- c. A phenolic spacer of larger inside diameter was used instead of the styrofoam spacer to eliminate the possibility of blocking the squib port and also to make additional room available for the additional BKNO_3 .
- d. The metal screen separating the BKNO_3 pellets from the igniter propellant grain was redesigned and metal washers were placed under the retaining screws.

Since the modified igniter did not undergo spin acceleration tests, and since this was the first flight of the modified igniter, the possibility existed that in the process of modifying the igniter it was made sensitive to spin acceleration, impact, or static electric discharge and possibly upon spin up in flight the igniter fired without the aid of the squib.

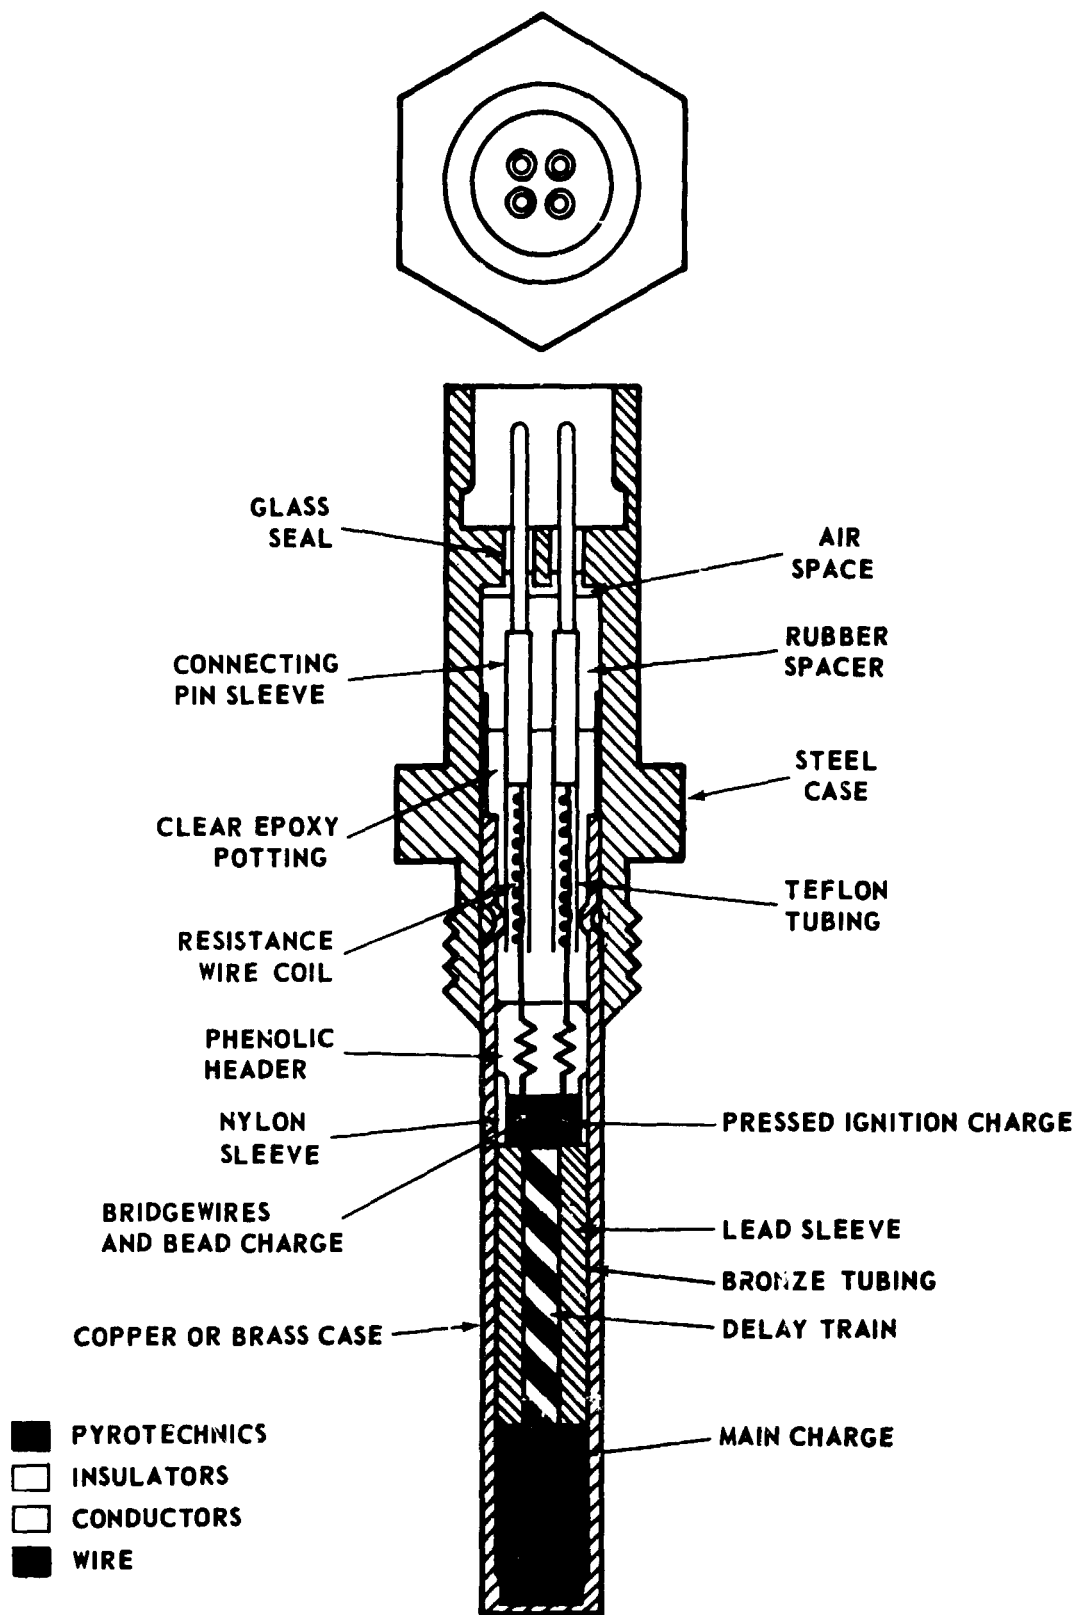
The SD60AO squib shown in Figure 2 contains a six second time delay train, dual bridgewires with a recommended all fire current of 5.0 amperes per bridge-wire. The bridgewires are covered with a single lead styphnate spot followed by a primer charge of 125 mg of lead oxide/boron which initiates the delay train composed of tellurium, selenium, and lead. The delay train fires the main charge

Figure 2-5D60A0 Squib Internal Construction

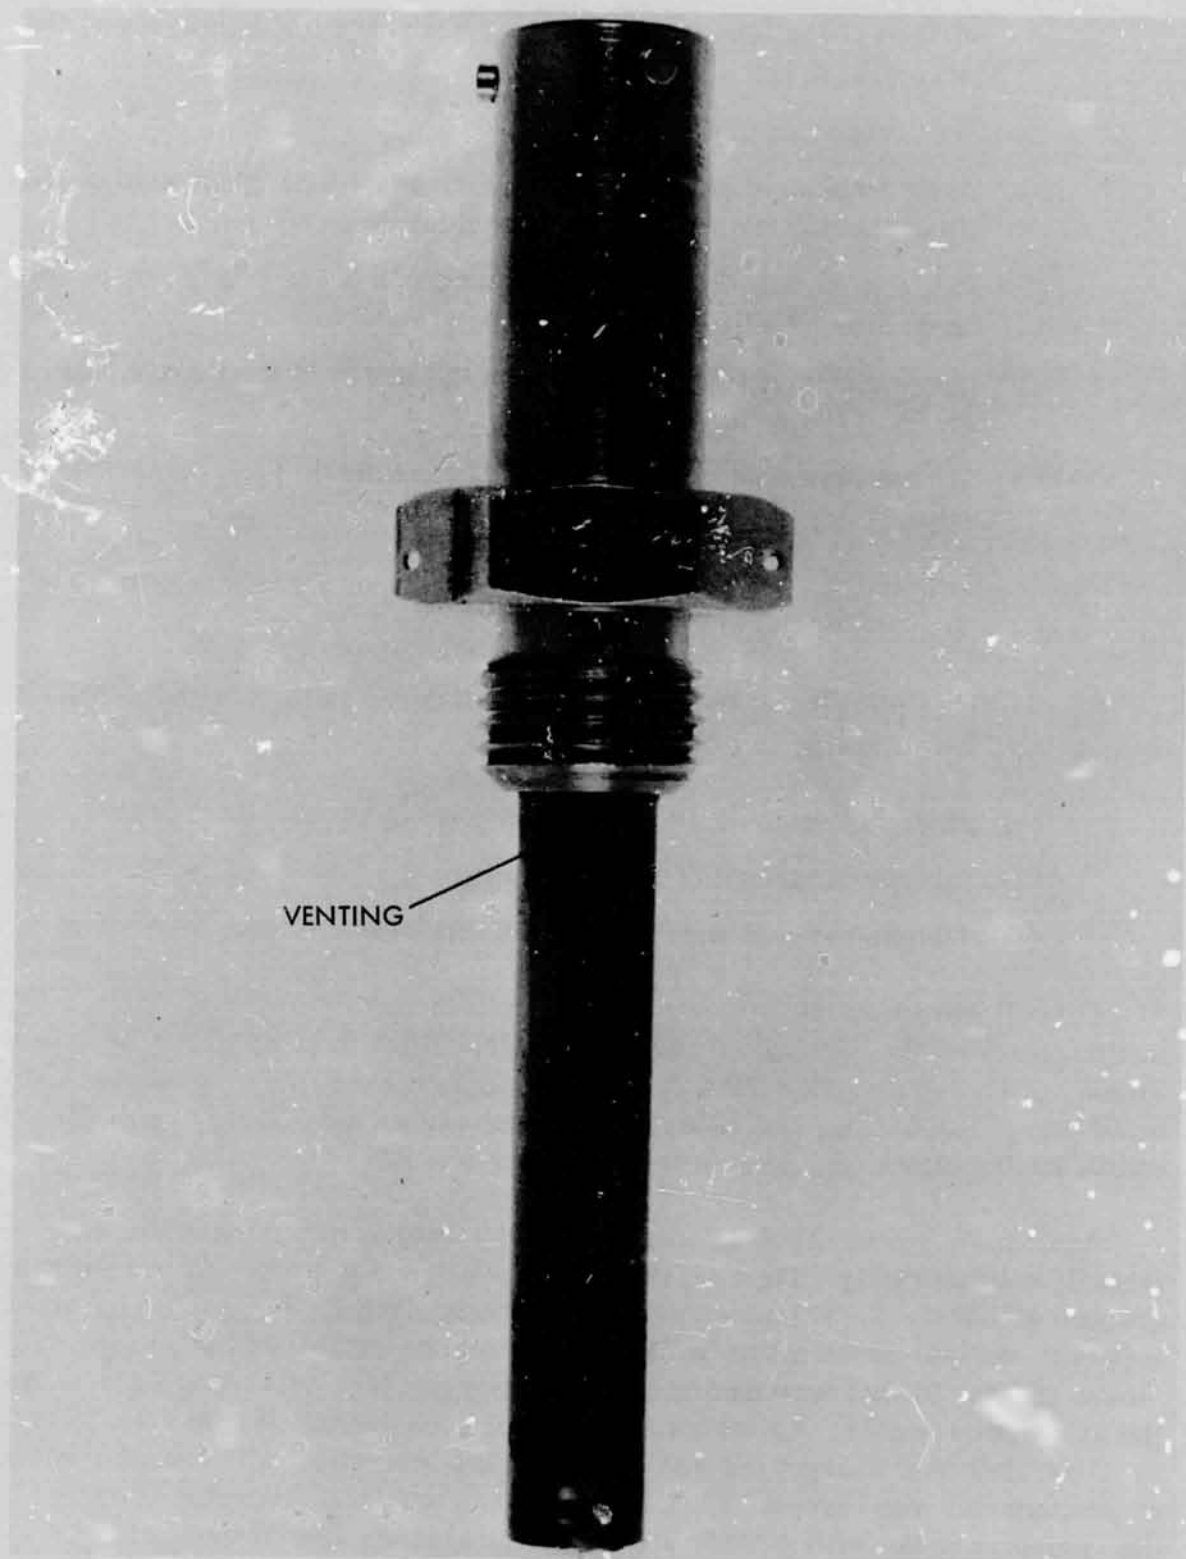
Figure 3. Showing "Venting" of "Jetting"

potting compound around the hot wires to boil and break away pieces. Presumably when some squibs are fired hot liquid or gas can be formed and escape between the sleeve and the header. If the sleeve to header bond is weak, a build up of gas pressure could conceivably eject the sleeve. In some tests this malfunction has happened. During a pyrogen static fire test, the squib initiation current remained on and the sleeve was ejected about 8 seconds after the bridgewire fired. Within this time span the other functions were normal. In other cases there is evidence of partial sleeve ejection (Figure 4) from the header.

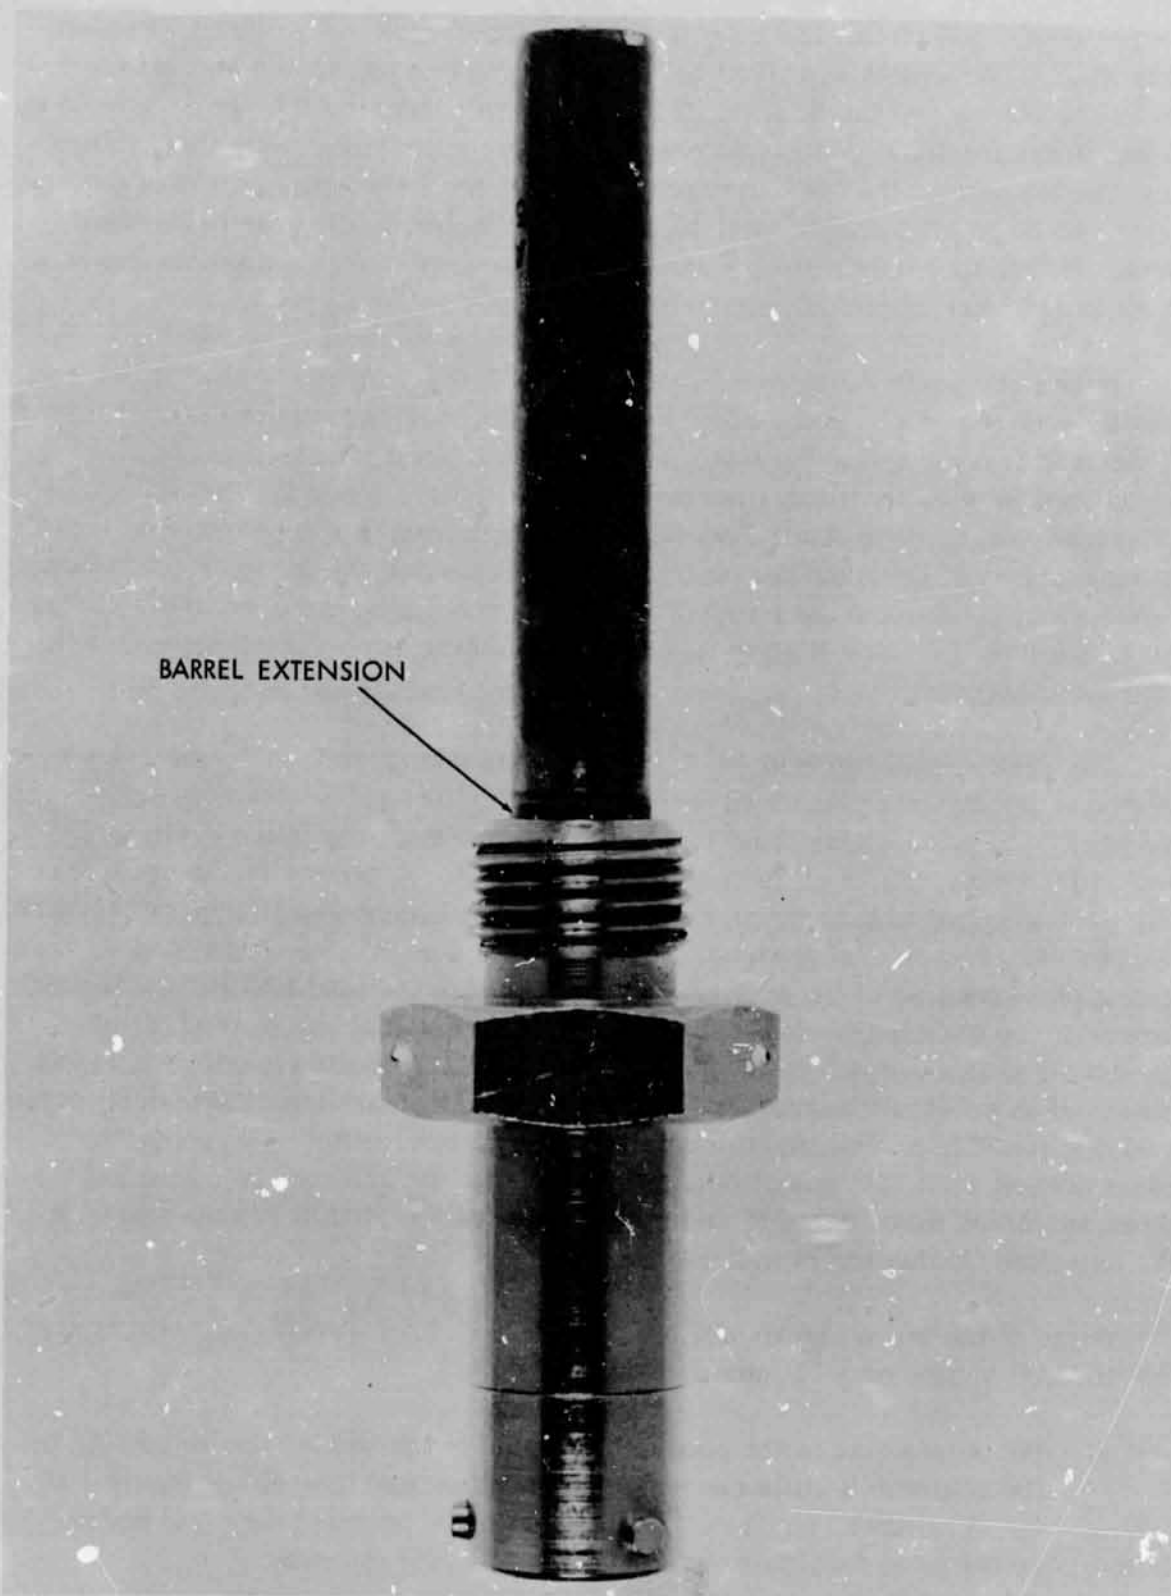
- a. Decomposition of the potting compound in the header due to heating by the resistance coils causes gas generation and internal pressure build-up. Pressure is relieved by "gas leakage" between the shell and header or barrel extension or in some cases barrel ejection.

Figure 4. SD60AO Showing Barrel Ejection

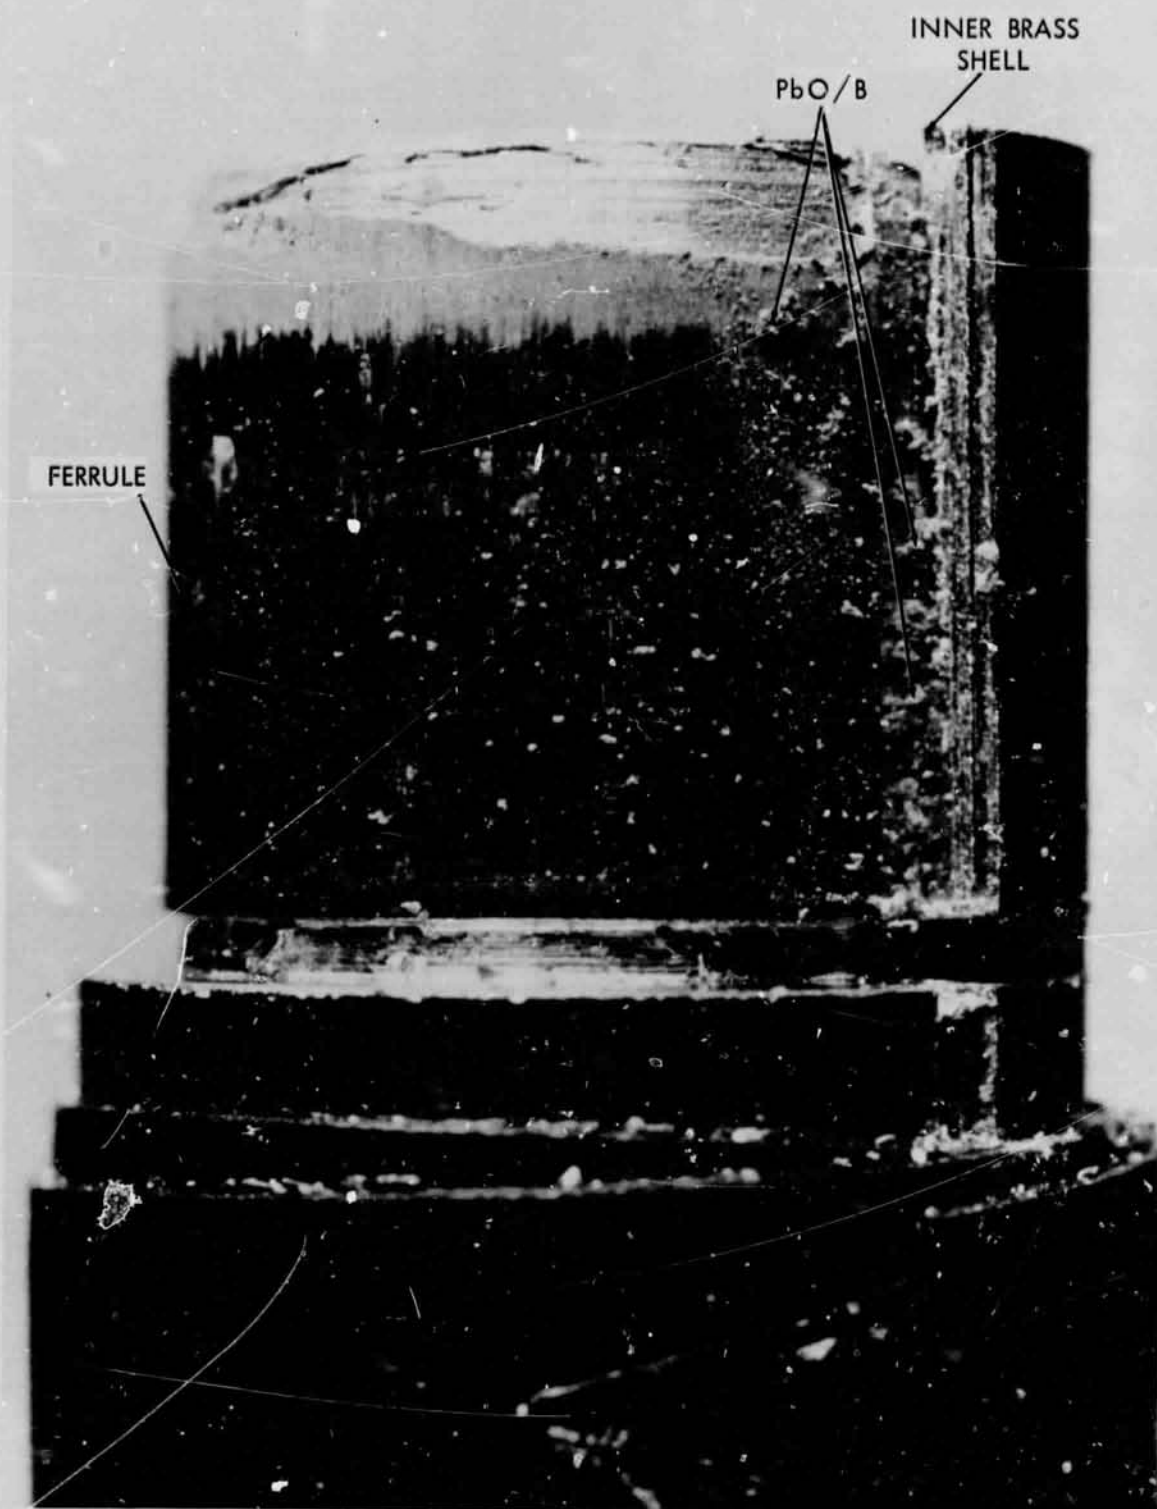
- b. Deposition of initiating and/or main charge (lead oxide/boron) material in some instances was observed between the lead ferrule containing the delay train and the brass shell (see Figure 7). Patches and globules have been observed extending from the main charge end up the length of the delay train and concentrated more heavily at both ends. Tests by Cornell indicate a gap greater than .005 inches is required for burning of this material. Gap widths greater than .005 inches are possible between the lead ferrule and the tubing due to fit tolerances, lead oxide/boron deposition and expansion due to temperature and pressure.

As a result of the above-mentioned tests on the SD60AO squib, it is concluded that there are several observed discrepancies in the manufacture and assembly of the squib that could result in premature ignition of the X-258 motor. The most significant discrepancies being (a) excessive ignition charge, and (b) deposits of lead/boron main charge material between the outside surface of the time delay lead ferrule and the inside surface of the innermost brass shell.

The most probable cause of the premature ignition of the X-258 rocket motor and the mission failure was the malfunction of the SD60AO squib. The most probable failure mode of the squib is for the initiation charge to bypass the delay train through a gap between the lead ferrule and the innermost brass shell.

Figure 7. Material Deposition on Lead Ferrule

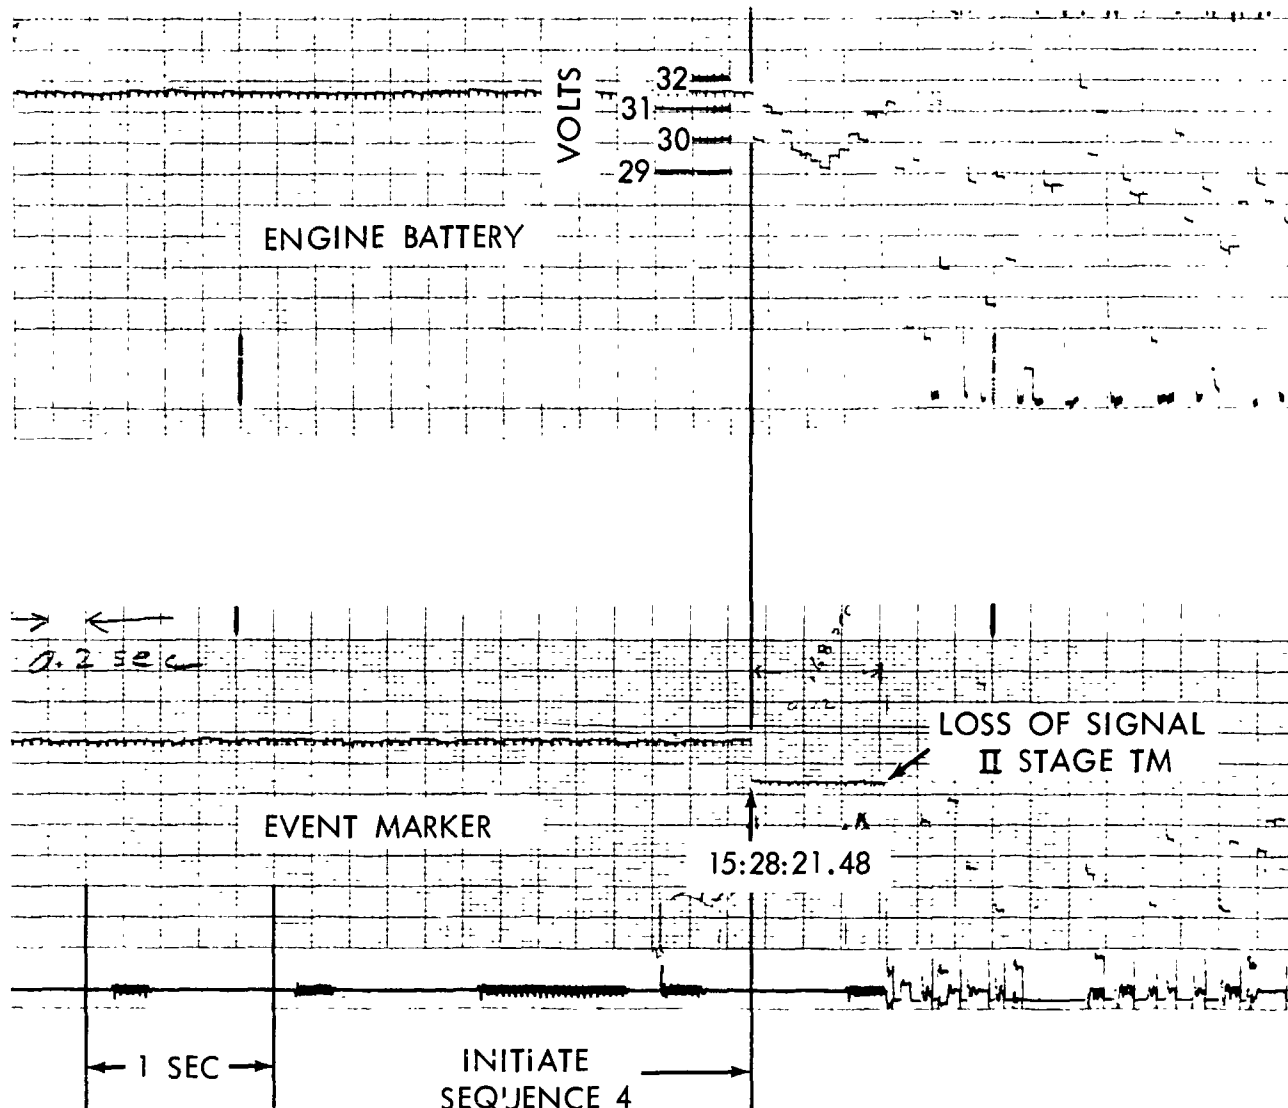
Figure C-6. Engine Battery Voltage at Sequence 4, Delta 33

may short to case, to each other; they may burn open or carbonize into a high resistance path to ground. This action is comparatively random and thus the varying load on the battery following the initial firing pulse. At 0.7 second after Sequence 4, all 2nd stage TM data was lost. Normally, however, the one (1) second time delay explosive switches would remove the power from the ordnance device and operate the wire cutters and it would be natural to expect a stepwise recovery of the battery voltage.
