AIRCRAFT ACCIDENT REPORT

ADOPTED: March 28, 1967**RELEASED:** April 4, 1967

AMERICAN FLYERS AIRLINE CORPORATION
L-188C, N183H,
NEAR ARDMORE MUNICIPAL AIRPORT
ARDMORE, OKLAHOMA
APRIL 22, 1966

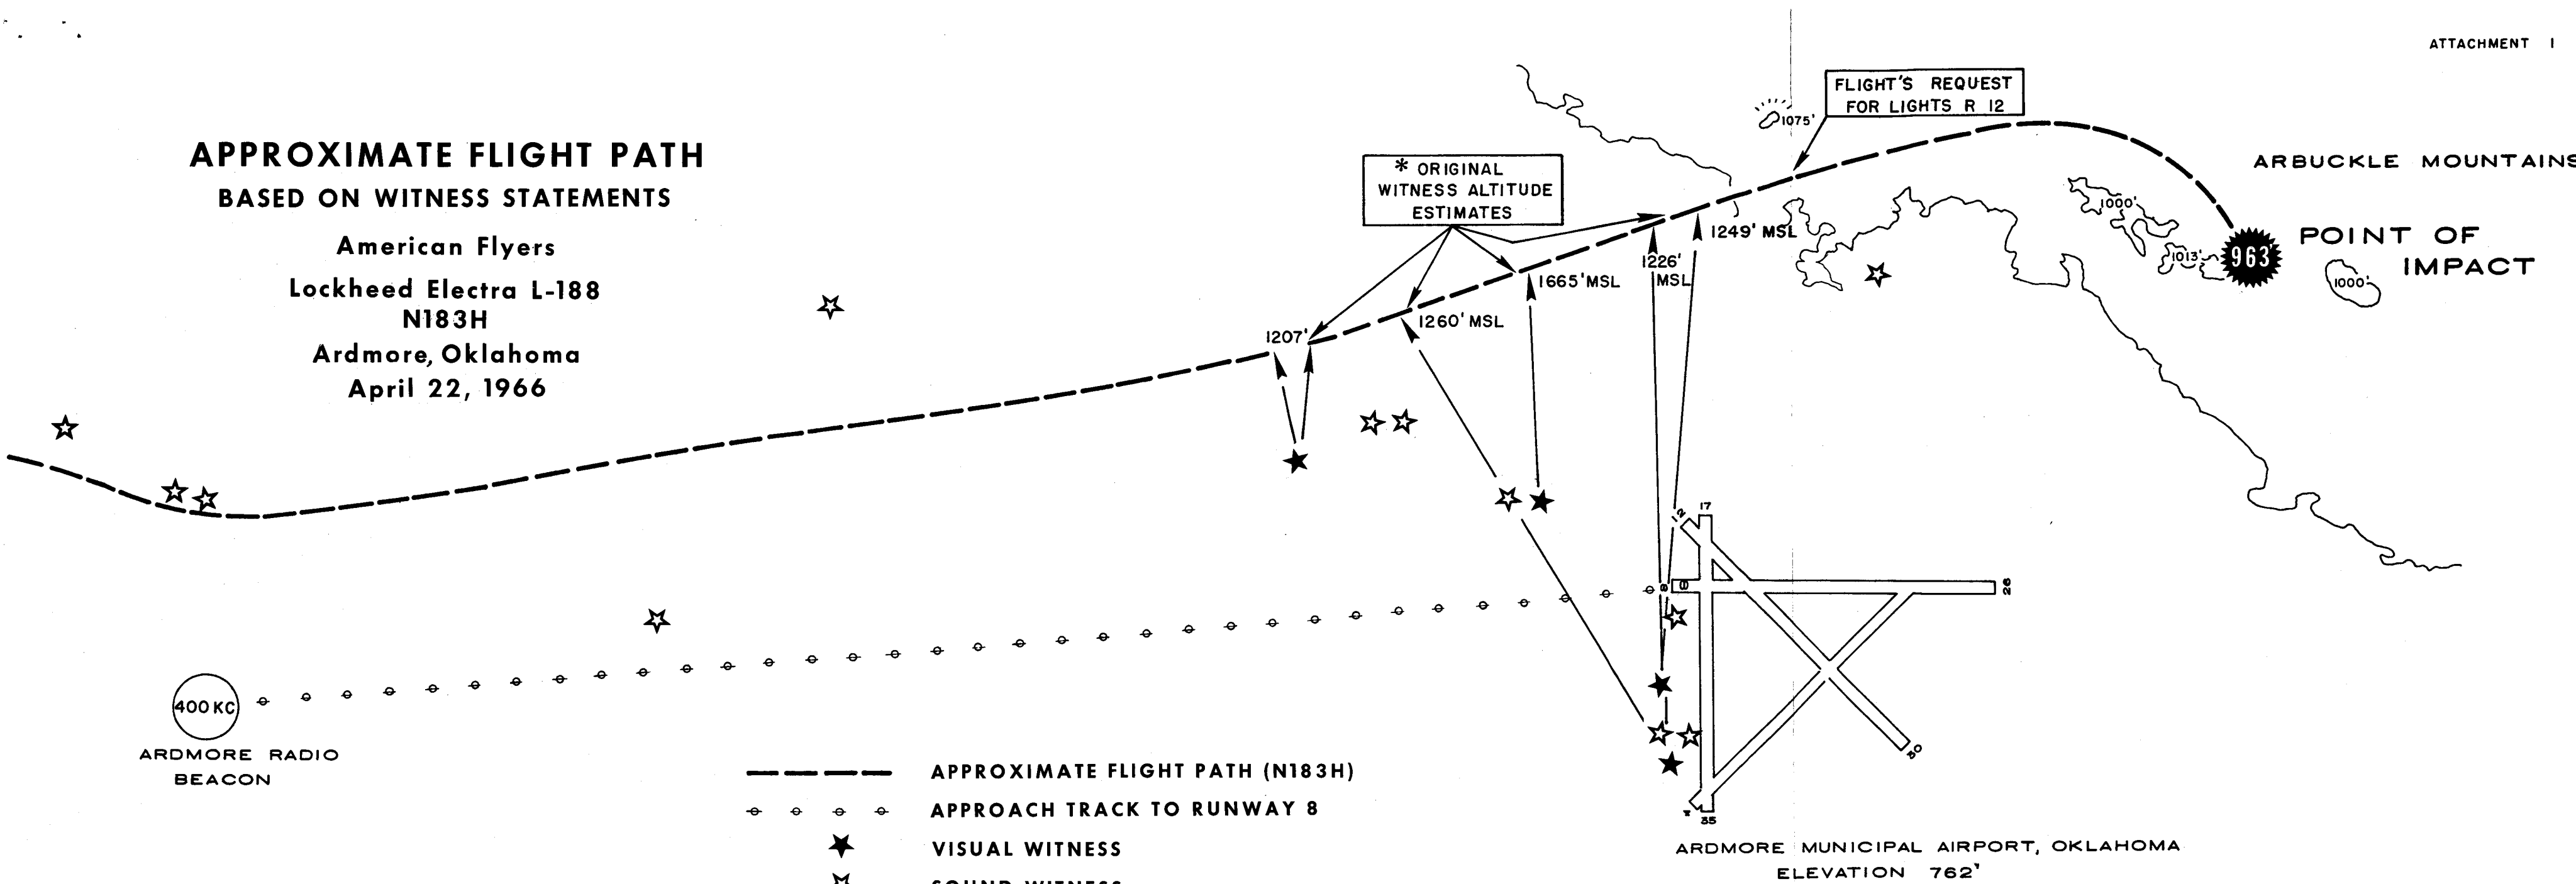
APPROXIMATE FLIGHT PATH BASED ON WITNESS STATEMENTS

At 2026, Ardmore Radio requested Flight 280/D's position and was advised they were over the beacon inbound. According to ground witnesses who observed or heard the original flight and watched and/or listened to the fly-bys, the aircraft passed approximately one mile north of the beacon and turned to the north-east establishing a track of approximately 071 degrees magnetic.

The aircraft's altitude at station passage should have been not less than 2,300 feet. The magnetic track from the Ardmore beacon to runway 8 was 076 degrees. It was calculated that Flight 280/D established a magnetic track after station passage of approximately 071 degrees. The aircraft was observed by a witness $1\frac{1}{2}$ miles northwest of the airport at approximately 1,160 feet m.s.l., and the average winds from station passage to this witness location were from 170 degrees at 27 knots. This would have introduced a drift of 10 degrees to the left. Since the aircraft was tracking 071 degrees magnetic, the aircraft would have been flying on a magnetic heading of 081 degrees.

Flight 280/D should not have descended below 1,362 feet m.s.l., unless the aircraft was clear of clouds. It has been determined that the aircraft did descend to approximately 1,160 feet, at which altitude it was observed north of the airport, and it crashed at 963 m.s.l. Since the ceiling was reported to be ragged, it is believed the crew descended below 1,362 feet in order to maintain visual flight and remain clear of clouds. The only obstruction within 5 miles of their approach path higher than 1,160 feet was a radio tower located 5 miles north of the beacon which was 1,579 feet m.s.l. The highest obstruction in the vicinity of the airport was located 2 miles north of the airport and was 1,075 feet above m.s.l. This was a tower located atop the Arbuckle Mountains which had an average terrain elevation of 1,000 feet m.s.l.
