No. 19

Trans World Airlines Inc., Boeing 707-331, N 769TW, accident at Leonardo da Vinci Airport, Fiumicino, Rome, Italy, on 23 November 1964. Report dated January 1966. released by the Ministry of Transport and Civil Aviation, Rome, Italy.

ACCIDENT TO B-707-331, N 769TW,
OF TRANS WORLD AIRLINES INC.,
AT ROME, ITALY. 23 NOVEMBER 1964

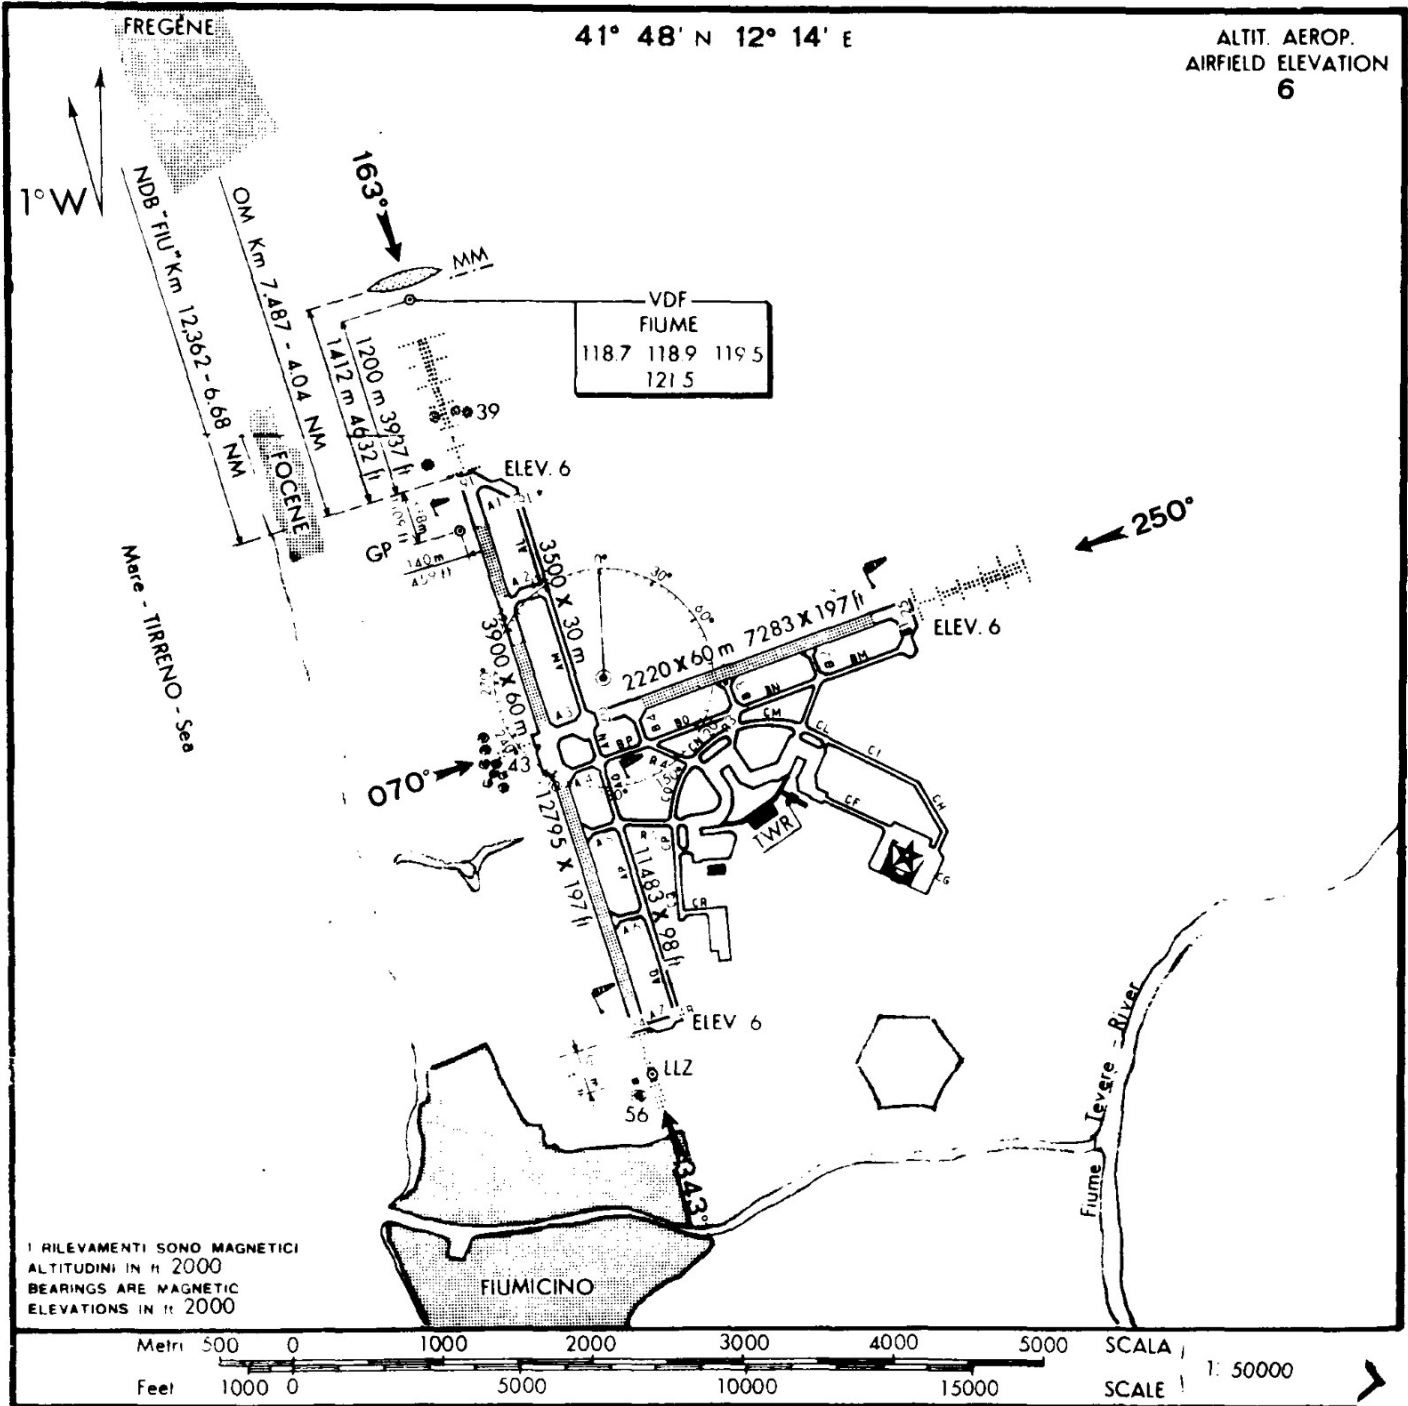
FIGURE 19-1

Runway 16/34 was usable over its entire length but taxiway 16/34 was not usable because of construction work (see Figure 19-1).

At the time of the accident, a power roller was located on taxiway 16/34, 301 m beyond the declared limit of runway 25 and 46 m north of the centre line of runway 25. It was moving northward and its height above the ground was 2.65 m, which was below the 1/50 gradient of the take-off climb surface specified in the ICAO Standards in Annex 14. Another piece of construction equipment, smaller in height (2.36 m), was also on taxiway 16/34, moving northward, at approximately the same distance beyond the declared limit of runway 25. This piece of equipment was also below the take-off surface.
