American Flyers Airline Corporation, Lockheed Electra L-188C, N 183H, accident near Ardmore Municipal Airport, Oklahoma, U.S.A. on 22 April 1966. Report No. SA-392, File No. 1-0001, released 4 April 1967 by the Civil Aeronautics Board, U.S.A.

ACCIDENT TO LOCKHEED ELECTRA L-188C, N 183H, NEAR ARDMORE MUNICIPAL AIRPORT, OKLAHOMA, U.S.A. ON 22 APRIL 1966

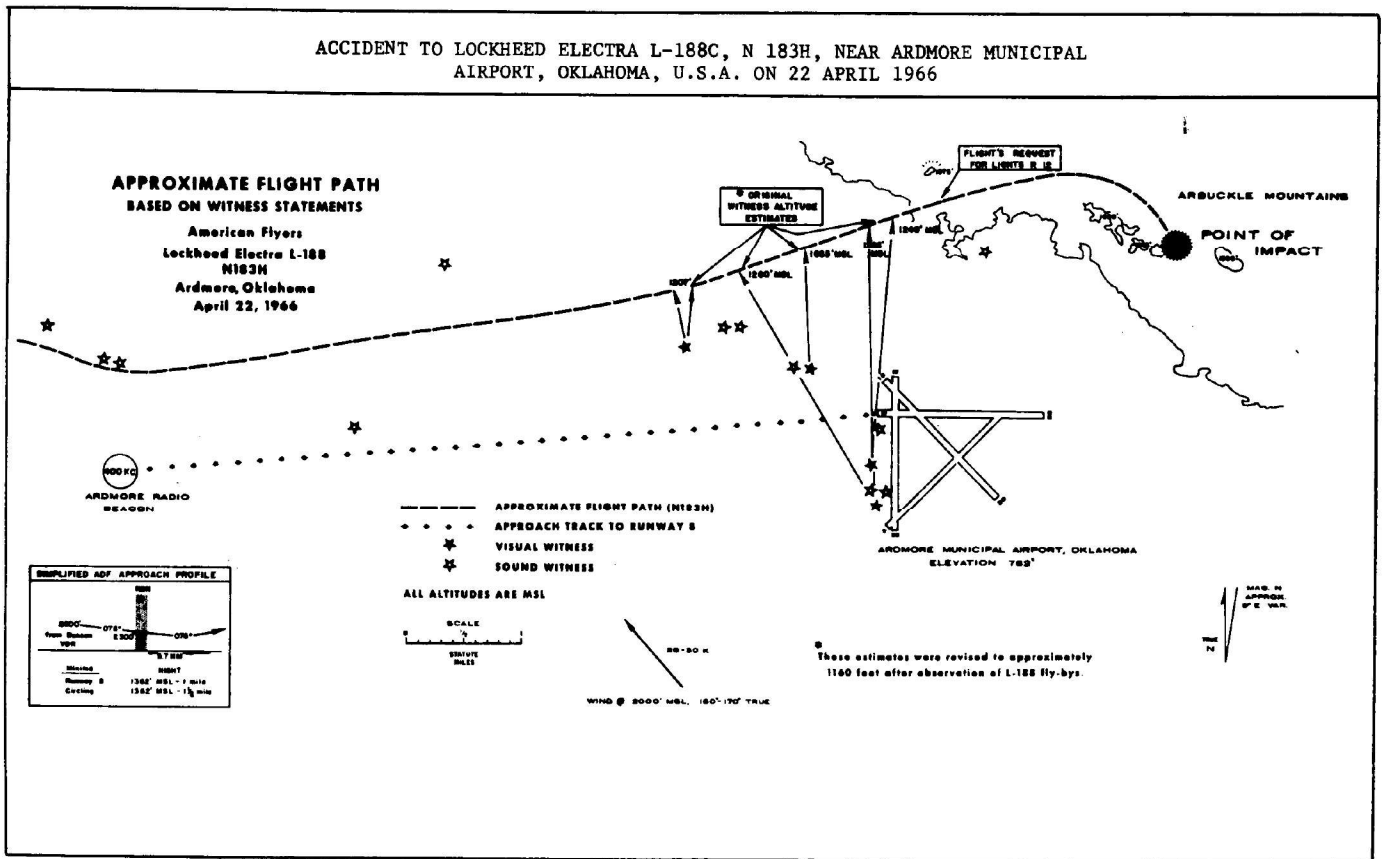
Fig. 9-1

Witnesses located along the route of flight stated that the aircraft passed approximately one mile to the north of the Ardmore beacon, then followed a path to a point approximately $1\frac{3}{4}$ to 2 miles north of the approach end of runway 08 at an altitude which was estimated as being approximately 1 160 ft (see Figure 9-1).
