No. 7

Cathay Pacific Airways, Convair 880-22M, VR-HFZ, accident, near Pleiku, South Viet-Nam, on 15 June 1972. Report dated 22 September 1972, released by Director of Civil Aviation, Republic of Viet-Nam

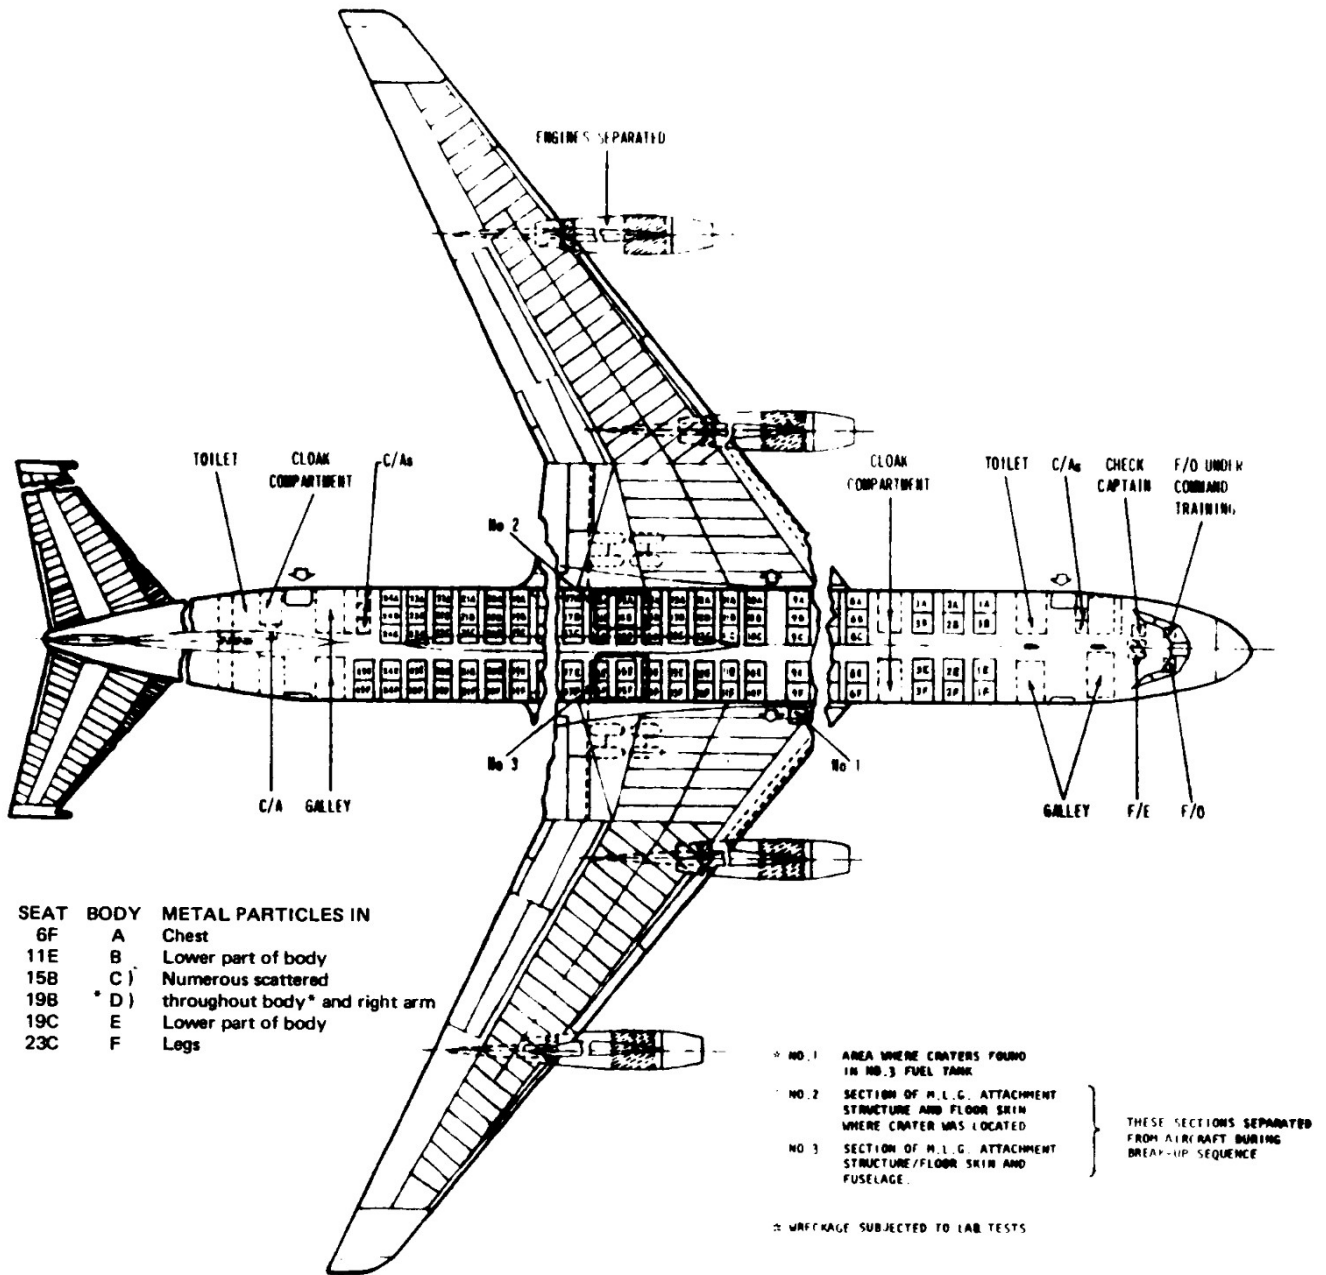
Following the initial examination, specimens were taken from the aircraft wreckage and metal particles were extracted from a number of bodies (see Fig. 7-1). These were examined at the United Kingdom Royal Armament Research and Development Establishment, Woolwich.

The starboard side wing root structure close to the fuselage exhibited damage which could only have resulted from the detonation of a high explosive device in close proximity inside the aircraft. In addition, the fuselage floor skin on the port side of the aircraft in the passenger cabin centre section area, contained a crater typical of that resulting from a very high velocity impact by a particle from an explosive device. Furthermore, nine of the recovered bodies contained many deeply embedded mild steel fragments consistent with the detonation of a high explosive device in their immediate vicinity. The seat allocation list showed that some of these passengers were seated in the centre section of the cabin.

Figure 7-1.- Chart showing aircraft break-up points, wreckage subject to laboratory tests and seat allocation of bodies from which metal particles were removed.
