HOAN BRIDGE FORENSIC INVESTIGATION FAILURE ANALYSIS FINAL REPORT

ATLSS Center
Lehigh University

Wisconsin Department of Transportation
and the
Federal Highway Administration

June 2001

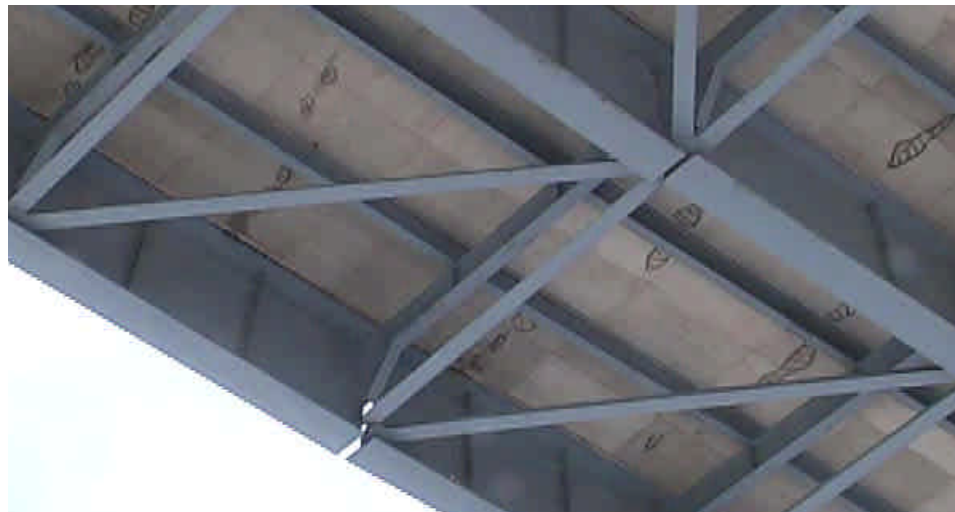
Figure 4 shows the fractures that developed in Center Girder E and outside Girder F prior to the demolition.

Figure 4: Visible Fractures of Center Girder E-28 and East Girder F-28

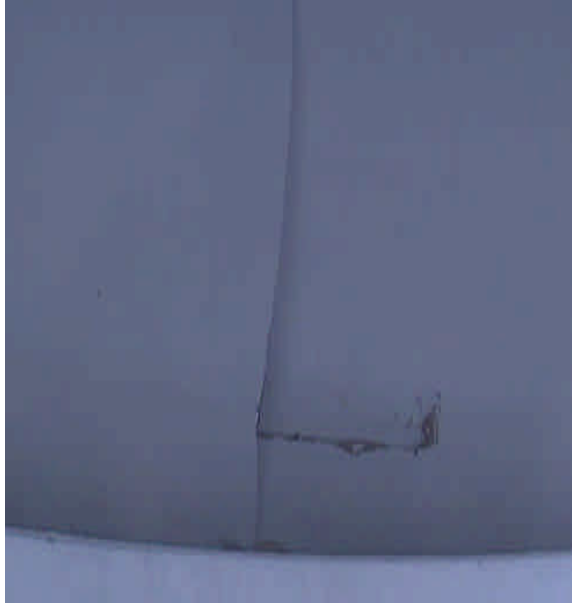
The west exterior girder D did not experience a flange fracture although a 3 ft. web crack had formed in the girder web, as illustrated in Figure 5.

Figure 5: Cracked Web of Girder D-28

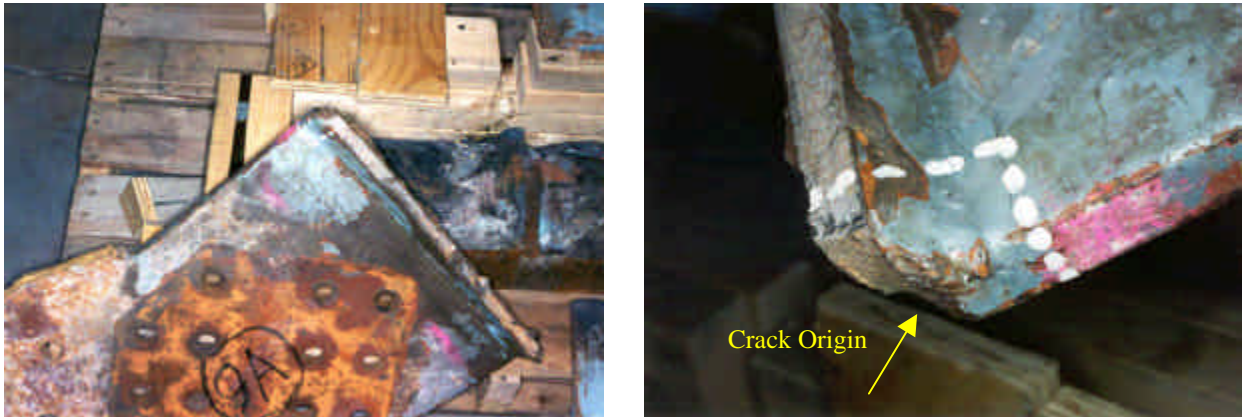
Figure 48: Shelf Plate With Web Fracture Origin at the Weld Termination. (Girder E P.P. 28)

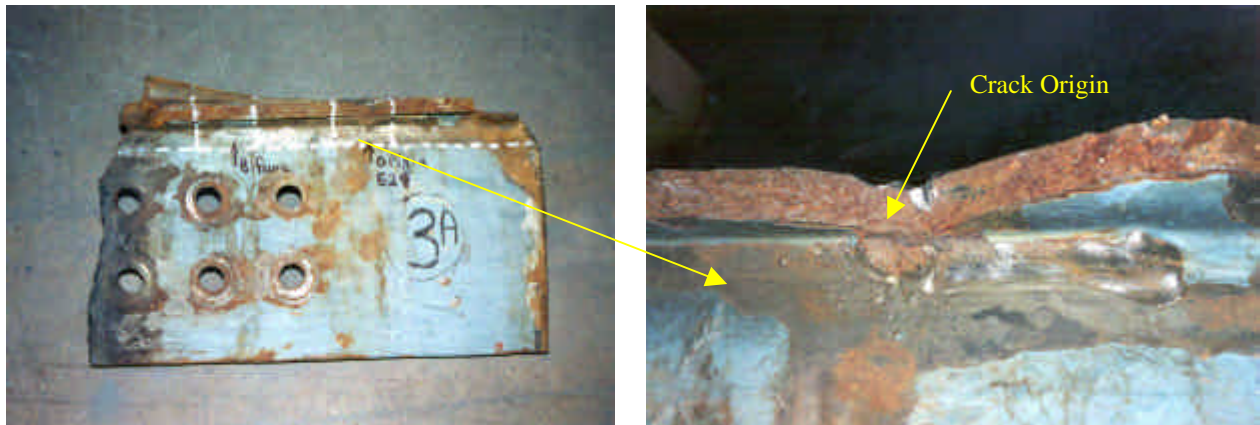
Figure 49: Opposing Web Crack Surface at the Fracture Origin Attached to the Vertical Connection Plate (Girder E P.P. 28)

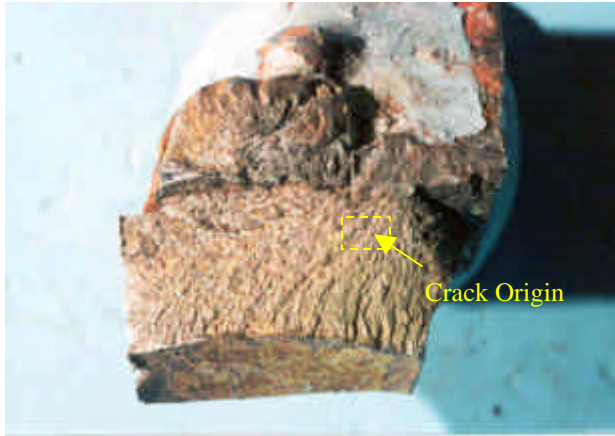
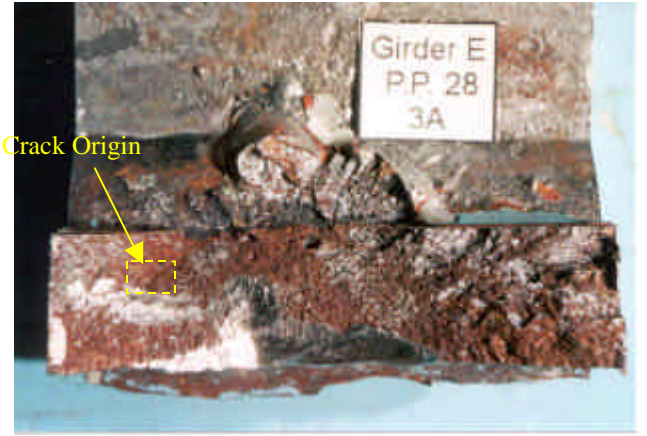
**Figure 50: Opposing Crack Surfaces Showing the Web Fracture Origin Near the Weld Root (Girder E P.P. 28)
(Enlarged View of Boxed Area Shown Below)**

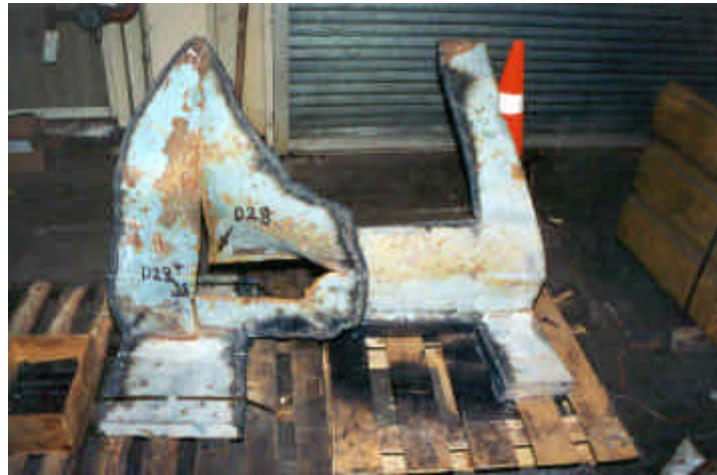
Figure 52: Section of Girder D P.P. 28 Containing the Crack Origin Area and Arrested Crack in the Bottom Flange

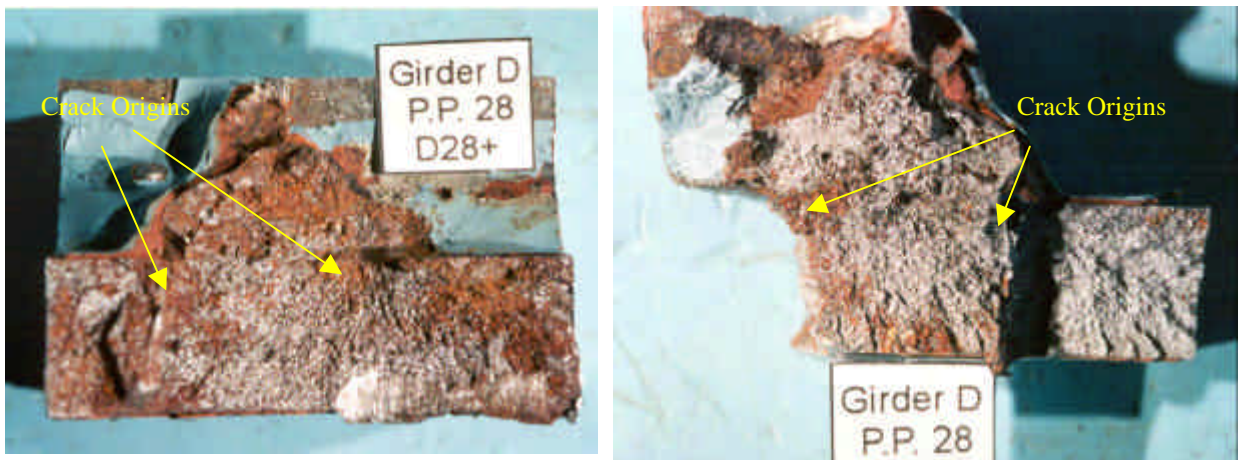
Figure 53: Opposing Crack Surfaces at the Shelf Plate Weld Termination Fracture Origin

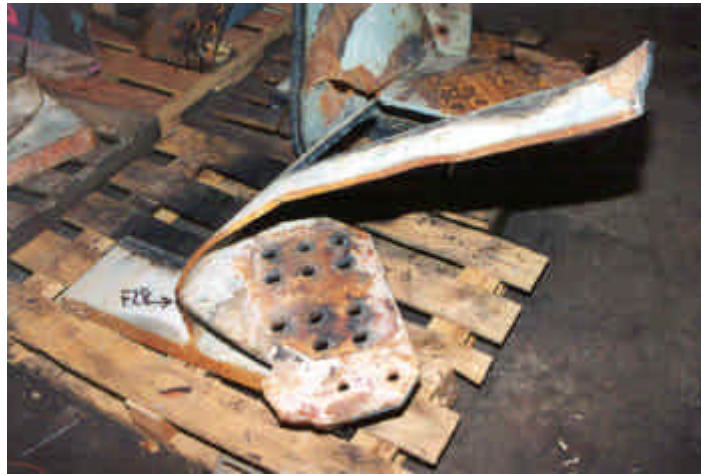
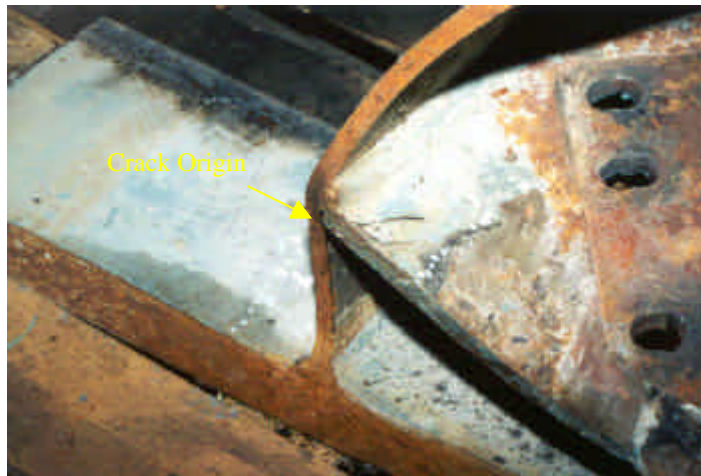
Figure 55: Section of Girder F P.P. 28 Containing the Shelf Plate Weld Fracture Origin

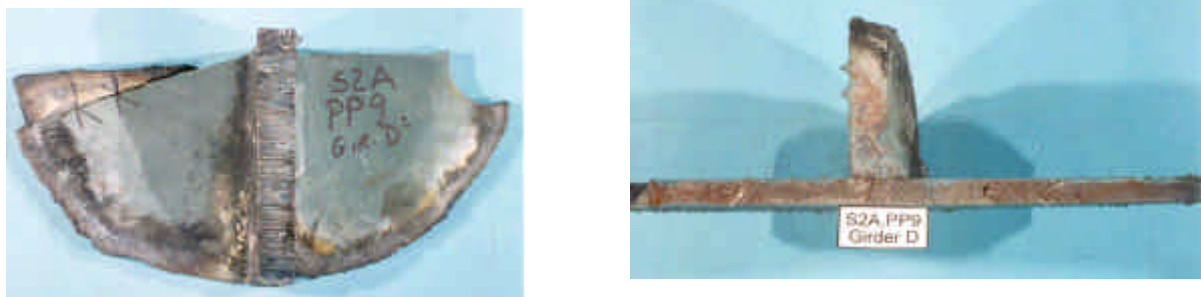
Figure 57: Web Crack Removed From Girder D at P.P. 9 at the Shelf Plate Connection

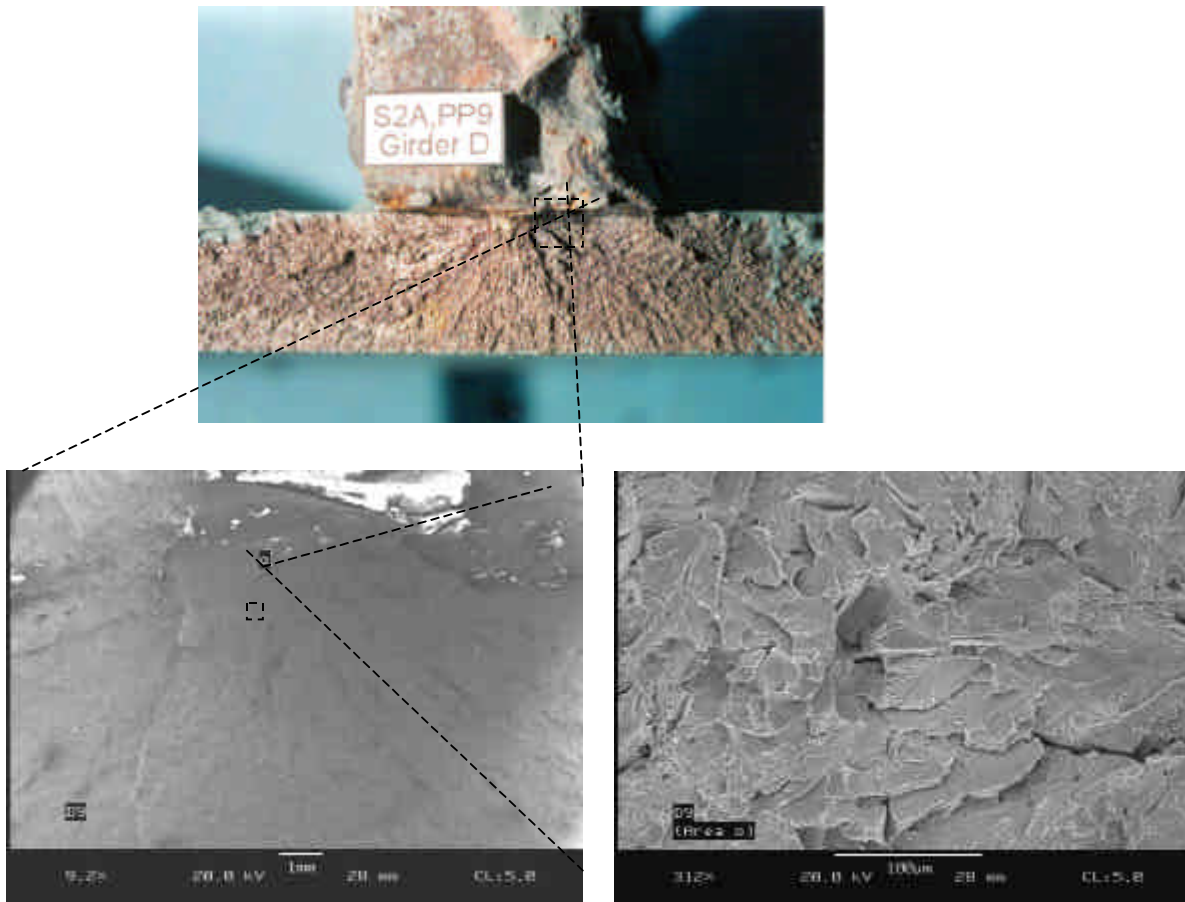
Figure 58: Fracture Origin in the Web Showing Cleavage Fracture (Girder D P.P. 9)

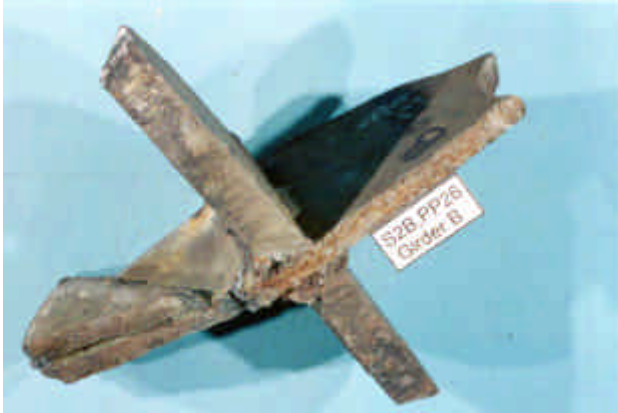
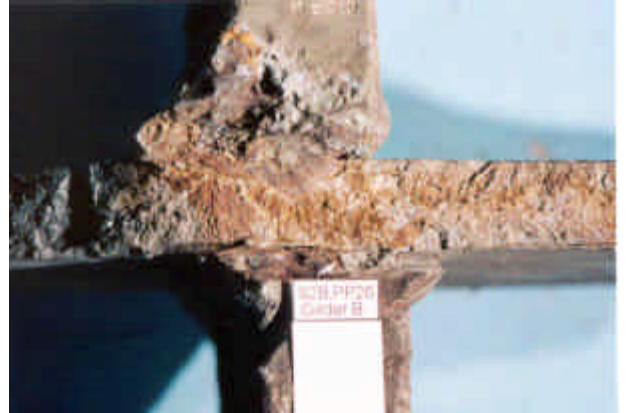
Figure 59: Web Crack Removed From Girder B at P.P. 26 at the Shelf Plate Connection

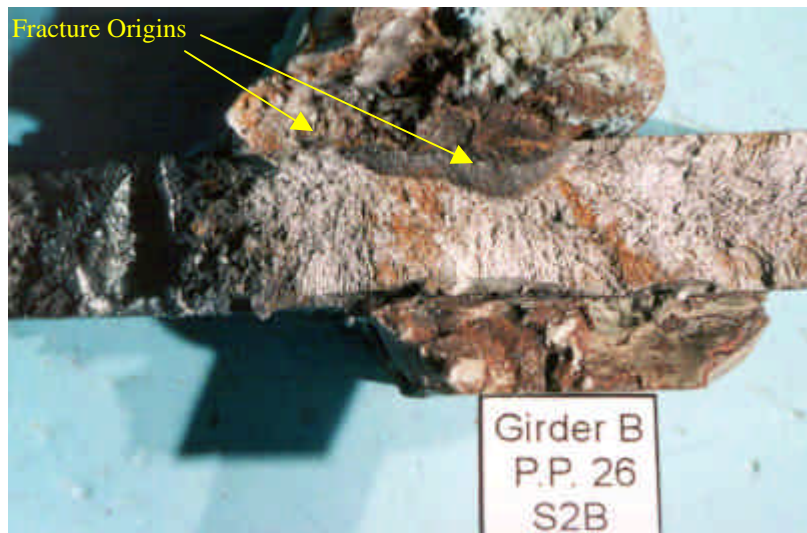
Figure 60: Fracture Origin Showing Blackened Thumbnail and Cleavage Initiation Areas (Girder B P.P. 26)

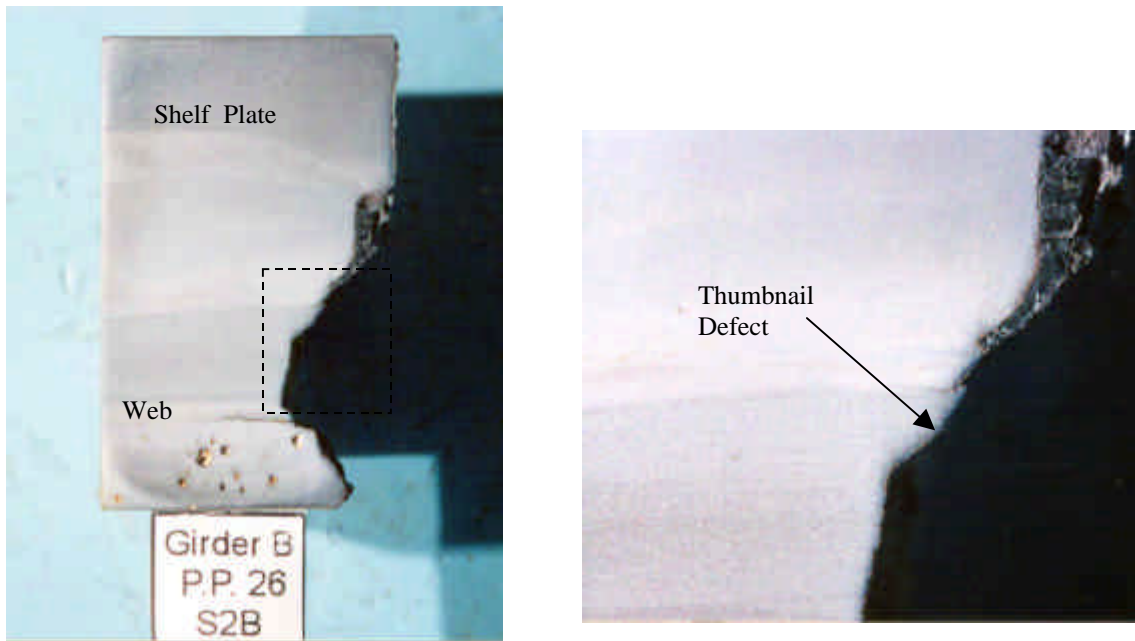
Figure 62: Etched Cross-Section Through Thumbnail Defect at Fracture Origin (Girder B P.P. 26)

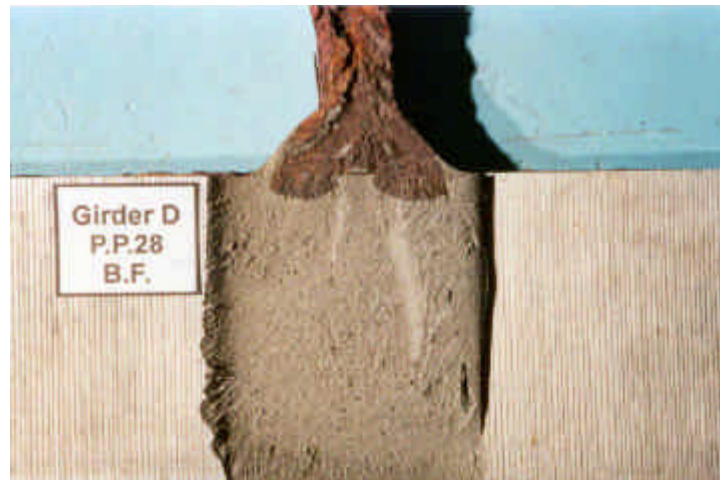
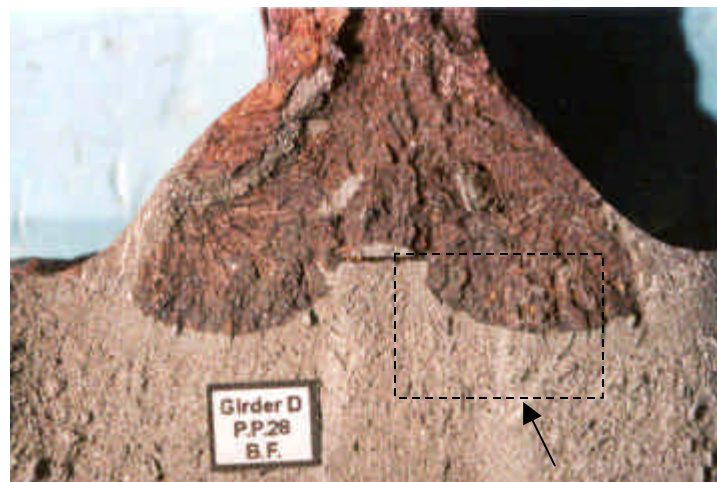
- Figure 63: Exposed Fracture Surface from Girder D, P.P. 28 Showing Crack Arrest in the Bottom Flange. Note the weld fusion line location
- Figure 64: SEM Micrographs of the Crack Arrest Boundary Showing Cleavage and Ductile Fracture. Dashed Lines Denote Crack Arrest Boundary (Girder D, P.P. 280)

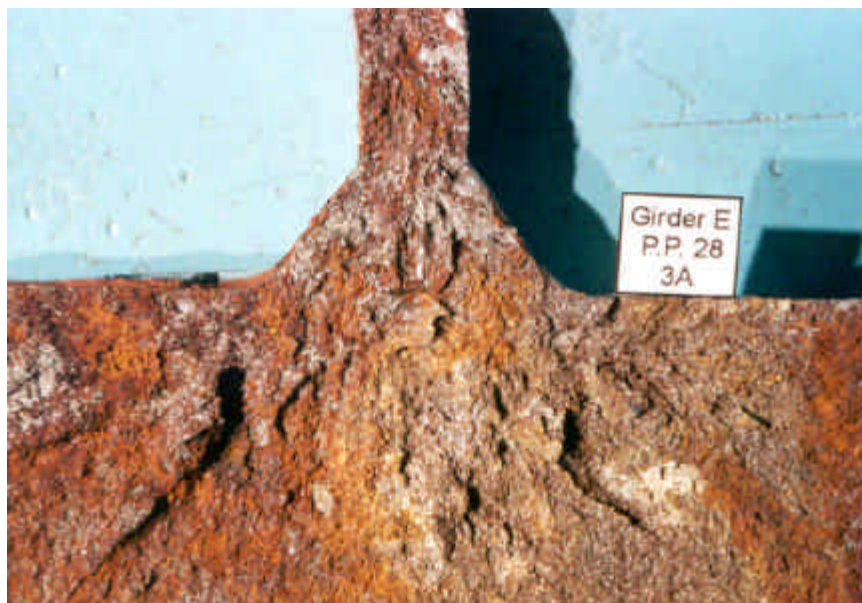
Figure 65: Cleavage Fracture in the Web-Flange Area of the Bottom Flange of Girder E P.P. 28

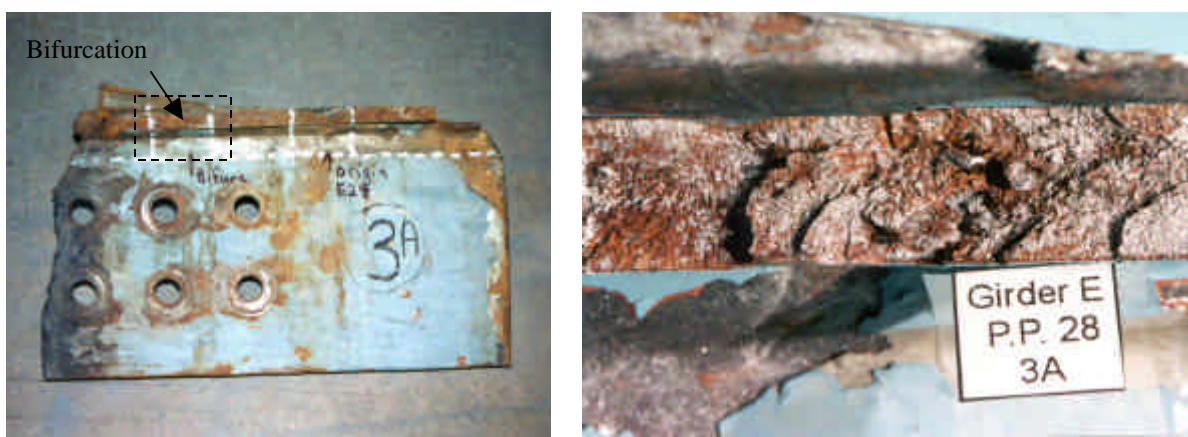
Figure 66: Crack Bifurcation in the Web of Girder E P.P. 28 Near the Fracture Origin.

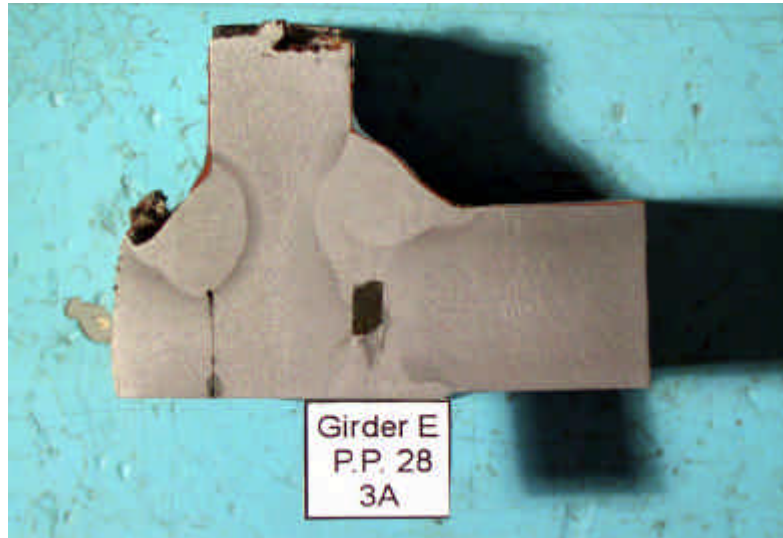
Figure 67: Etched Cross-section Through the Web and the Crack Bifurcation Location.

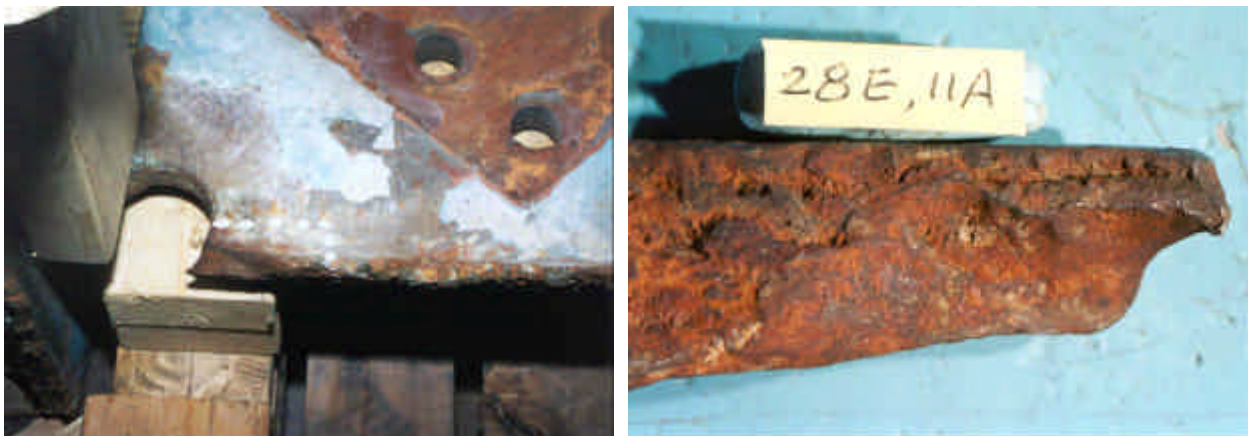
Figure 68: Girder E P.P. 28 Shelf Plate Showing the Hole Repair and Crack Surface Adjacent to the Hole

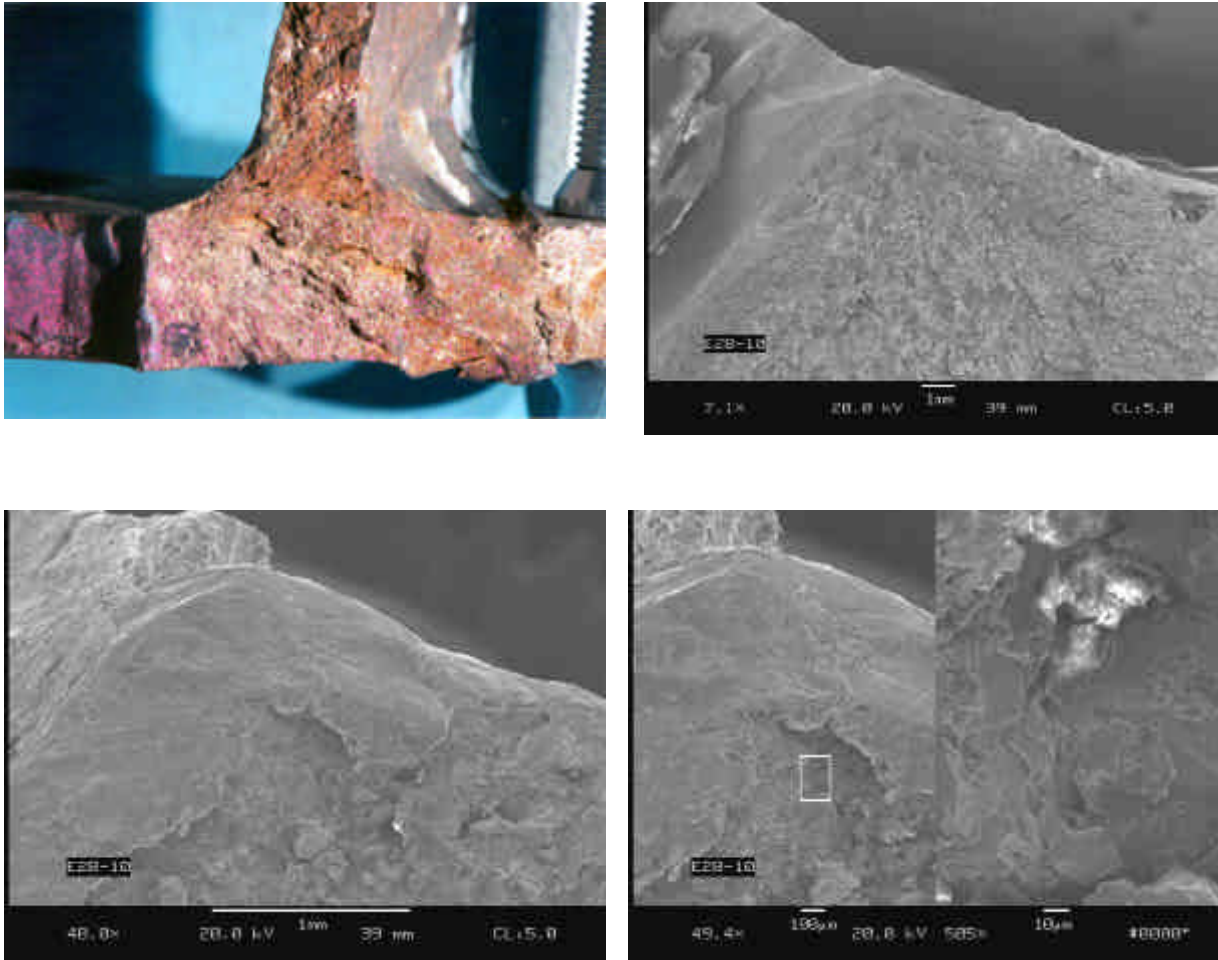
**Figure 70: Transverse Brace Fracture at Girder E P.P. 28. Cleavage Fracture Initiated in the Radius of the Flame Cut Cope at the Corner
Cleavage was Observed Next to the Abraded Crack Surface at the Corner**
