Watershed Study No. 5

McAlpine Creek Watershed

Preliminary Engineering Report

MCSWS Project No. 26005

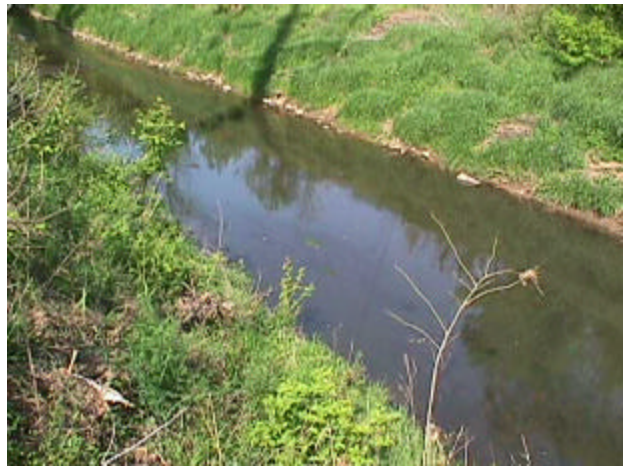
Fig. 1 Downstream of Trib 3 Confluence at Lancer Dr

tributaries are given in the following paragraphs. Under the base flow conditions, the flow is mostly tranquil as shown in Figures 1 to 4. Secondary sanitary sewer lines adjoining the main trunk line frequently cross the main stream as shown in Figure 4. Current plans are to eliminate these crossings, and to place them under the creek bed. In addition, from Sardis Road to Independence Road crossings there is a greenway trail along the creek, which helps stabilize the banks for reasons given above.

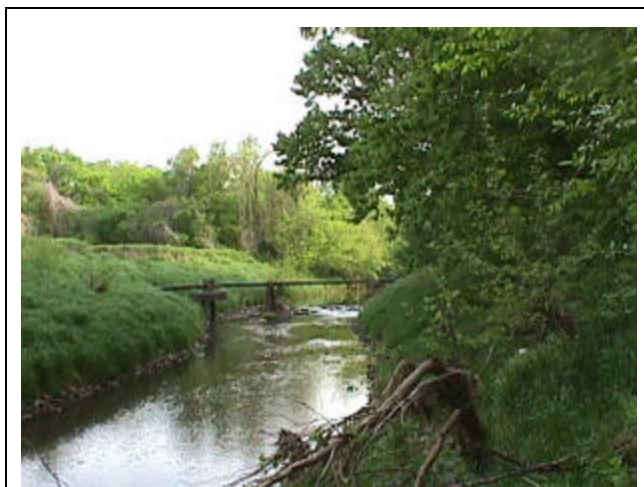
Fig. 4 Near Riley Ridge Road

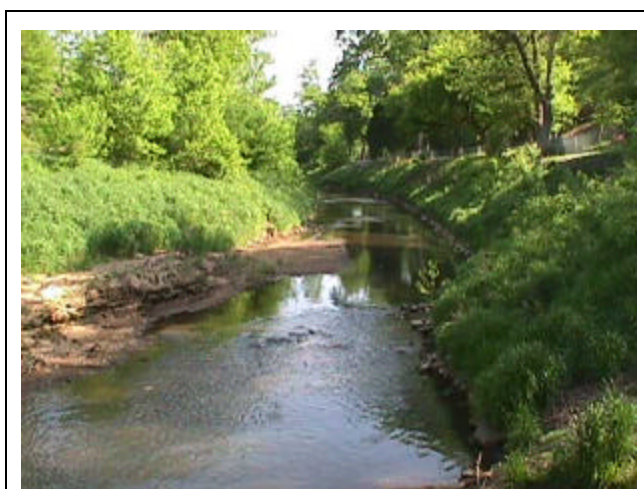
Fig. 5 Upstream of Trib 3 Confluence

As stated before, deposition of sediments was observed in field visits to McAlpine Creek in April and June 2001. Some of the deposition was in the form of alternate bars on the stream as shown in Figures 5 and 6. Most of the sediment load of the stream is likely caused by the construction activity, since there is good vegetative cover along the stream. In general, bank instability is not a major problem along McAlpine Creek.

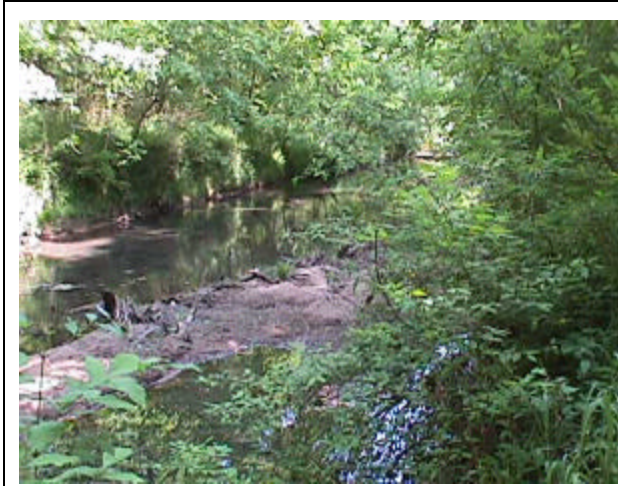
Fig. 6 At Pineville-Matthews Road

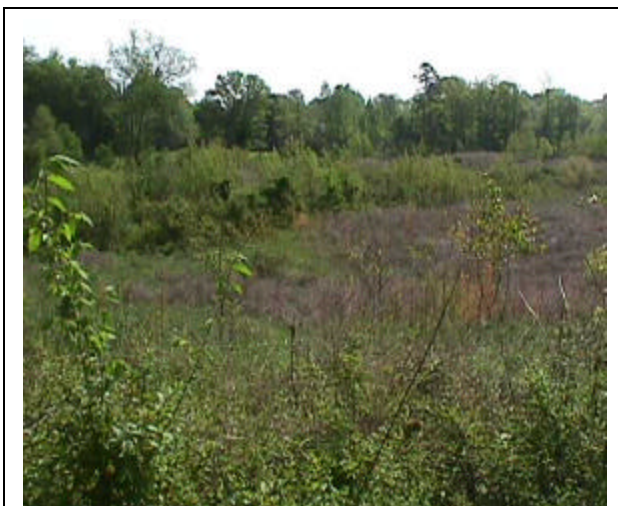
Fig. 7 At Old Providence Road

of the foundations. Figures 7 and 8 show the floodplain in two typical sections of the creek.

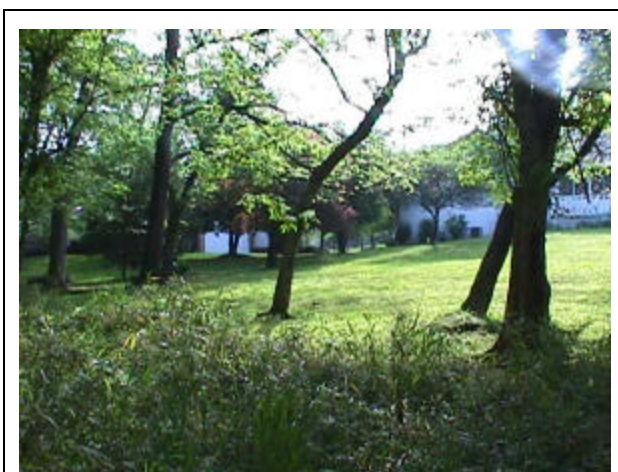
Fig. 8 At Rileys Ridge Road

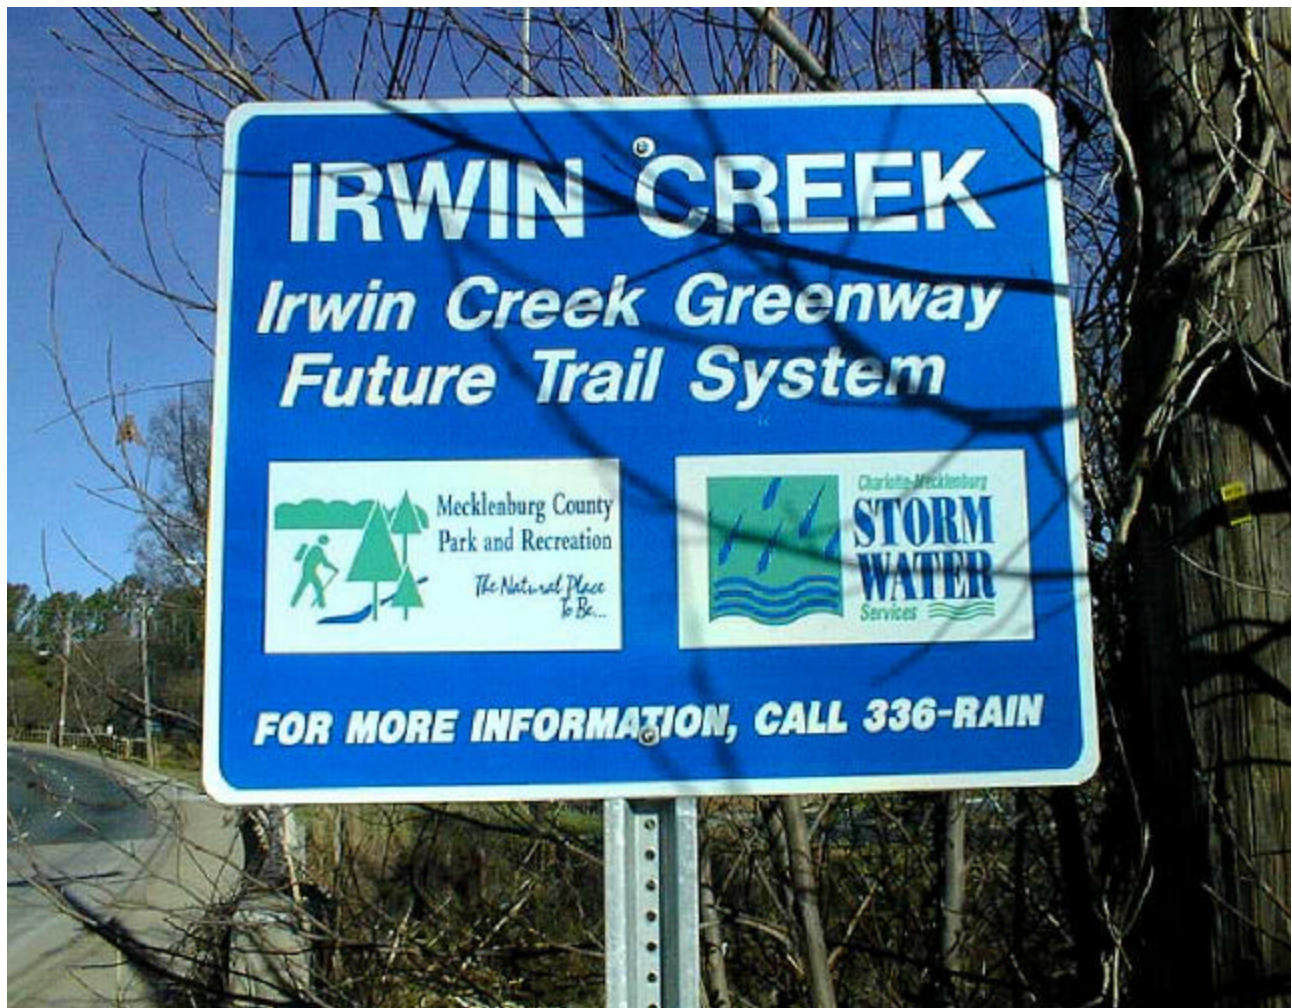
The greenway trails are next in significance of the CIP's listed in Table 2. These trails are typically created by clearing plants, stabilizing a pathway for pedestrians/bicyclists, and building structures for crossing over tributaries or depressions. While clearing and smoothing a trail result in higher conveyance for the stream, trail crossings obstruct flow and have an adverse effect on conveyance. However, most of the crossings are built low, and have minimal effects during large low-frequency storm events. For the purposes of this report, the effects of all CIP's on the hydraulics of McAlpine Creek are neglected. The effect of Albemarle Road improvements may be the subject of a Letter of Map Revision at the time of construction.

Fig. 10 Example of Proposed Greenway Trail
