**AIRCRAFT ACCIDENT INVESTIGATION BUREAU**

**INVESTIGATION REPORT ON**

**ACCIDENT TO THE B737-MAX8 REG. ET-AVJ OPERATED**

Report No. AI-01/19

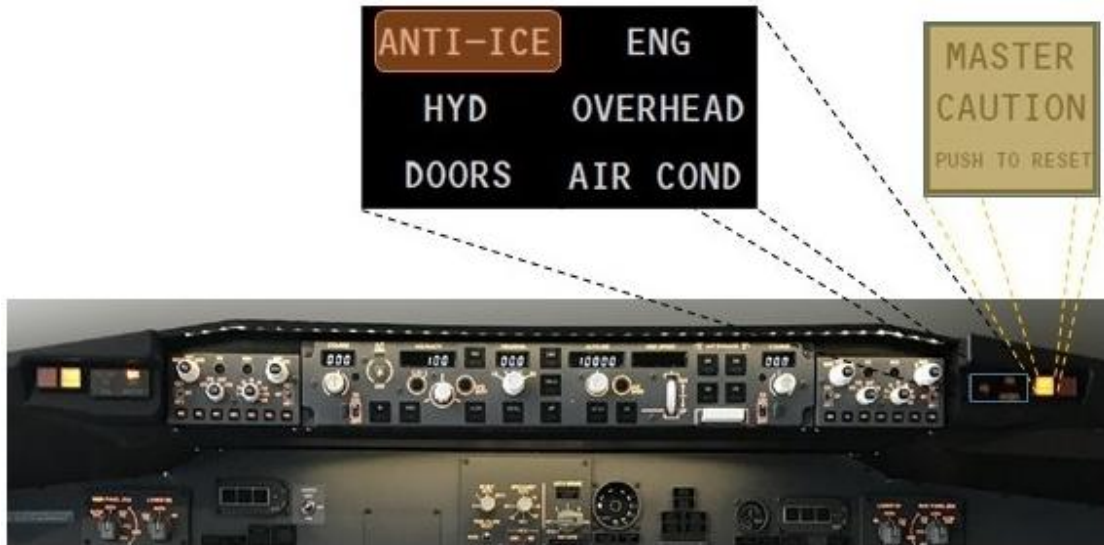
FIGURE9: MASTER CAUTION ANTI-ICE

- the master caution triggers (master caution light illuminates)
- the ANTI-ICE light (right system annunciator) illuminates
- The [L/R] ALPHA VANE message illuminates (on the Probe heat panel of overhead panel).

The vane heating monitoring is based on current detection circuit. After the current drops, there is a delay of 3 to 5 s before the light “[L/R] Alpha Vane” illuminates and the master caution triggers. In other words, the airplane suffered a loss of power to the left AOA Sensor Heater.

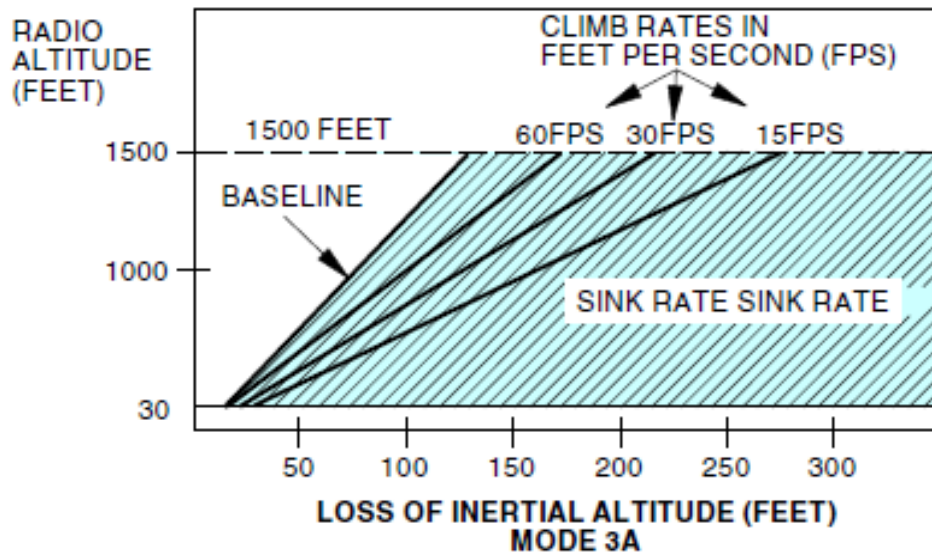
FIGURE26: ALERT ENVELOPE FOR THE MODE 3A (FROM AMM §34-49-00)

The mean vertical speed of the Airplane before the Maximum value was around 12 ft/s. An alert triggering around 1,271 ft – after 229 ft of altitude loss was consistent with the GPWS Mode 3A alert envelop shown in Figure 26.

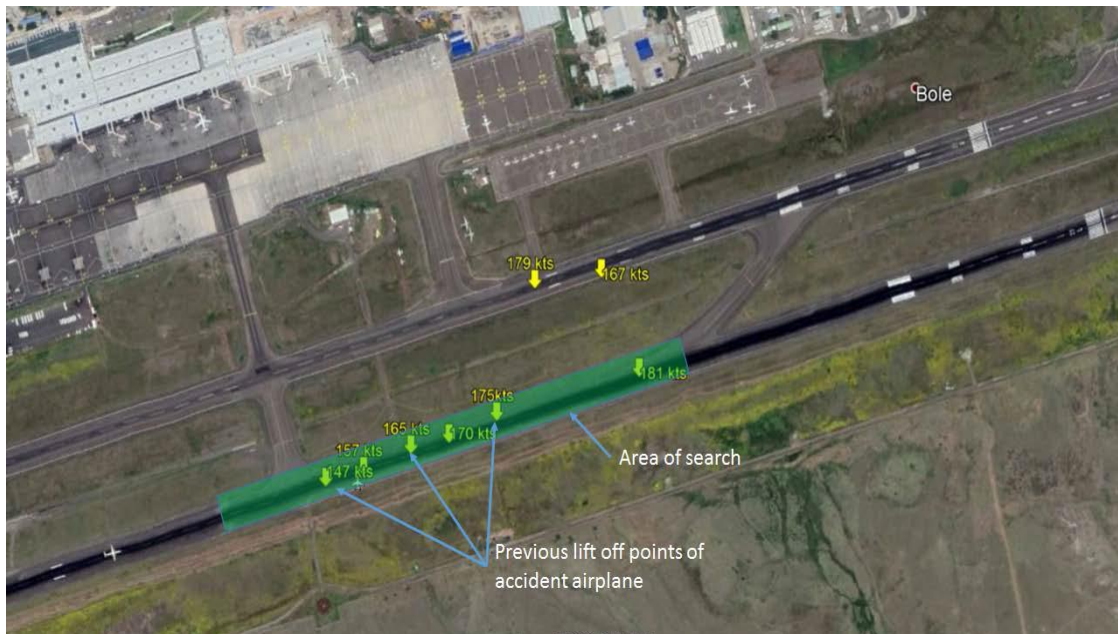
PICTURE: 29 AREA OF SEARCH FOR AOA VANE & BIRD REMAIN

The EAIB investigation, Airworthiness group chairman and team members obtained permission to walk the runway and its sides to check for airplane debris and any evidence of a bird-strike or tail strike. The Investigators walked the area of runway 07R (12,400 feet in length) highlighted in green in the picture 29 below. The length and width of the runway inspected was approximately 3,000 feet and 150ft to the left and

right of the centerline. The team started the search in the vicinity of taxiway C and extended toward taxiway D as well as back towards taxiway B. Those participating in the walk searched along in the grass and the runway side where small broken rocks were. The team walked two rounds along the same area but there were no bird remains and AOA vane wreckage. The investigation team confirmed that there was no evidence of a bird and AOA vane remains in the highlighted search area. The team also noted no evidence of damage to the runway surface in this area consistent with a tail strike. FDR data shows that Left AOA deviations began when the airplane was located over taxiway D.

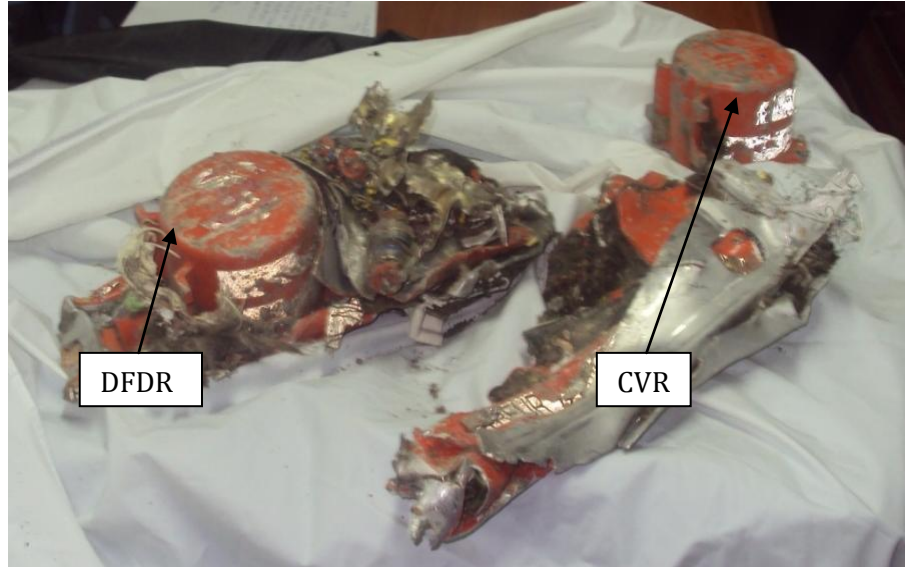
FIGURE 32: DFDR AND CVR AS DISCOVERED ON THE ACCIDENT SITE.

The Airplane was equipped with a Digital Flight Data Recorder (DFDR) and Cockpit Voice Recorder (CVR), which were located in the aft cabin and aft cargo hold (respectively) section of the Airplane.

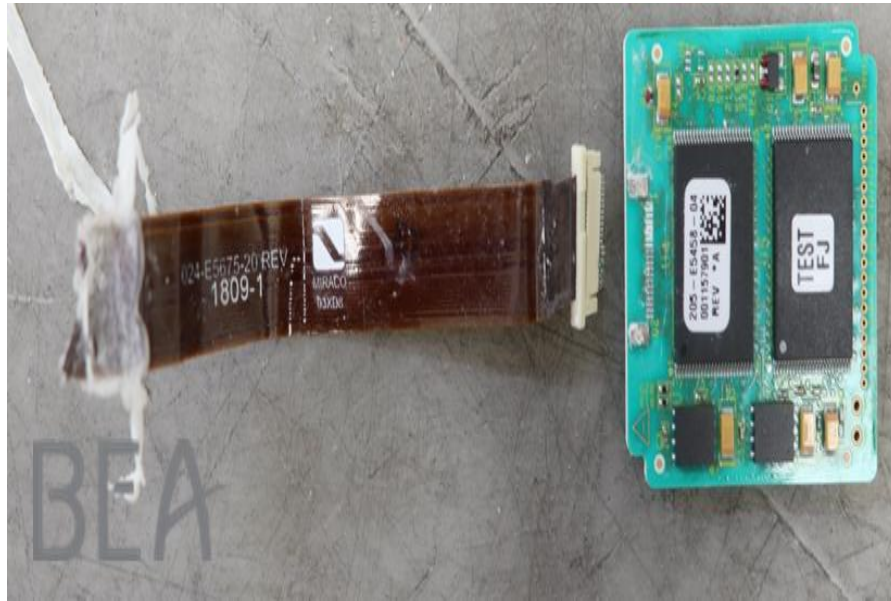
FIGURE 34: FDR MEMORY BOARD, FLEX AND CONNECTOR

The memory board was visually inspected with a Keyence microscope. Apart from the connector pads, the memory board was in good condition. There was no trace of impact. The two memory chips as well as the micro-processor were found in good condition.

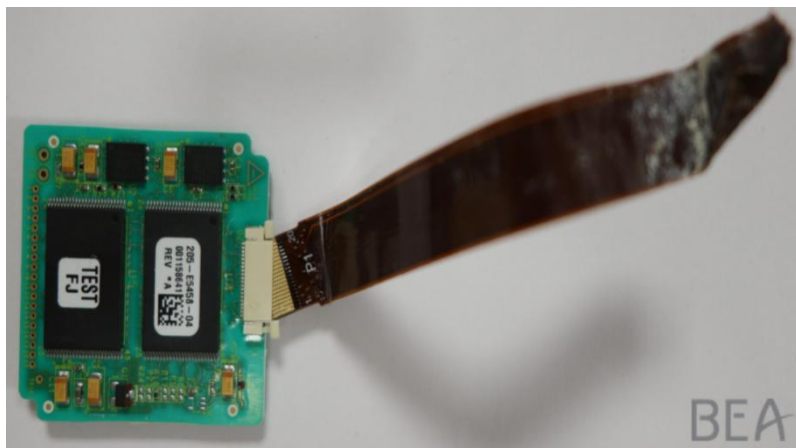
FIGURE 39: CVR MEMORY BOARD AND FLEX

The CVR memory board and flex were visually inspected with the Keyence microscope. There was no damage on the board and the connector was in good condition.

A second observation with the X-ray was made, which confirmed that the connector soldering were in good condition.

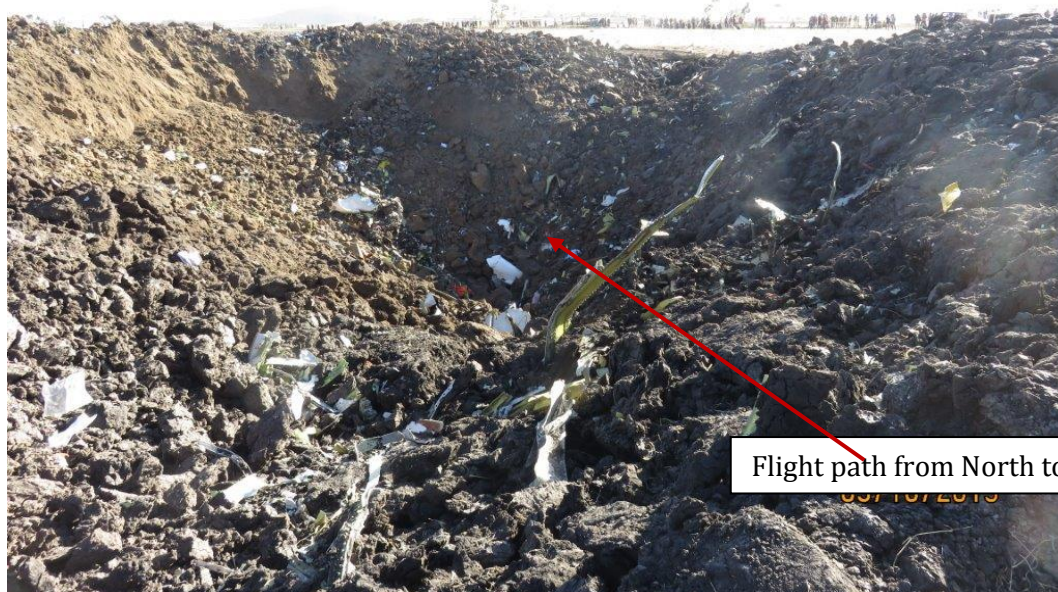
FIGURE 41: CLOSE VIEW OF THE CRATER BEFORE EXCAVATION

The Airplane impacted terrain at a farm field and created a crater approximately 10 meters deep (last Airplane part found) with a hole of about 28 meters width and 40 meters length. Most of the wreckage was found buried in the ground; small fragments of the Airplane were found scattered around the site in an area about 200 meters wide and 300 meters long. Damages to the Airplane were consistent with a high energy impact.

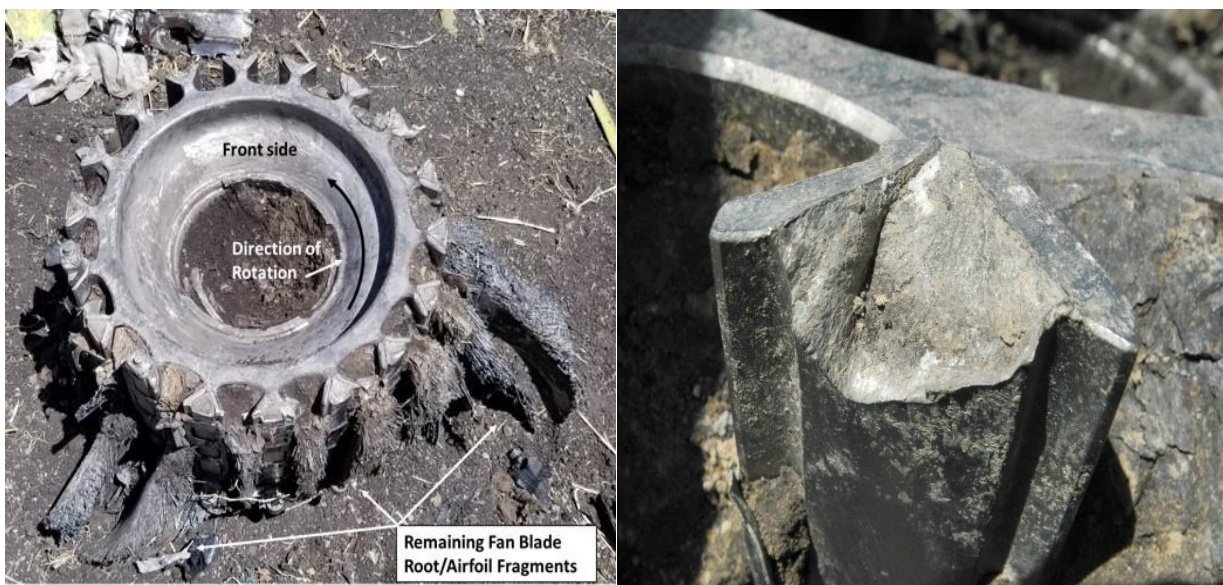
FIGURE46: R/H ENGINE - S/N 602695 - FAN DISK    FIGURE47: R/H ENGINE - S/N 602695 - RETENTION LUGS - FRACTURED

The right engine core was recovered from the site and examined by the group. The recovered core of the right engine was more damaged than the left-hand engine. The engine was reportedly recovered at a depth of approximately 10 to 15 meters depth on the right side of the excavation site.

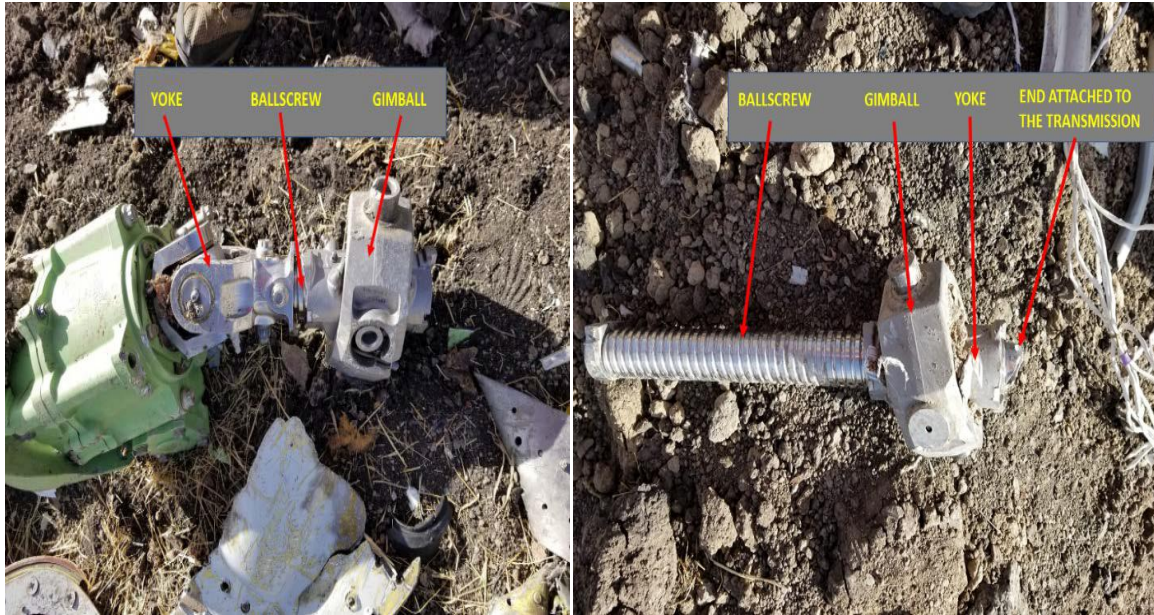
FIGURE54: FLAP TRANSMISSION & BALLSCREW FIGURE55: FLAP TRANSMISSION

Two parts of the actuation system were located and examined at the impact site. One consists of the ballscrew, yoke, gimbal and flap transmission; the other consists of just the ball screw, yoke, and gimbal (see **Figures** respectively).

The installed location of each unit has not been identified. The position of each gimbal is consistent with the flaps in the fully retracted position.

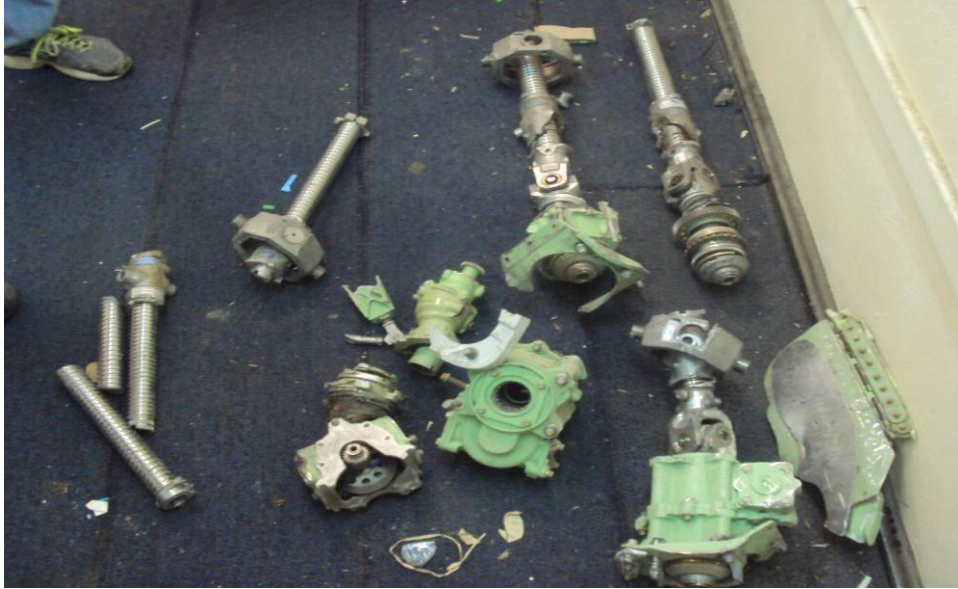
FIGURE56: TRAILING EDGE FLAP TRANSMISSIONS AND BALL SCREWS

During the examination of the wreckage pile located at the Addis Ababa airport EAIB store, the Airworthiness group identified a total of 4 (including the ones identified at the impact site) trailing edge flap transmissions (there are 8 total); three of these had the ball nut and gimbal still attached.

Again, all three were found in the fully retracted position. There was one additional transmission portion that was found as well as three ball screw segments. All examined damage appears consistent with high energy impact.

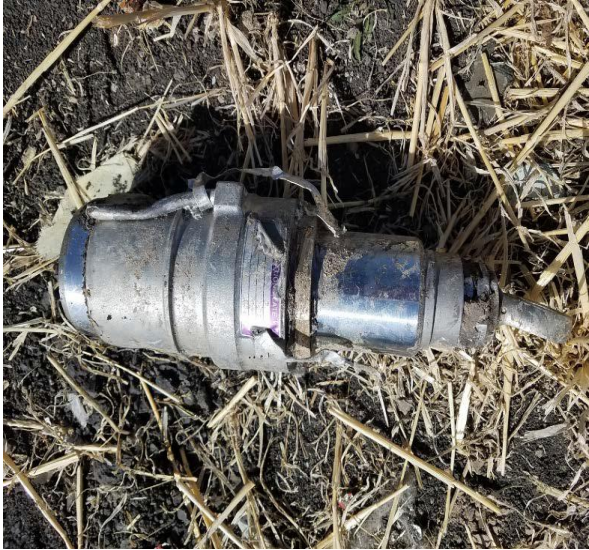
FIGURE 57: SLAT ACTUATOR (POSITION UNKNOWN)

Three of the 8 leading edge slat actuators were photographed (see Figures below) at the impact site. The installed location for each actuator has not been identified. The actuator position, as photographed, is in the fully retracted position.

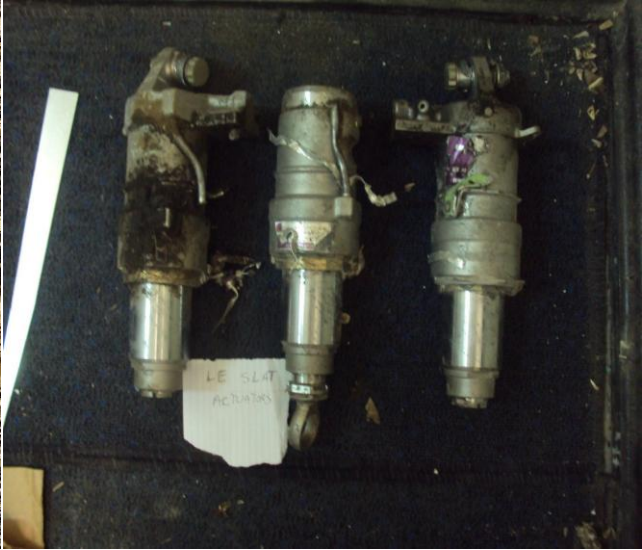
FIGURE 58: LEADING EDGE SLAT ACTUATORS

During the examination of the wreckage pile located at the Addis Ababa airport EAIB store the Airworthiness group identified a total of three leading edge slat actuators at the impact site. The actuator position, as photographed, was in the fully retracted position.

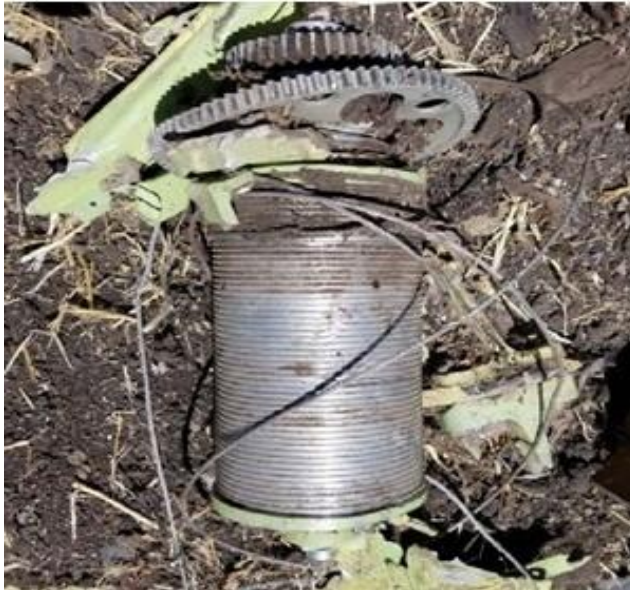
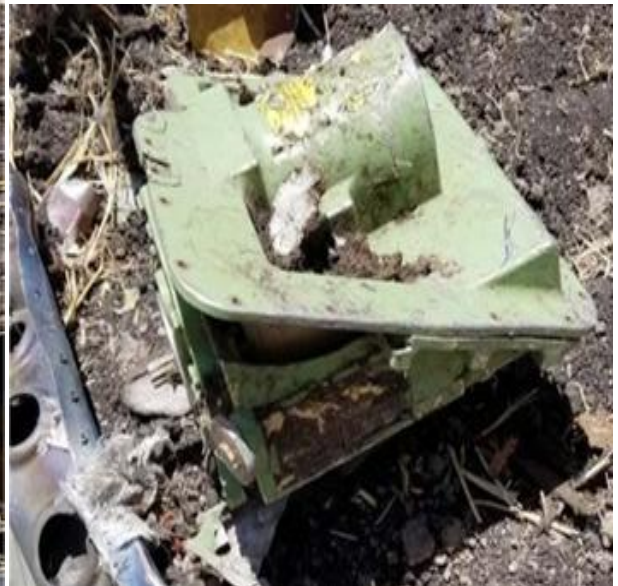
Two parts of the control system were located and examined at the impact site. One consists of aft cable drum; the other consists of the stab trim actuator (see Figures 59 & 60 below respectively). These

components do not provide any evidence of what position the horizontal stabilizer may have been at the time of impact.

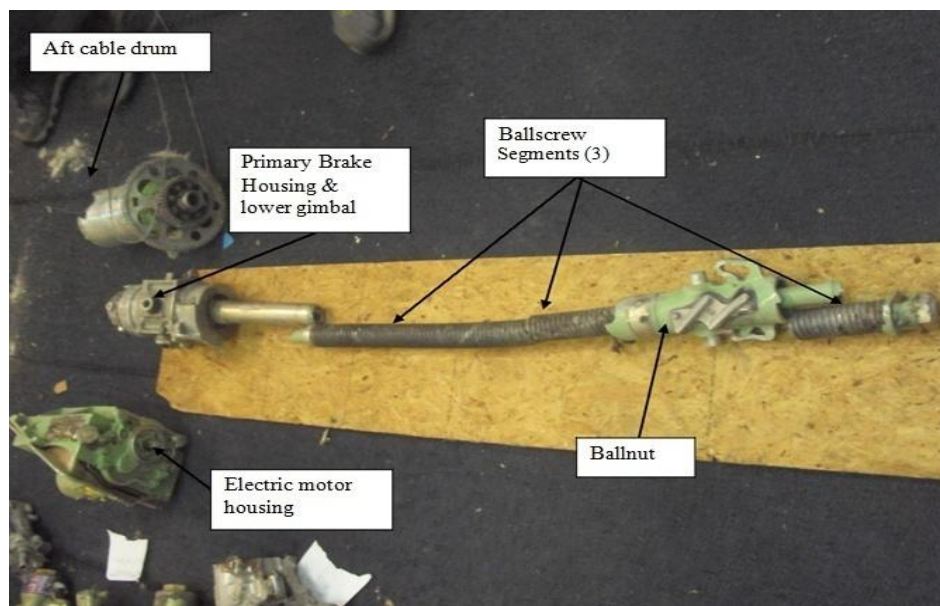
FIGURE 61: RECOVERED STABILIZER TRIM COMPONENTS

Most of the located components of the stabilizer trim system were located once the wreckage was transported to Bole International Airport. The only part of the stab trim system located on site was the motor housing (see above). Referencing **figure-54** above, the parts located in the wreckage pile at the airport consisted of the Primary Brake Housing (has the Lower Gimbal on it), the entire jackscrew (fractured into three pieces), and the ballnut (jammed onto the screw). Damage to the components of the stabilizer trim system is consistent with a high energy impact.

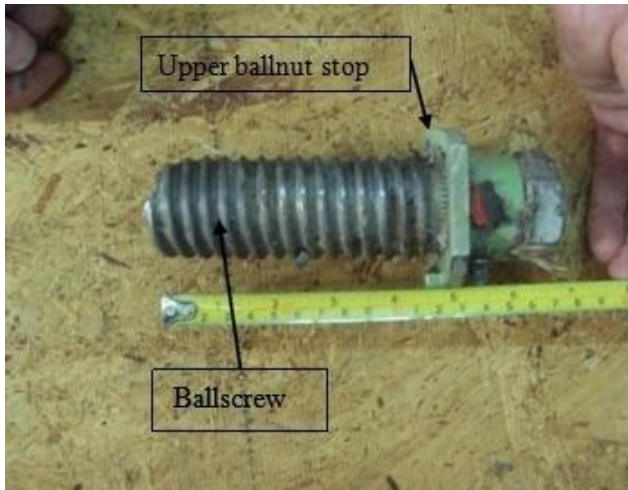
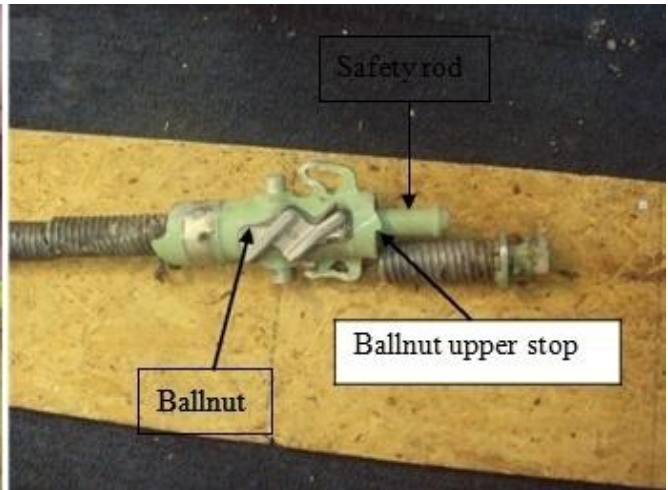
Examining the fracture surfaces, the upper screw segment fits with the fracture face just inside the ballnut giving a measurement between the stops on the ballnut and the upper ballnut stop of ~5". Referencing Boeing document D251A122 (737NG Control Position Data), this measurement equates to a stabilizer trim setting of 1.5 degrees Airplane Nose Down (AND) or an indicated position of 2.5 units of trim. Although the data is for the 737NG, the position of the MAX stab trim holds the same relationship. According to Boeing:

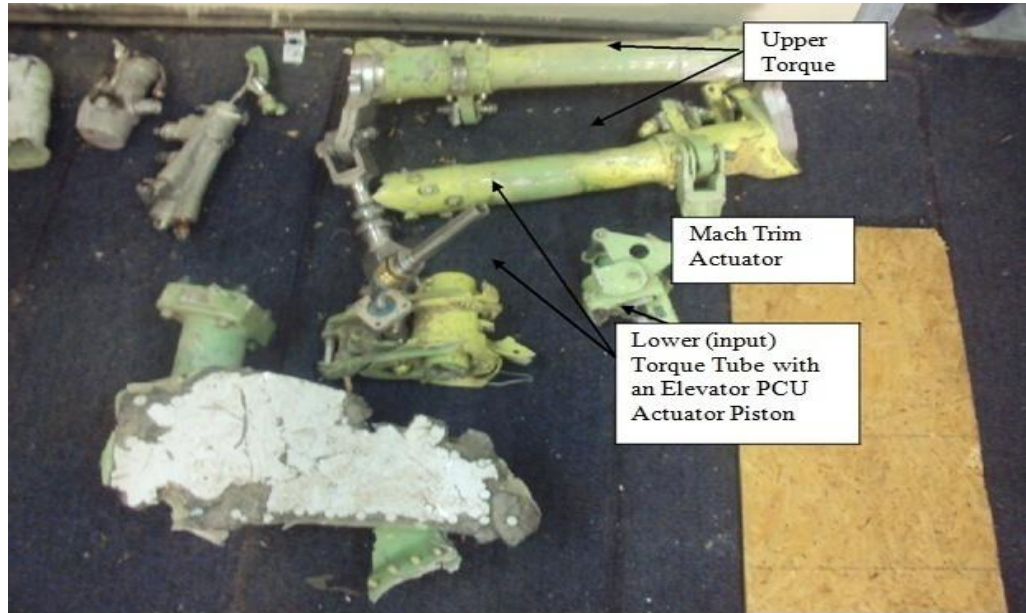
FIGURE64: ELEVATOR PCU ACTUATOR PISTON

The only components that were located for this system were the output torque tube, the mach trim actuator, a small portion of the Elevator feel and centering unit, and a small piece of the elevator input torque tube. Figure 55 above shows the recovered components of the elevator control system. Note that all components, like the lateral components show significant damage consistent with a high-energy impact. The upper torque tube was fractured in half. Only a small portion of the lower (input) torque tube was recovered along with a piston of the Elevator Power Control Unit actuator. The Mach Trim Actuator was found in the fully retracted position.

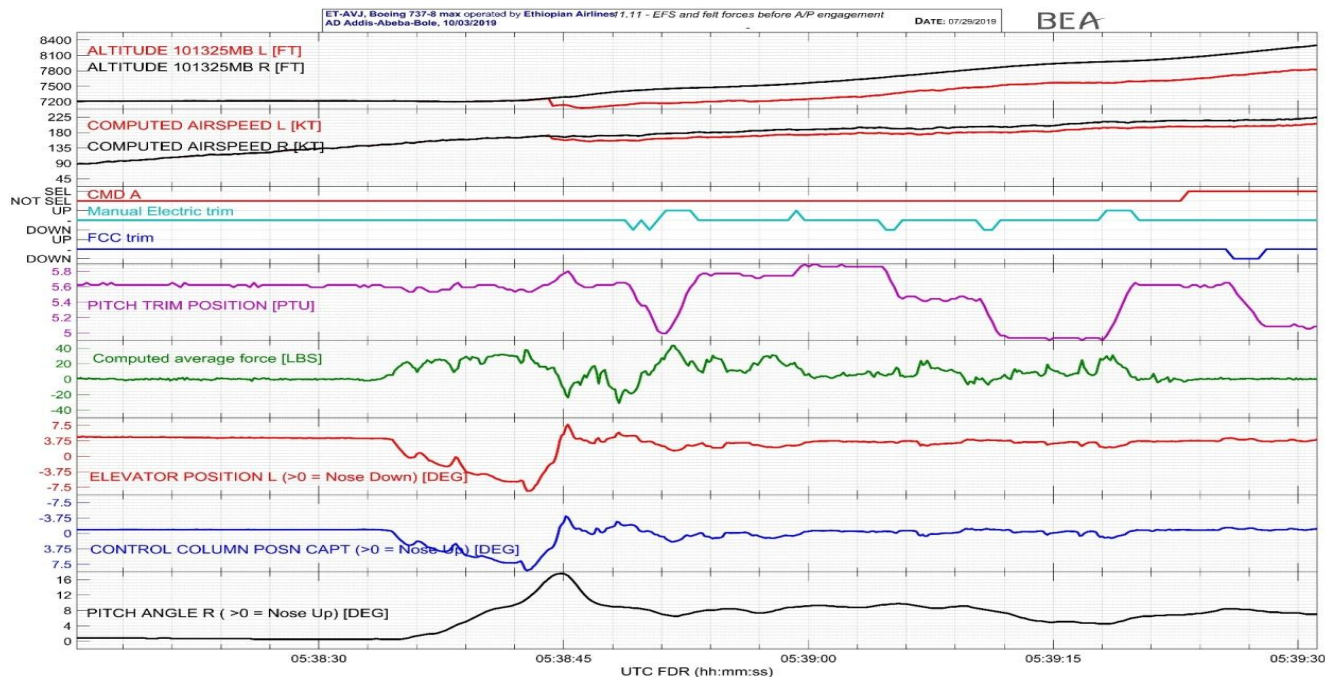
FIGURE78: FORCE BEFORE A/P ENGAGEMENT

Before the A/P engagement, the recorded low force level underlined an Airplane rather properly trimmed in pitch. At that time, the stabilizer position was 5.62 units (nose up setting) and the elevators position was of 3.5° (nose down setting).

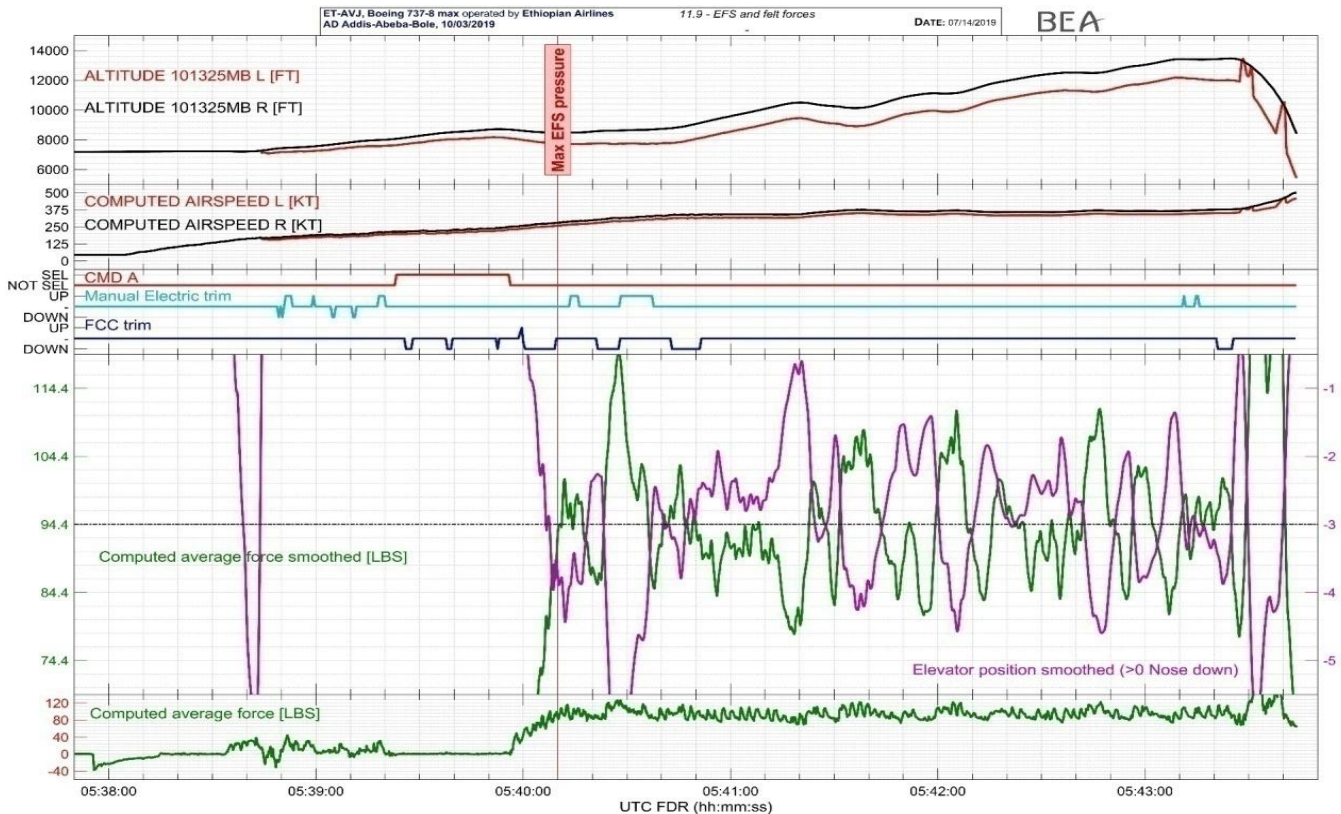
FIGURE 79: FELT FORCE AND ELEVATOR POSITION

The gradient of force felt by the crew can be illustrated by the comparison between the force applied on the control column and the position of the elevator. Note that because the flight conditions resulted in the Maximum feel pressure, the activation of EFS had no effect on these forces.

Figure 79 shows that from 5 h 40 min 10 s until the end of the flight:

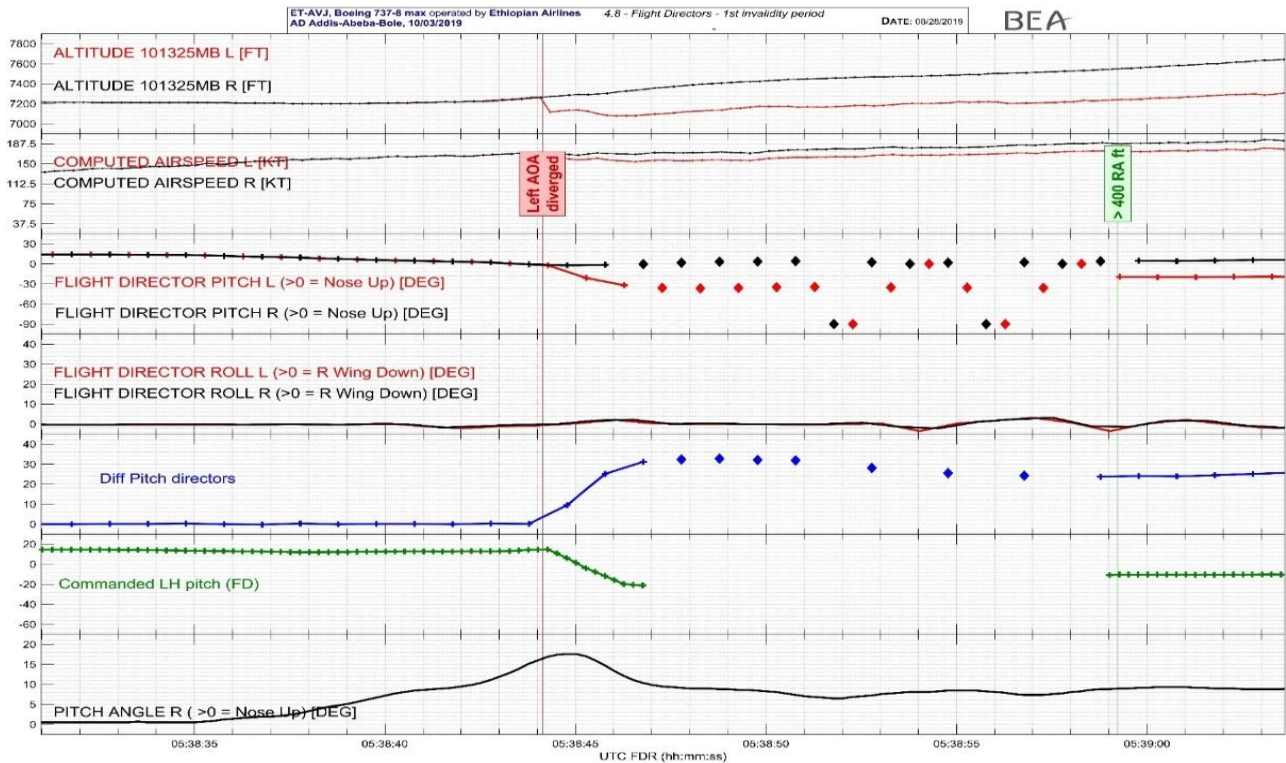
FIGURE 81: FLIGHT DIRECTORS - START OF THE FLIGHT

At the time of the 1<sup>st</sup> invalidity, F/D was in T/O mode and the radio altitude was lower than 400 ft.

**Note:** Below 400 ft, during TO mode, LH and RH pitch bars positions are compared with each other. If the difference between both pitches bars position exceeds a defined threshold, both pitch bars are BOV.

When the LH and RH AOA values diverged, LH pitch F/D commands recorded values quickly decreased to  $-32^{\circ}$  while RH pitch F/D recorded values slightly increased to  $-0.4^{\circ}$ . The difference between LH pitch F/D values and RH pitch F/D values were greater than the threshold above which FCCs comparators triggers and both F/D pitch were biased out of view.

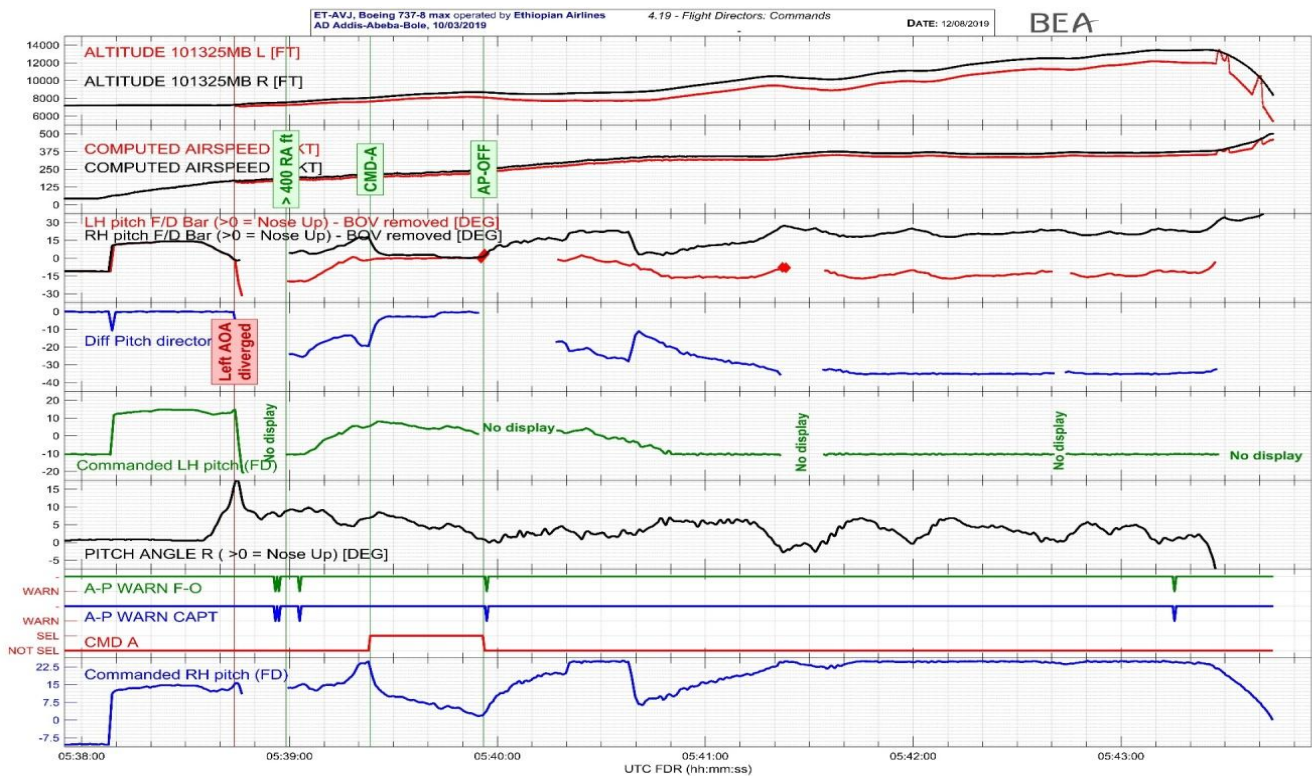
FIGURE82: PITCH F/D COMMANDS

- The F/D was in speed mode.
- The Airplane should have been climbing but the computed vertical speed value of the Airplane had been lower than the Climb threshold for 5 consecutive seconds.
- At the LH side the Airplane approached to stall
- LH F/D pitch commands (A/P not engaged)

**Note:** *No anomalies were observed in the RH pitch F/D bar positions the RH pitch F/D bar positions are then considered as valid positions based the Airplane attitude, altitude, and speed engaged modes. Except under the autopilot, the LH pitch F/D bar position was at least  $10^{\circ}$  lower than the RH pitch F/D bar. The commands provided by the LH pitch F/D bar were not consistent with the true Airplane status and the engaged modes, due to the effects of the erroneous AOA on the calculation of the minimum operation speed.*

- Each time the LH pitch F/D bar automatically reappeared, without any crew action. The underlying cause of the anomalous LH pitch F/D behavior was confirmed to be erroneous LH AOA sensor values. Erroneous AOA results in display of the IAS DISAGREE and ALT DISAGREE alerts. The appropriate NNC for these alerts is the Airspeed Unreliable NNC, which, as a memory item, requires that the crew turn off both flight directors.

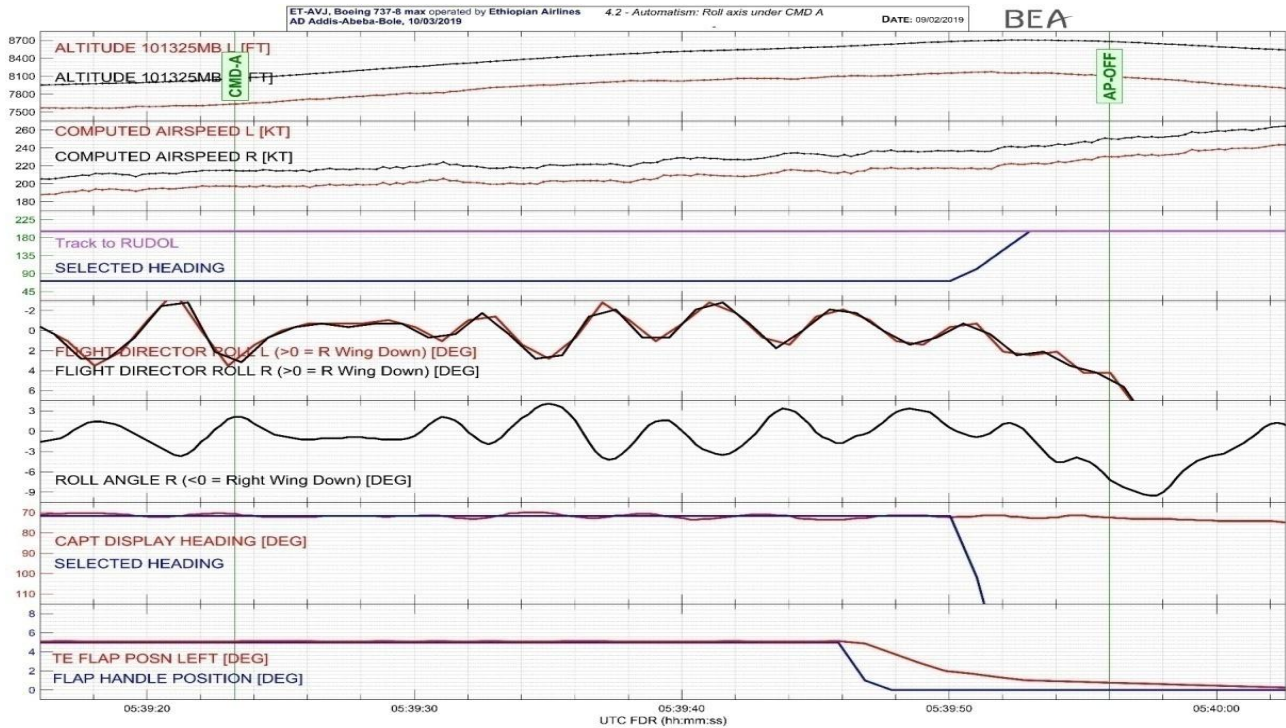
FIGURE 83: ROLL AXIS UNDER CMD A

The roll axis under CMD A behaved as expected:

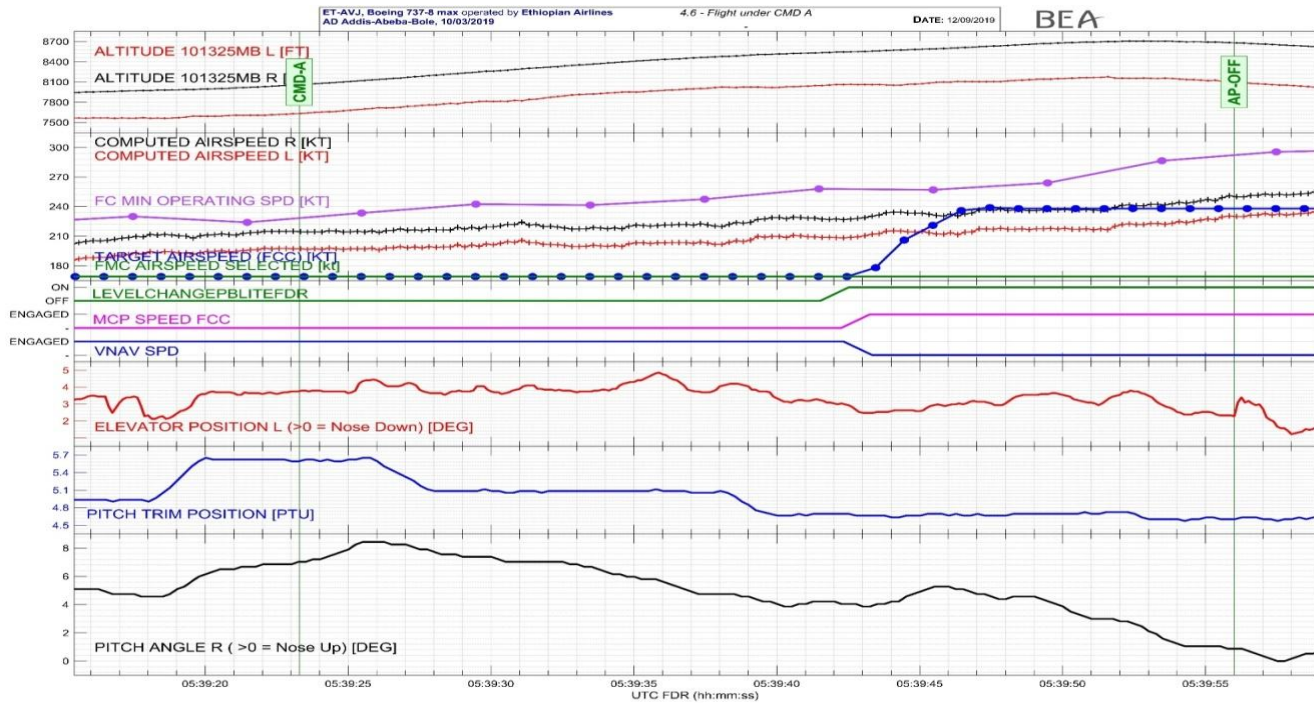
FIGURE 84: CMD A ENGAGEMENT

With the VNAV SPD mode engaged, the Airplane was expected to climb towards the target altitude of the flight plan (32,000 ft) at a speed close to the FMC target airspeed.

The longitudinal engaged mode (VNAV SPD) is a speed mode.

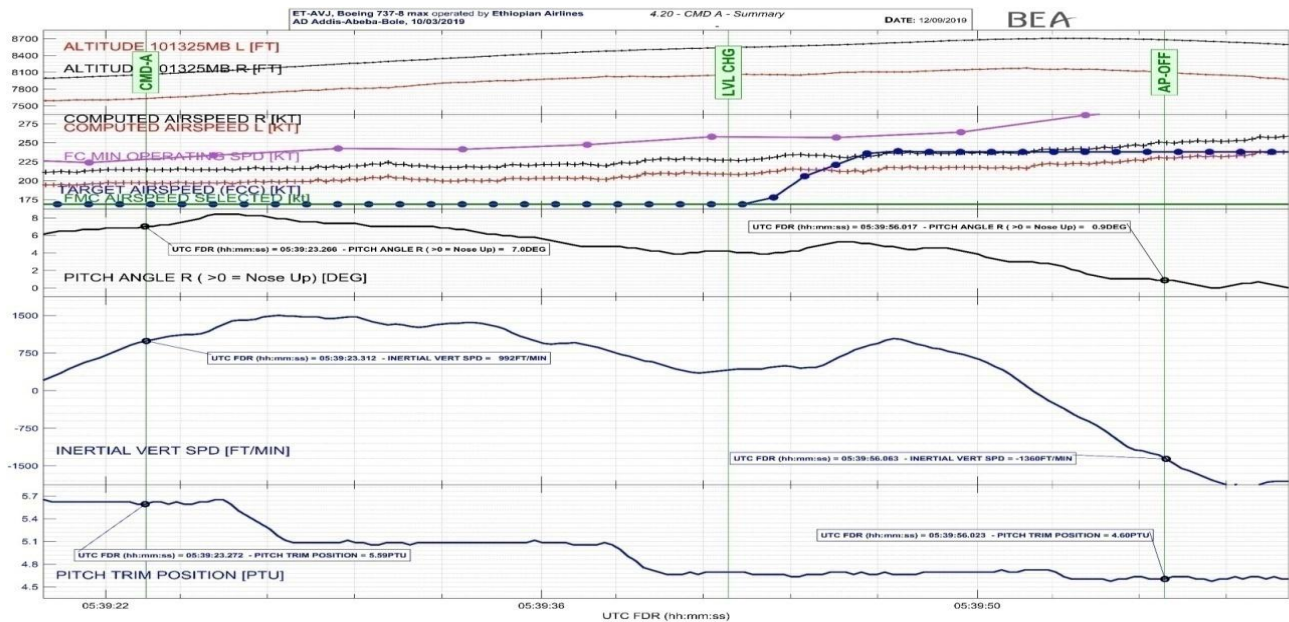
FIGURE85: CMD A - SUMMARY

At the connection of CMD A, the Airplane was climbing with a vertical speed of around 1,000 ft/min increasing, a pitch value of around 7° increasing and a stabilizer position of 5.6 units.

When CMD A automatically disconnected, the Airplane was descending with a vertical speed of around -1,400 ft/min, a pitch angle of around 1° and a stabilizer position of 4.6 units.

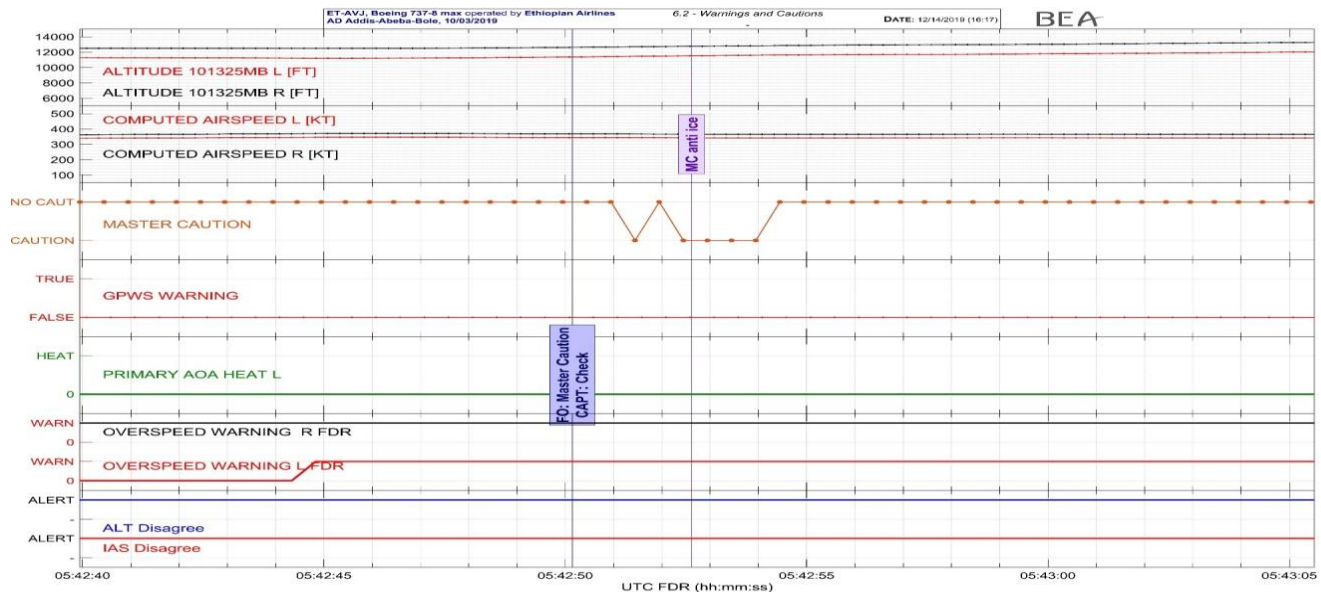
FIGURE 89: MASTER CAUTION RECALL

The first master caution triggered at 5 h 38 min 48 s during 7s. The reason for this master caution was anti-ice left alpha vane. This caution is triggered when low current is sensed in the AOA vane internal heater circuit. At 5 h 42 min 47 s, the crew exchanged about the master caution.

Then master caution triggered a second time at 5 h 42 min 51 s during 2.5 s. The crew detected: “Master Caution/anti Ice/left Alpha Vane”.

The third master caution triggered at 5 h 43 min 40s, but had no bearing on the sequence of events which led to the accident.

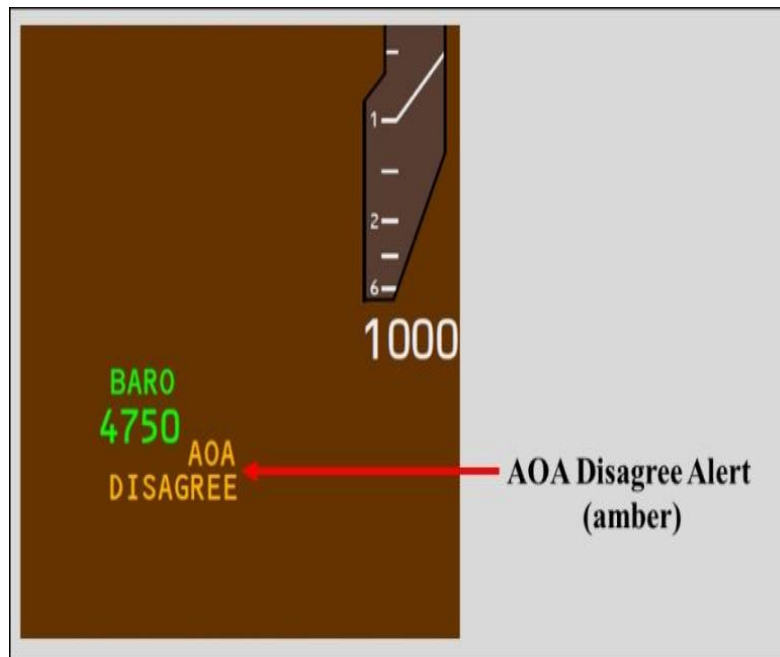
**Figure11:AOA Disagree Message on the PFD**

As shown in Figure 11 the AOA DISAGREE message appears on the captain’s and first officer’s PFDs when the values of the left and right AOA transmitted by the ADIRUs sufficiently diverge. The annunciation is only displayed in the air because AOA values are unreliable when the Airplane is stationary on the ground.

The AOA DISAGREE message was first implemented on the Boeing 737 NG fleet in 2006 in response to customer requests. Since 2006, the AOA DISAGREE alert has been installed on all newly manufactured Boeing 737 NG Airplane and is available as a retrofit for older Airplane. The requirements for the AOA DISAGREE alert were carried over from the Boeing 737 NG to the Boeing 737 MAX 8. In 2017, however, within several months after beginning Boeing 737 MAX 8 deliveries, Boeing identified that the 737 MAX 8 display system software did not correctly implement the AOA DISAGREE alert requirements. As with the Boeing 737 NG, the Boeing display system requirements for the 737 MAX 8 called for the activation of the AOA DISAGREE alert as a standard feature on all Airplanes. The software delivered to Boeing, however, linked the AOA DISAGREE alert to the AOA position indicator, which is an optional feature on the Boeing 737 MAX series. Accordingly, the software activated the AOA DISAGREE alert only if an airline opted for the AOA indicator. At the time of the accident, Boeing advised that the AOA indicator has been selected by approximately 20% of airlines.

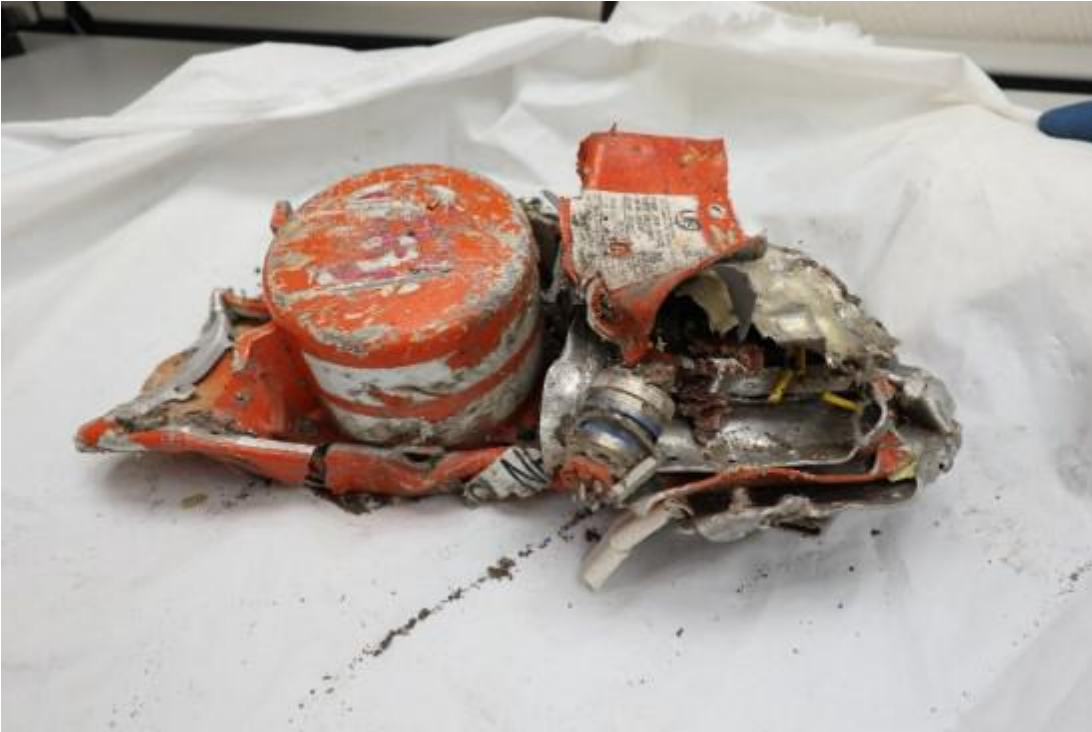
FIGURE 1: FDR FOUND IN THE SUITCASE BROUGHT BY ETHIOPIAN EAIB

The FDR was first visually examined. The chassis was damaged and folded on itself. The acquisition boards were visible as well as some internal connectors. The protected module Crash Survival Module Unit (CSMU) was still attached to the chassis and presented scratches. There was no ULB attached to the CSMU. A recorder identification plate was found close to the CSMU on the chassis, but not fixed to the chassis, on which the following numbers were written: P/N 2100-4945-22, S/N 001217995

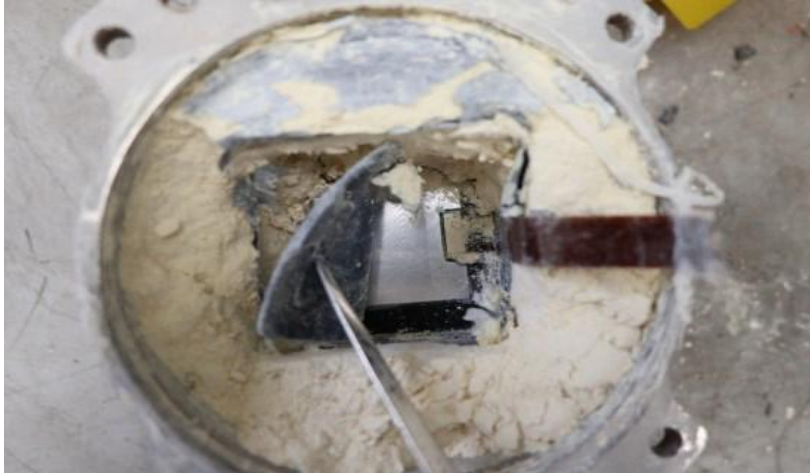
**FIGURE 2: AT OPENING THE FDR CSMU, SHOWING THE MEMORY PUCK AND FLEX**

The cover of the CSMU was unscrewed. The insulation material inside the CSMU was no longer compact and it was scooped out to access the memory puck.

It was first attempted to extract the memory puck by gently pulling on the flex. It was found that the connector was not properly attached to the memory puck.

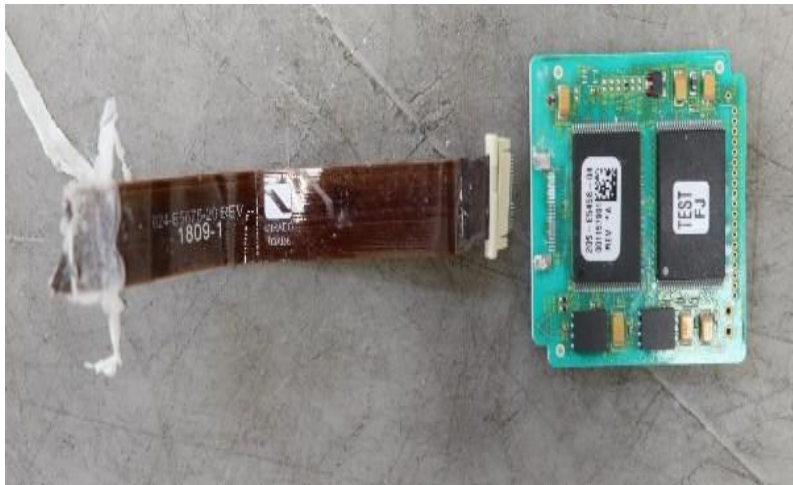
**FIGURE 3: FDR MEMORY BOARD, FLEX AND CONNECTOR**

The memory puck was opened and the electronic board containing the memory component support was extracted. The memory board identification was P/N 205-E5458-04, S/N 001157901 and the flex identification was 024-E5675-20 REV, 1809-1.
