**AIRCRAFT ACCIDENT INVESTIGATION BUREAU**

**INVESTIGATION REPORT ON**

**ACCIDENT TO THE B737-MAX8 REG. ET-AVJ OPERATED**

Report No. AI-01/19

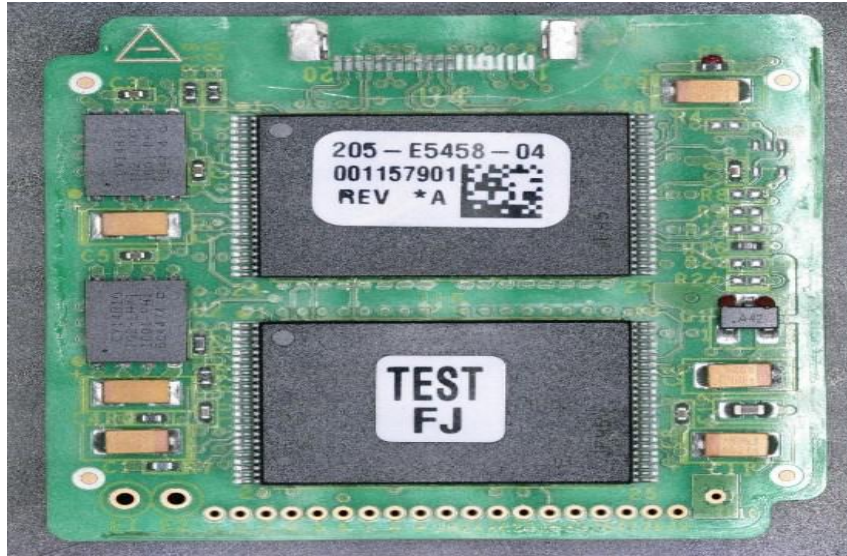
FIGURE 4: FDR MEMORY BOARD

The memory board was visually inspected with a Keyence microscope. Apart from the connector pads, the memory board was in good condition. There was no trace of impact. The two memory chips as well as the micro-processor were found in good condition.

At the connector location on the memory board the first 8 pads (on Figure 4)) were found missing. The holes were filled with insulation dust. The last 12 pads were in good condition.

The FDR memory board was also inspected with the X-ray machine. This confirmed that the first 8 pads of the connector were missing on the memory board (*Figure 4*) and that the 12 others were in good condition. There was continuity between those 12 pads and their vias (left side on *Figure 4*).

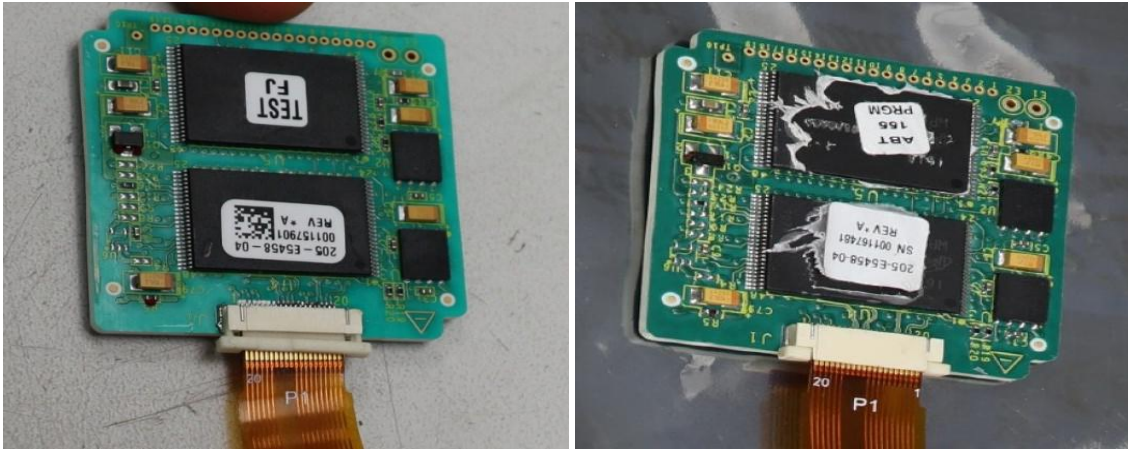
FIGURE 7: ET-AVJ FDR MEMORY BOARD WITH INTERFACE BOARD CONNECTOR FROM BEA SURROGATE RECORDER (LEFT), BEA SURROGATE RECORDER MEMORY BOARD WITH ORIGINAL CONNECTOR (RIGHT), BOTH MOUNTED WITH FLEX CABLE PIN VISIBLE AND "P1" WHEN PERFORMING READOUT

As the validation process, a focus was made on the angle of attack parameters. The left and right angle of attack parameters showed significant differences during the accident flight. Those two parameters showed similar values during the end of the previous flight (and were within coherent range).

On March 16th, all parties agreed that it was only necessary to resolder the last 12 pins of a new connector (pins 9 to 20, on the left side of *Figure 10*) to the FDR memory board to download the data.

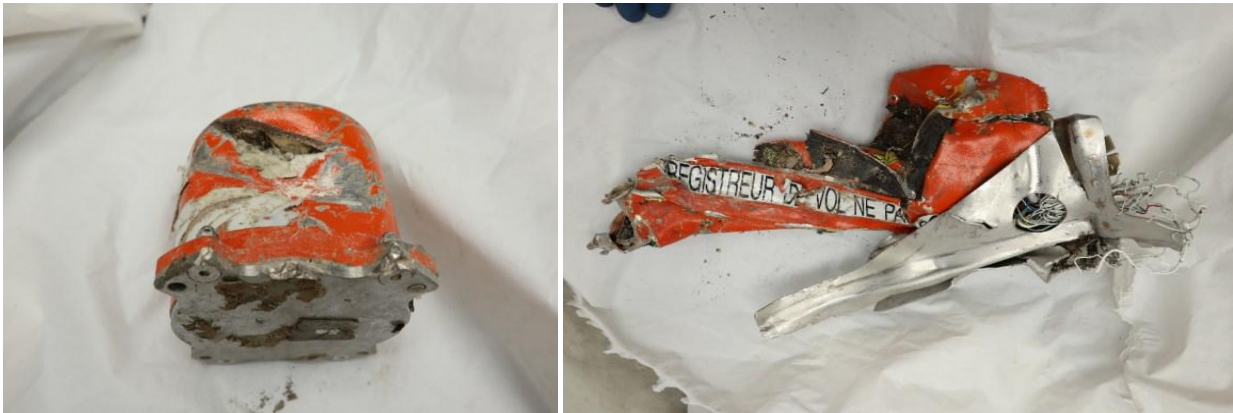
FIGURE 8 CVR CSMU AND CHASSIS WHEN BROUGHT BY ETHIOPIAN EAIB

The CVR CSMU was already separated from its chassis when it was brought to the BEA facilities. There was no ULB attached to it and no identification plate was found on the CSMU.

The isolated chassis was damaged and still partially attached to the Airplane rack on which it was mounted. There was no identification plate on it. Wires were visible on the back side.

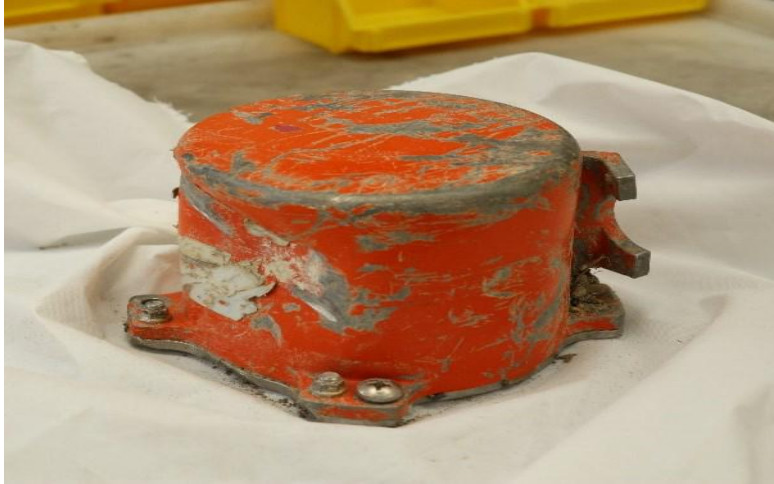
FIGURE 9: CVR WHEN OPENING THE SUITCASE BROUGHT BY ETHIOPIAN EAIB

The CSMU case showed an opening. The hole on the side opposite to the ULB fixation allowed seeing the internal insulation material

The interface board that is supposed to be located under the CSMU was missing and the flex connecting it to the memory puck was damaged.

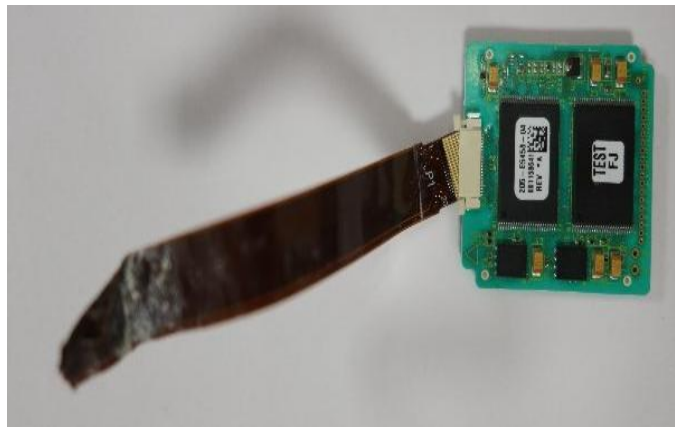
FIGURE 10: CVR MEMORY BOARD AND FLEX

The CVR memory board and flex were visually inspected with the Keyence microscope. There was no damage on the board and the connector was in good condition.
