**REPORT ON A MID-TO-LATE NINETEENTH-CENTURY WOODEN SHIPWRECK
IN THE EAST CHANNEL OF THE MOBILE RIVER SUGGESTED AS A CANDIDATE
FOR THE 1855 SCHOONER *CLOTILDA*,
BALDWIN COUNTY, ALABAMA**

JULY 2018

JAMES P. DELGADO, PHD, RPA, KYLE LENT, MA, RPA, JOSEPH GRINNAN, MA, RPA,
DAVID W. MORGAN, PHD, STACYE HATHORN, MA, AND DAVID CONLIN, PHD

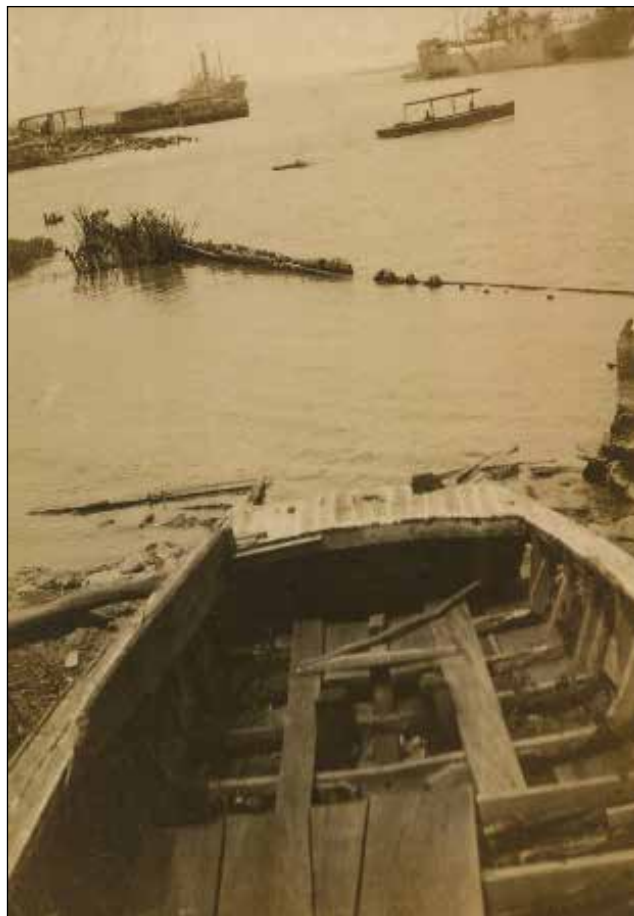
The first photographic occurrence of the Twelvemile Island Wreck (1BA694) comes from a ca. 1912 photograph published in 1914 by Emma Langdon Roche (1914:102). This photograph is noted as “showing the remains of *Clotilda*” (Figure 12), although there is no way to confirm the wreck in the photograph is actually that of *Clotilda*. In comparing this historic 1912 photograph with features present in historic aerials, as well as archival imagery from Google Earth from 1997 to 2011, general observations can be made that suggest certain features present in the 1912 photograph are also visible in the historic aerials, such as a filled section of the bank lined by pilings. This may be the same structure present in the background of the 1912 image, which could potentially represent a barge landing on the river south of the wreck. The landscape and environment in the 1912 photograph is comparable with the landscape and environment in which the Twelvemile Island Wreck (1BA694) Site is located. The ca. 1912 photograph depicts what may be a barge just south of the Twelvemile Island Wreck (1BA694), which is supported by the previously discussed aerial imagery of the area. It may have been wrecked in association with the presumed barge landing identified in the 1938 aerial, which is delineated in the photograph by pilings and fill. The exposed pilings are visible on a 1938 historic aerial; and visible in the background of the ca. 1912 photograph labeled as the *Clotilda* wreck (Figure 13). The obstruction/landing is no longer visible in aerials dated after 2011.

Figure 12. Historic photograph (ca. 1912) identified as showing the remains of *Clotilda* (Roche 1914:102).

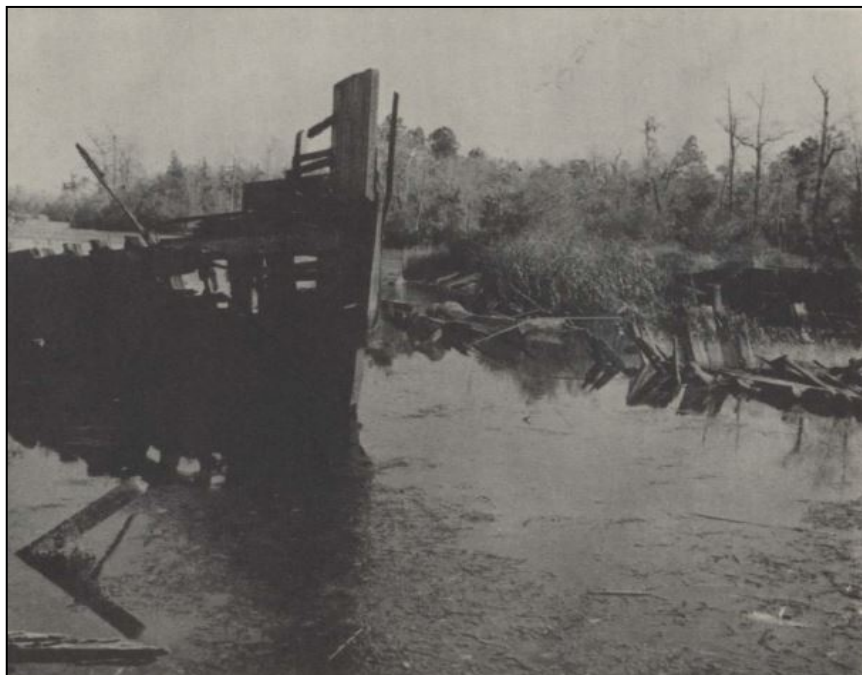
In addition to the historic 1912 photograph, a 1965 newspaper article identifies the remains of a wooden vessel in a photograph as that of *Clotilda* (Figure 14). The article reports that the “Rotting Hulk of Schooner Clotilde, last “slaver” yields museum piece” (*Alabama on the Go* 1965:29). A comparative analysis between the available historic photographs and historic aerials suggest that the ca.-1912 photograph and the ca.-1965 photograph may potentially be the same wreck site, which was relocated and identified by Raines (2018). The wreck, as discussed by Roche, was said to still lie “in the marsh at the mouth of Bayou Canot and may be seen at low tide” (Roche 1914:97).

Figure 14. "Rotting hulk of Schooner *Clotilde*, last 'slaver' yields museum piece" (June 1965). Source: *Alabama on the Go* 1965:29.

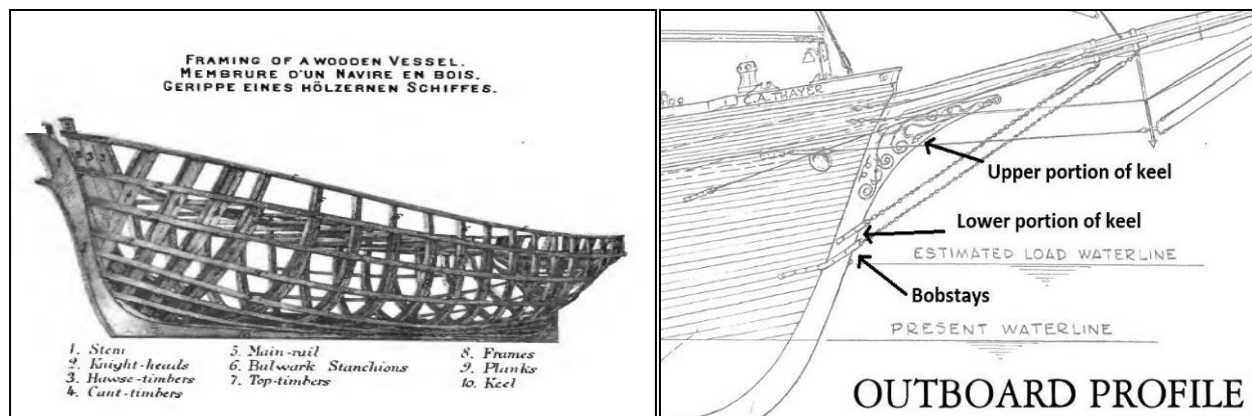
Plans from the Historic American Engineering Record (HAER) of the historic 1895-built three-masted schooner *C.A. Thayer* show the placement and characteristics of the bowsprit and foremast rig on the type of vessel which may be similar to that of the Twelvemile Island Wreck (1BA694) (Figure 24). In addition, Heinrich Paash's "From Keel to Truck" *Marine Dictionary* provides a description of the basic hull structure and framing of a wooden vessel from the Twelvemile Island Wreck (1BA694) time period (Figure 25).

Figure 25. Left: The basic form of a nineteenth-century wooden hull (Paasch 1885). Right: the location of visible elements on the stem of the Twelvemile Island Wreck (1BA694). Profile example of *C.A. Thayer*. Source: Library of Congress.

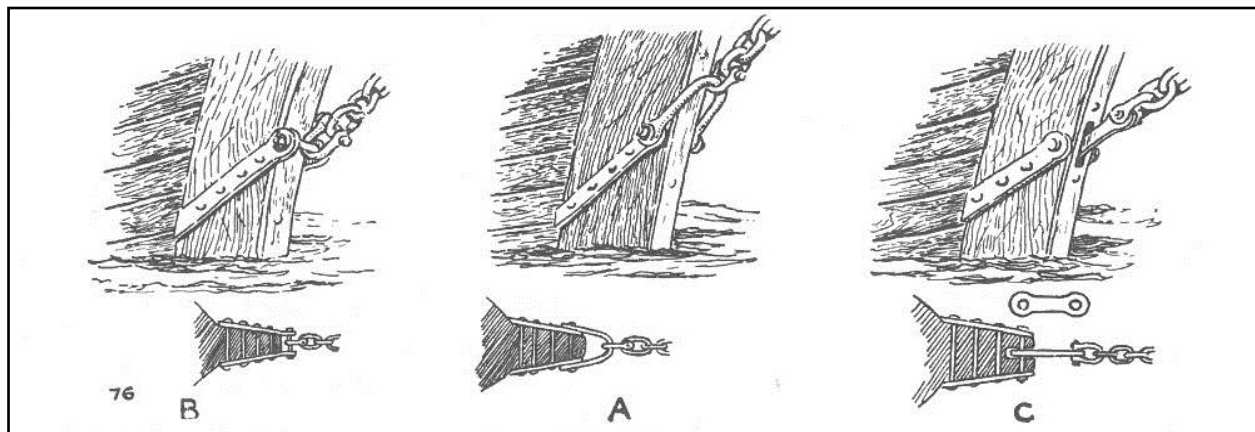
The bobstay fasteners that are visible on the Twelvemile Island Wreck (1BA694) Site are angled, which was typical. The straps, which can be seen above water during two different field visits, show the amount of tidal fluctuation within the river (**Figure 28**). The bobstay fasteners are located above the waterline on the stem at the Twelvemile Island Wreck (1BA694). The visible frames above the mudline on the starboard side of the hull indicate that they are likely the fourth frame futtocks above the waterline, based on their orientation (**Figure 29**).

Figure 28. Examples of bobstay fasteners on wooden vessels (Underhill 1946).

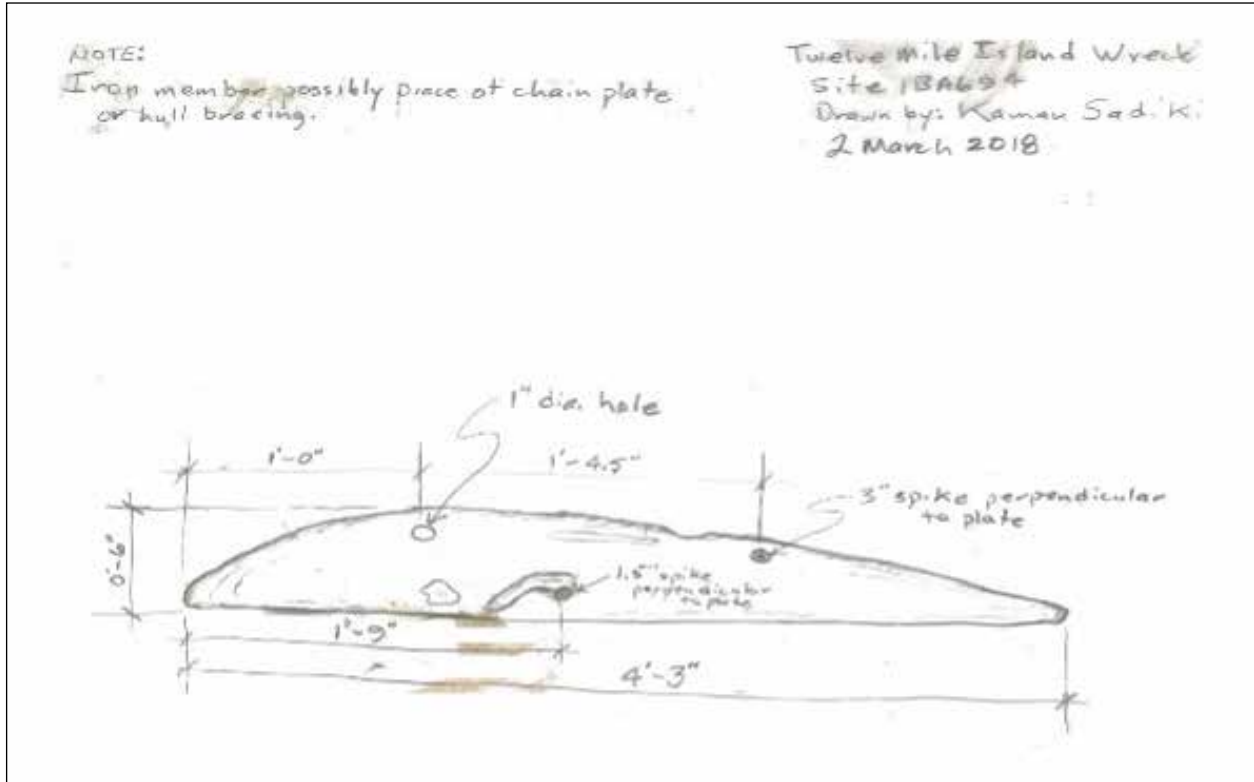
Archaeologists believe that the three artifacts protruding from the water, represented at the Twelvemile Island Wreck (1BA694), are the remains of diagonal or arch strapping (**Figure 36**). All three pieces of iron strapping were photodocumented, while the one disarticulated strap was removed for archaeological illustration (**Figure 37**) and then returned to its position lying outside the starboard hull midships. Furthermore, there is the lesser possibility that they are fragments of flat-bar iron or steel chainplates. Chainplates, fastened to the outer hull, anchor the standing rigging that supports each mast. The shape and form of chainplates evolved from what essentially began as enlarged “chains” attached to the side of the hull to single strops with a “deadeye” at the terminal end. An example chainplate is found on the 1895-built three-masted schooner *C.A. Thayer* (see **Figure 24**).

Figure 37. Probable iron reinforcing strap from the Twelvemile Island Wreck Site (1BA694). Illustration by Kamau Sadiki.

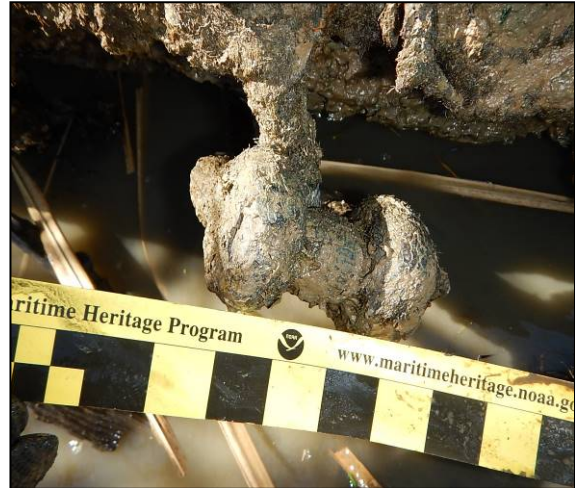
[REDACTED]. While it may be isolated, or a later feature, it may also be evidence that the wreck [REDACTED] (Figure 41).

Figure 41. Shackle and wire rope identified at the site during the March 2018 field visit.

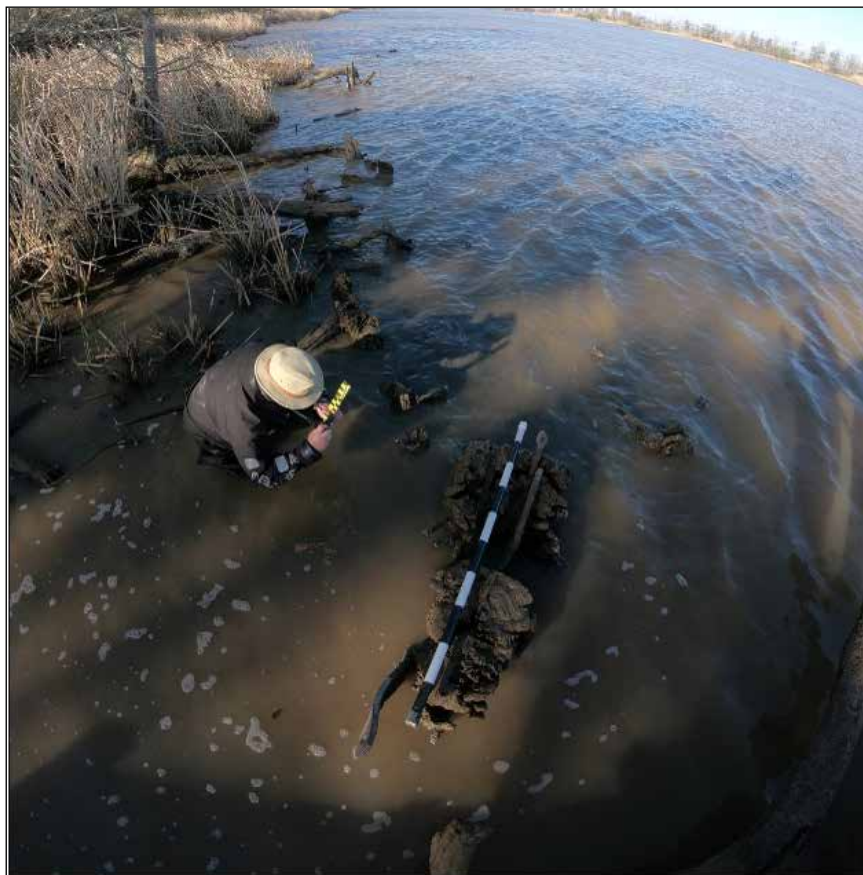
Figure 46. View of Twelvemile Island Wreck (1BA694) site from forward cant frames down starboard side; Joe Grinnan measuring drift bolt fastener; David W. Morgan in background with stadia rod; image facing west.

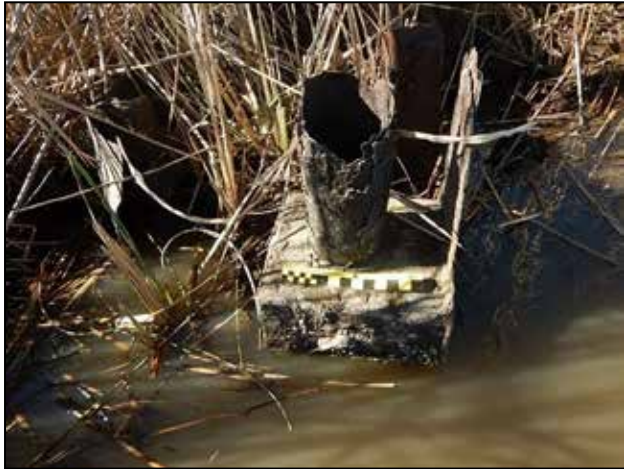
Figure 57. Probable bollard at southeast corner of Target 1, facing southwest.

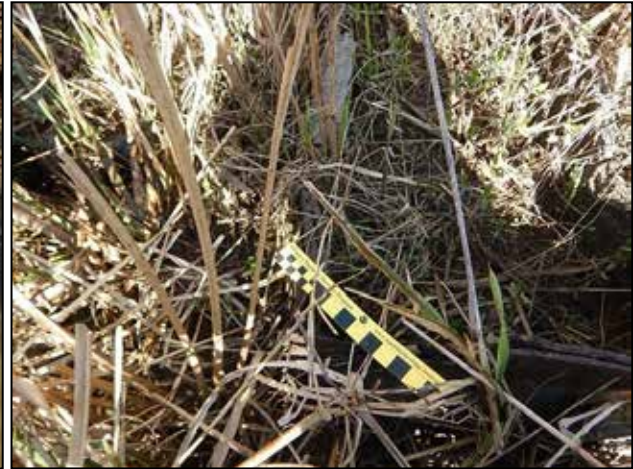
Figure 58. Southwest corner of Target 1, facing northeast.
