DELTA VEHICLE FLIGHT FAILURE REPORT LAUNCH 33

OCTOBER 1966

GODDARD SPACE FLIGHT CENTER
Greenbel , Maryland

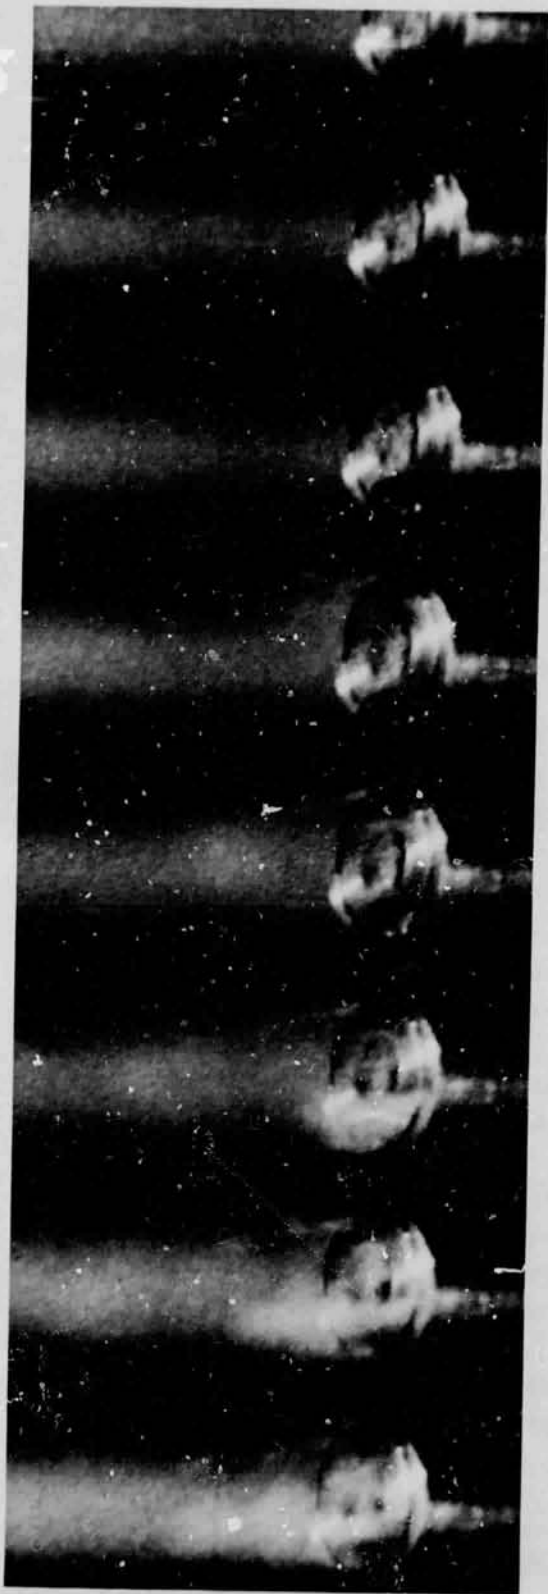
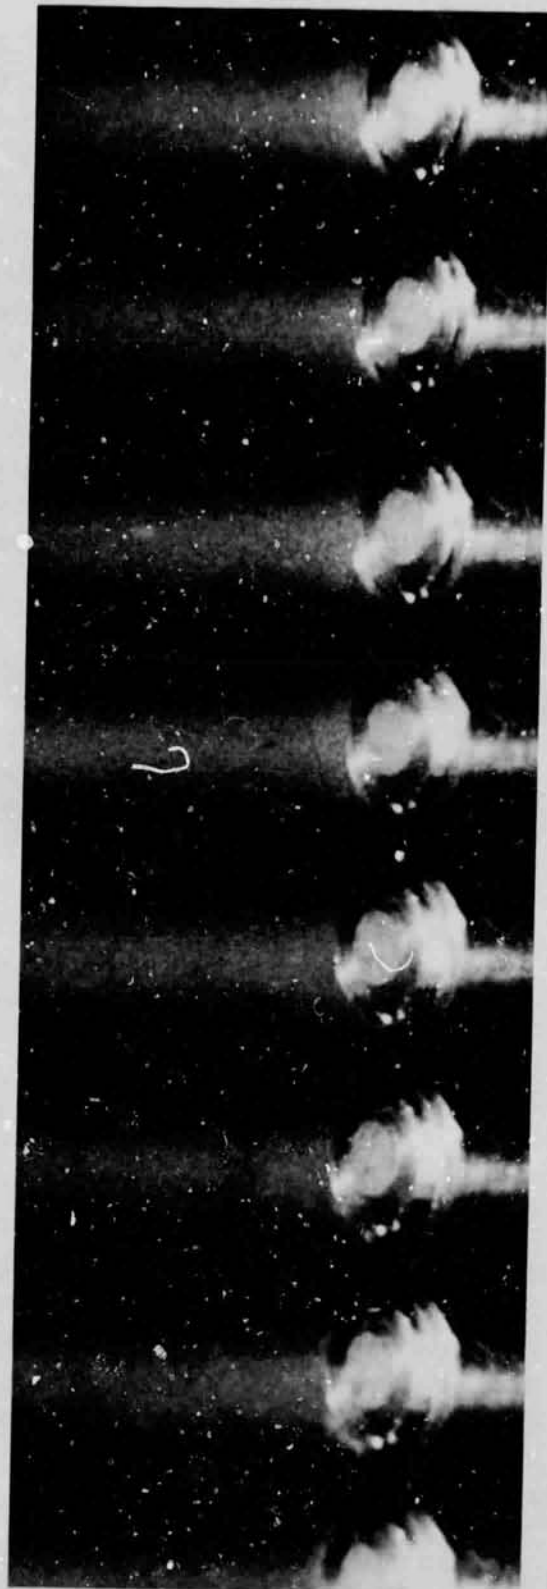
Figure 5. High Speed Photograph
of Squib Action

In another squib firing test all of the PbO/B main charge following the lead ferrule was removed and the sleeves machined back flush with the terminal face of the lead ferrule and delay mix. The squib was fired and the exposed end photographed at 5,000 frames per second (see Figures 5 and 6). Nearly simultaneously with ignition of the PbO/B charge something that appears to be rapidly moving gas emerges from between the lead ferrule and the inner bronze sleeve, then a short pause, and the entire lead ferrule containing the delay train moves out of the tube, perhaps 1/32 of an inch. This entire action takes place in less than a millisecond.

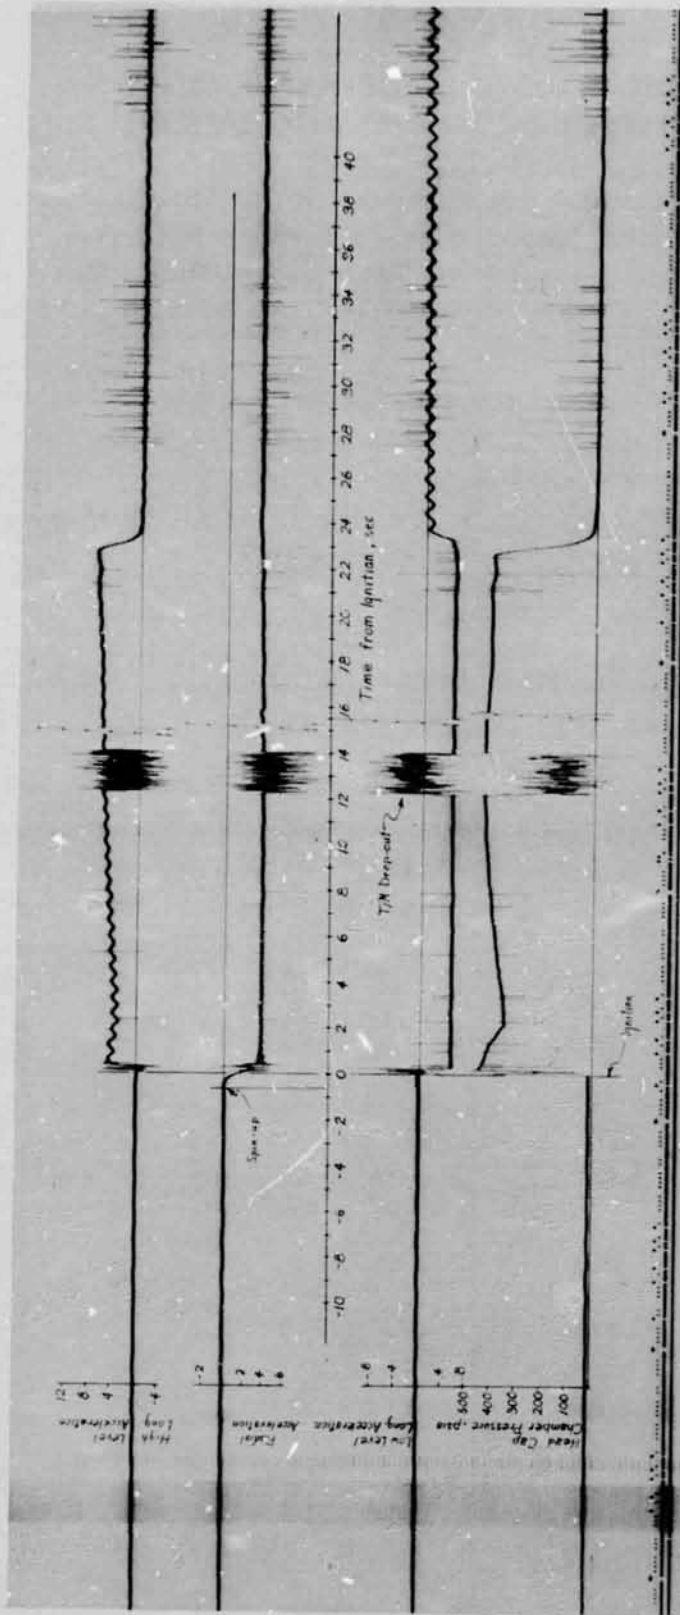
Expanded records of the chamber pressure shown in Figure A-4 were integrated by means of a planimeter over the time interval from ignition to apparent zero pressure. The pressure-time integral obtained by this method is 9,561 PSIA-Sec. Multiplying by an average $C_F A_T$ of 14.5 yields a total impulse of 138,645. This is slightly less than the expected for this motor however the discrepancy can most probably be attributed to overall accuracy of the T/M system and the method of data reduction. The chamber pressure trace indicates that the motor burned to completion with no unusual events occurring after separation.

Expanded records of the high range longitudinal acceleration shown in Figure A-4 were integrated by means of a planimeter over the time interval from ignition to apparent zero acceleration. The acceleration-time integral obtained is 3,758 ft/sec. which is 18% less than the predicted of 4559 ft/sec. This apparent decrease in performance was probably caused from (a) damage to the X-258 nozzle during separation which would result in a decrease in specific impulse realized and (b) the possibility that parts of the spin table remained attached to the aft end of the motor resulting in an increase in effective payload weight. The acceleration trace indicates large amplitude coning starting at separation and damping out during burning of the motor. This coning is probably caused from from the abnormal second to third stage separation experienced on this mission.

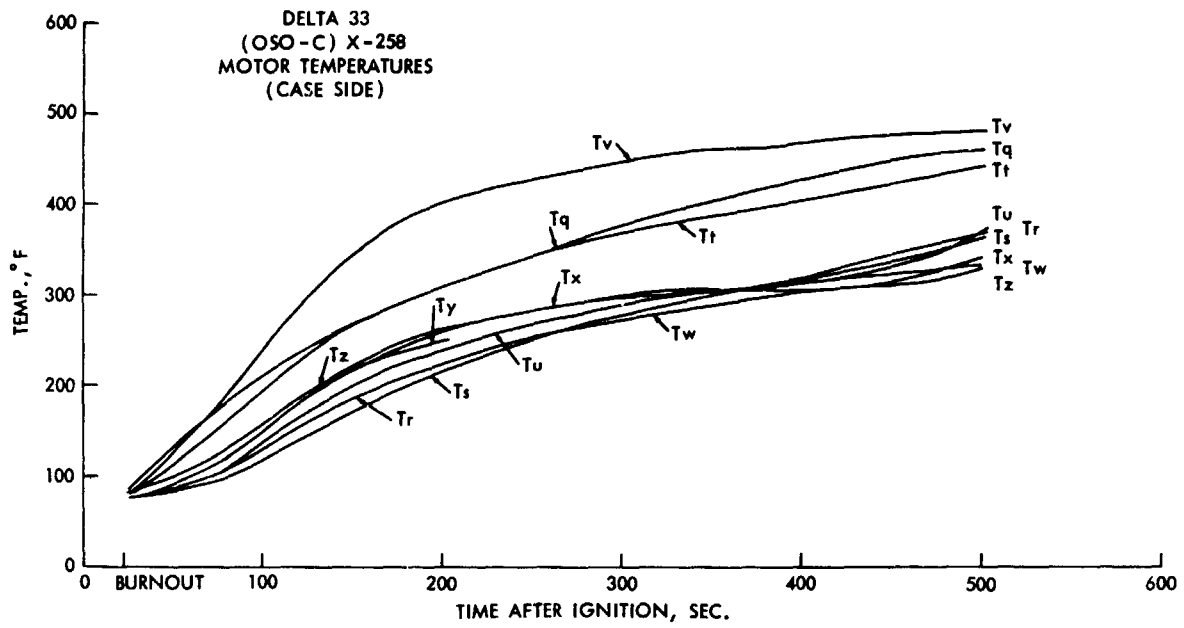
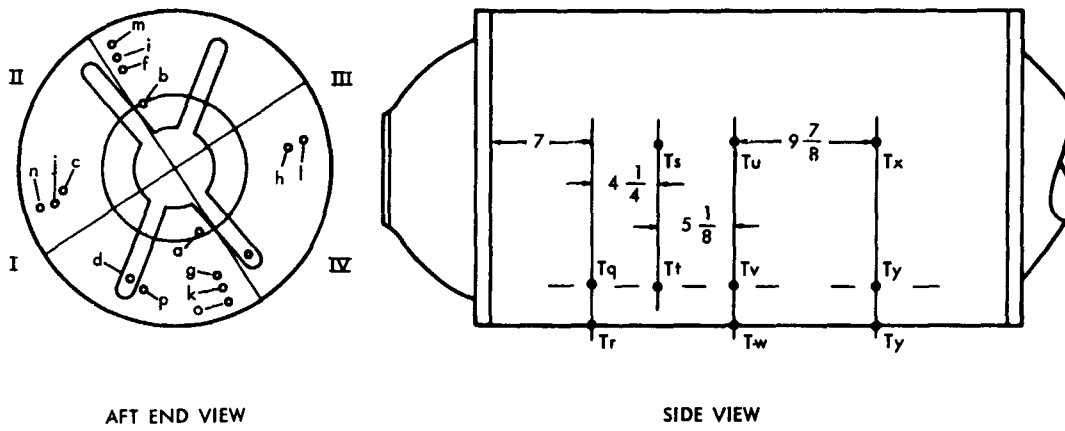
Figure A-5

Temperature data received from the ten sensors located on the side of the X-258 motor case indicate a maximum temperature of 475°F at 500 seconds after motor ignition. This is the first time the case temperature has been measured on an X-258-C4 motor and indicates the effectiveness of the added chamber insulation. The motor case was completely covered with aluminum foil which makes this test the most severe thermal condition the motor will be subjected to in flight. Past data indicates that the addition of aluminum foil to the outside of the case will increase the maximum case temperature by approximately 100°F. Figures A-5 and A-6 are temperature-time plots of the case temperature.

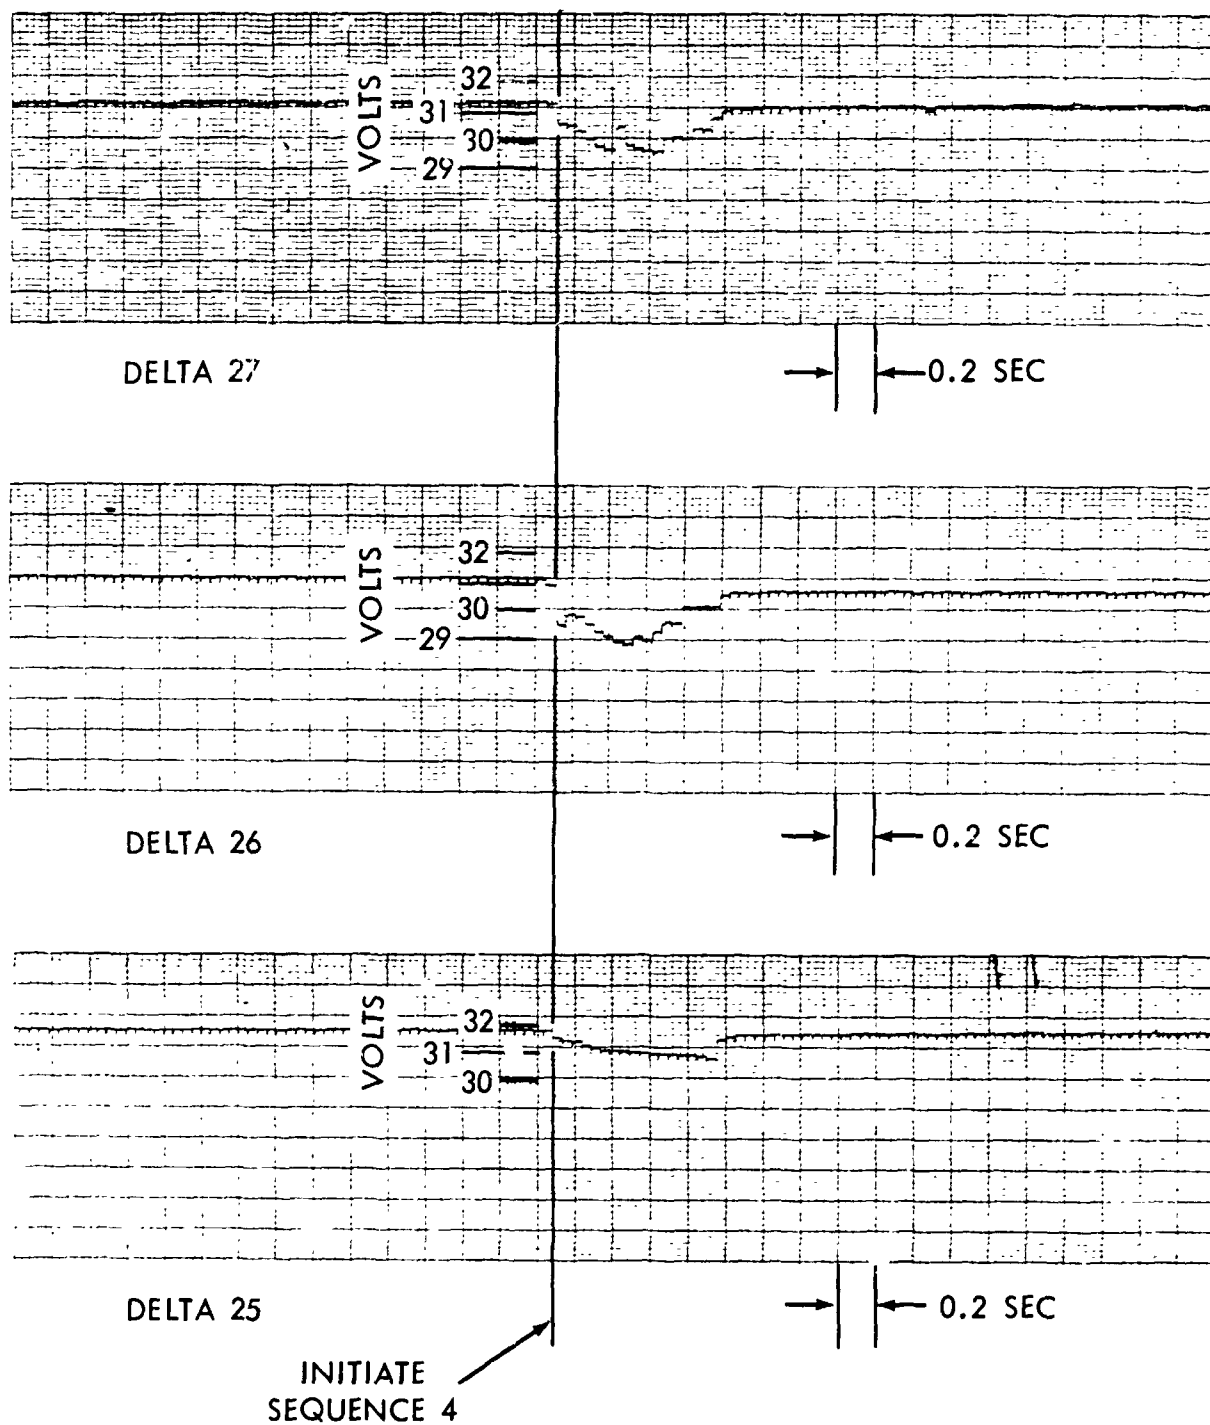
Figure C-7. Engine Battery Voltage at Sequence 4, Delta 25, 26, and 27

Referring to Figure C-7 they are the Delta 25 class and the Delta 26 class. Past flights which fall into the Delta 25 class are Deltas 29, 30, 31, and 25. The remainder are classed with Delta 26, except Delta 28 which appears to be a combination of both 25 and 26. The initial voltage drop, observed in Delta 33 and the Delta 26 class, was not observed in the Delta 25 class probably due to the sampling period of the TM system. The stepwise increase in voltage at 1 second after sequence 4, clearly apparent in the Delta 25 class, is not so clearly visible in the Delta 26 class. The differences may be due only to the random load caused by the spent bridgewire. Specifically, any shorted bridge wires may be "burned clear" prior to the 1 second time so that there was less load to be removed by the explosive switches (S1200/1201). In the records examined, the battery voltage had returned to normal at the end of the 1 second period, indicating that all load was removed by this time.

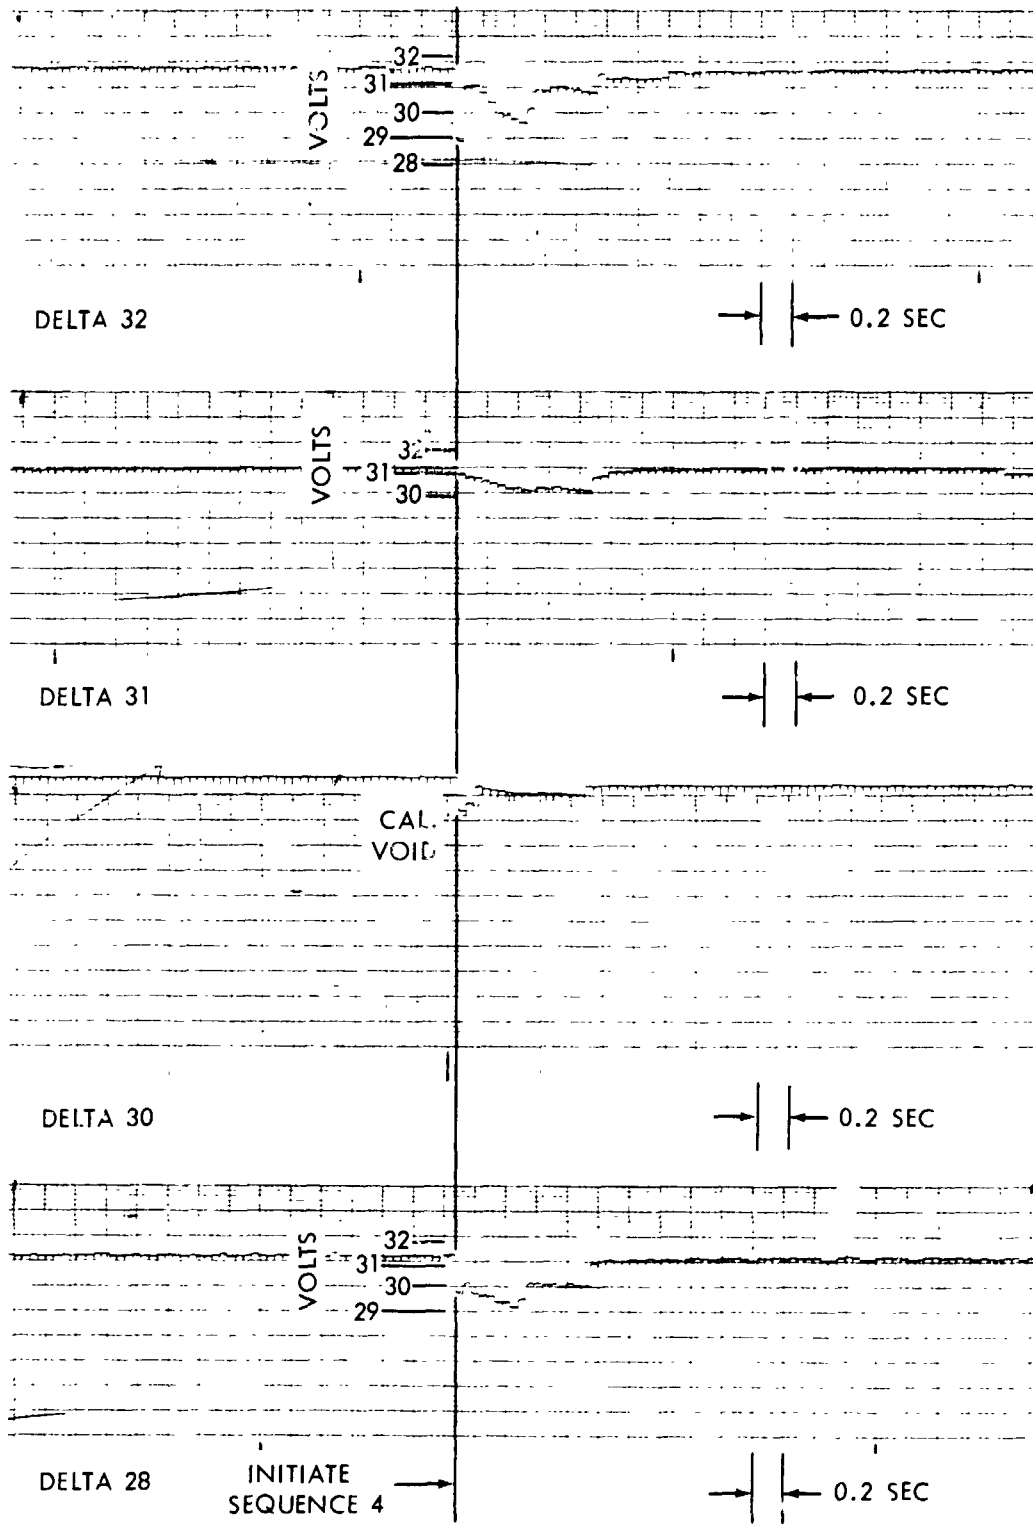
Figure C-8. Engine Battery Voltage at Sequence 4, Delta 28, 30, 31, and 32

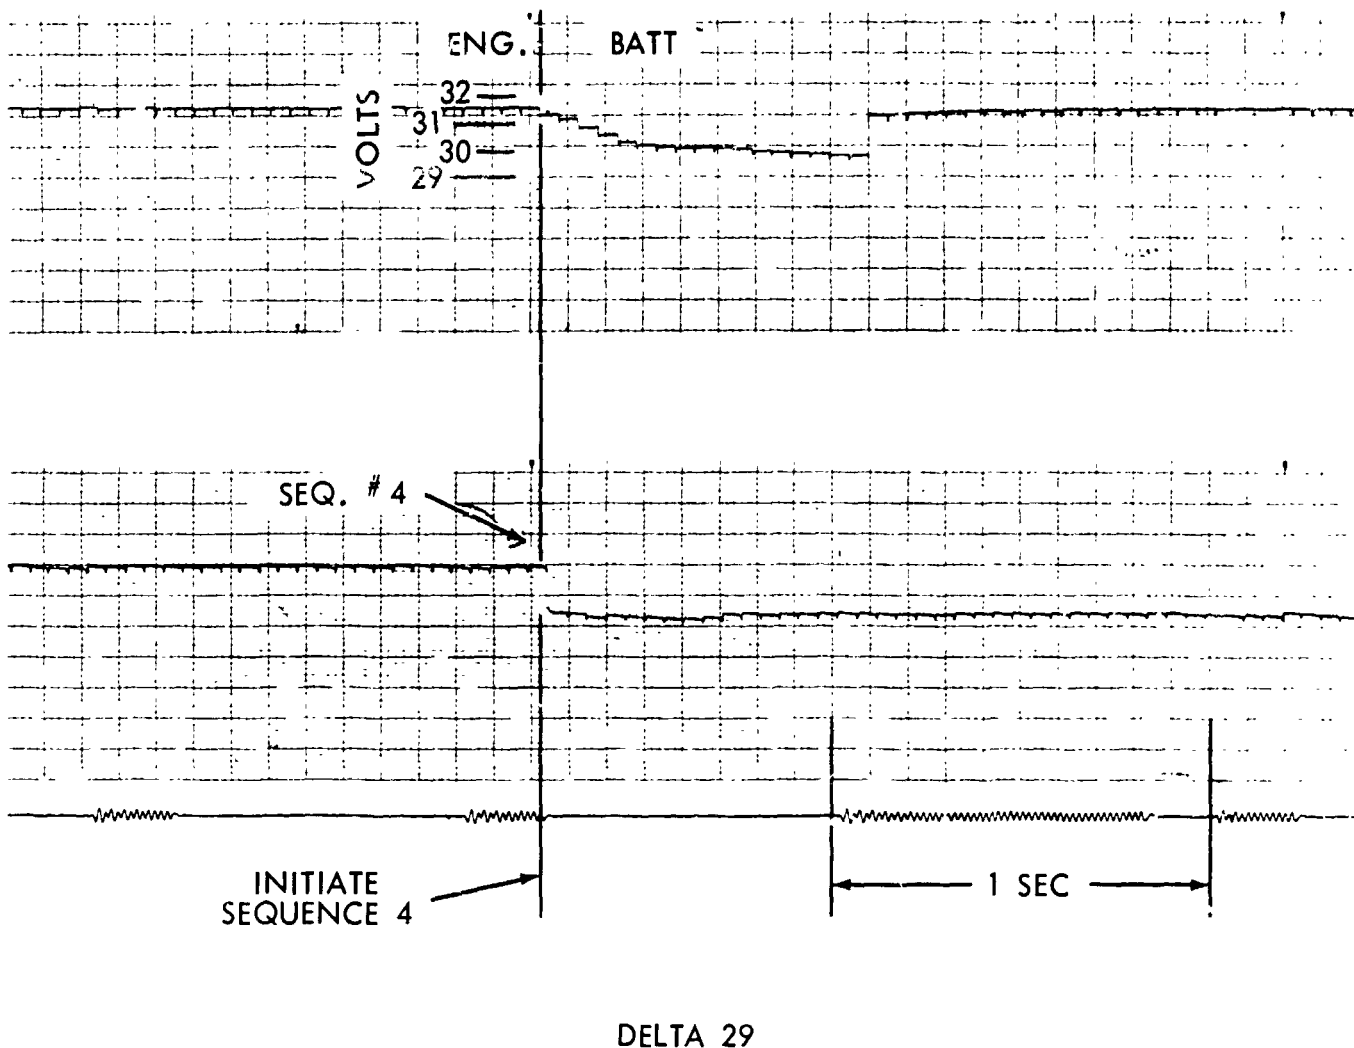
Figure C-9. Engine Battery Voltage at Sequence 4, Delta 29

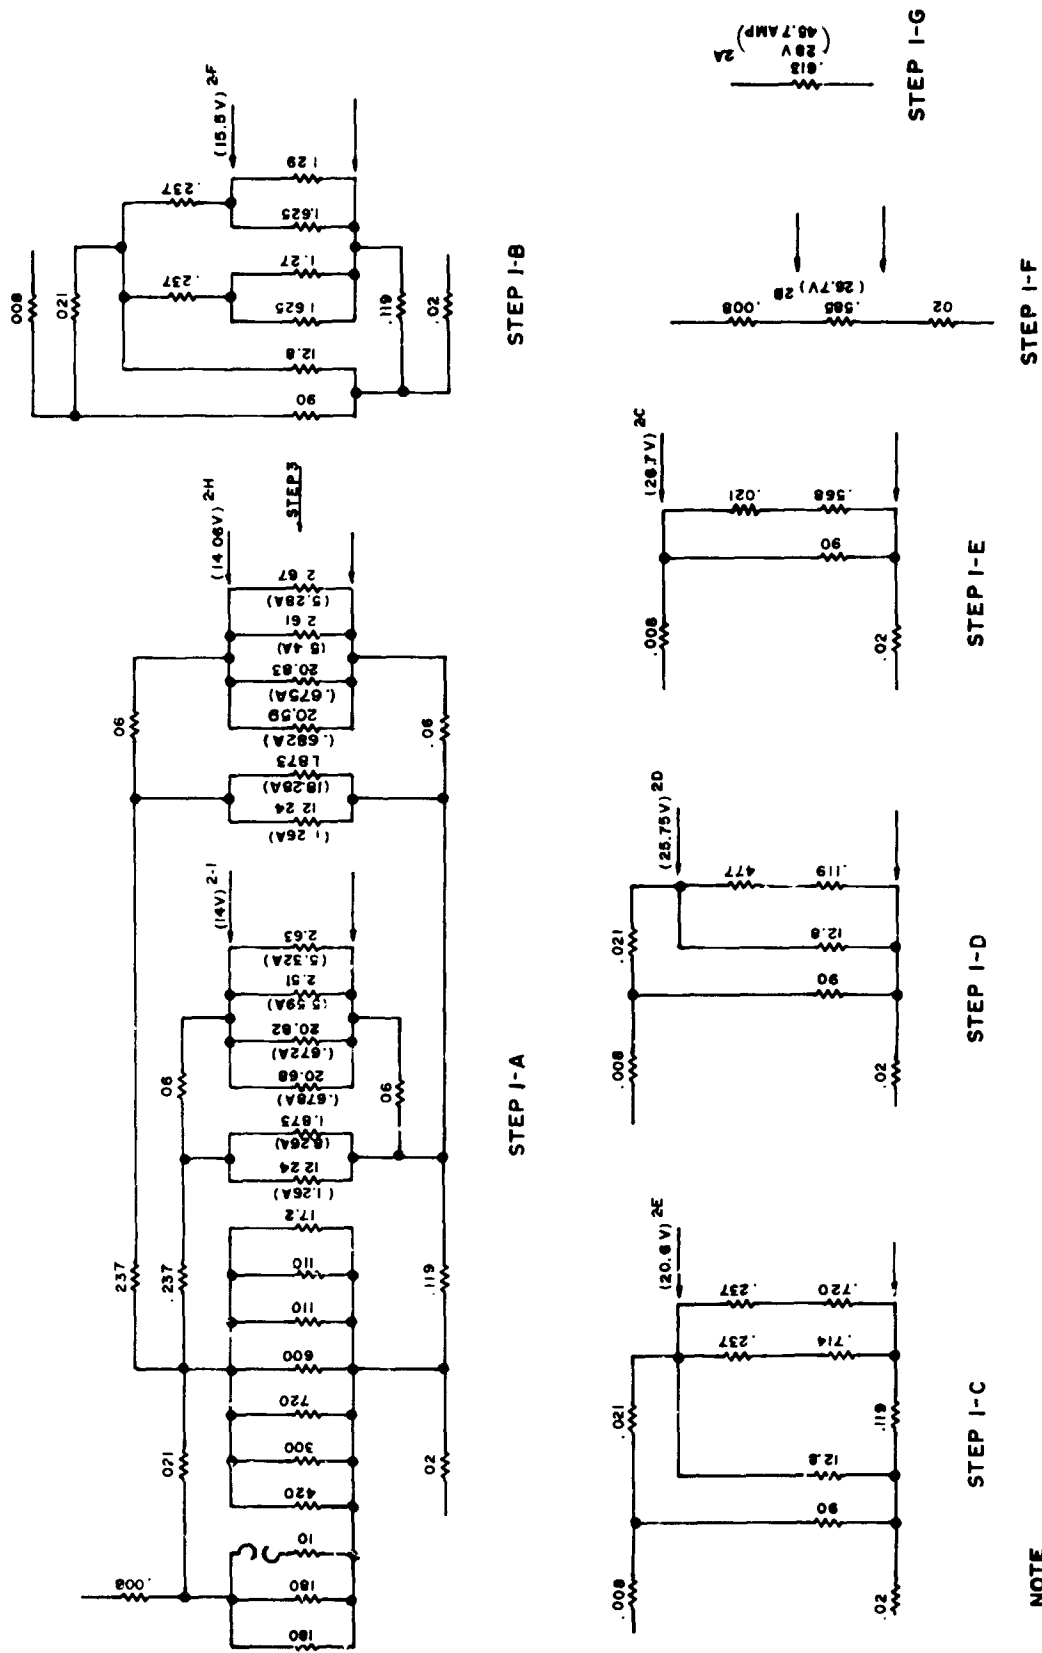
The load on the engine battery at sequence 4 was calculated to determine the total current available from the battery. The current distribution was determined from this quantity. Figures C-11 through C-13 depict the load for three conditions of the sequence relay K703. First is the normal operation in which all bridgewires are connected to the engine battery through two contacts of the relay. Then, operation of each contact of the relay is considered. These might correspond to a momentary closure or short circuit. These are summarized in Table C-5.

Figure C-11. Sequence 4 Initial Current Flow-Normal Operation

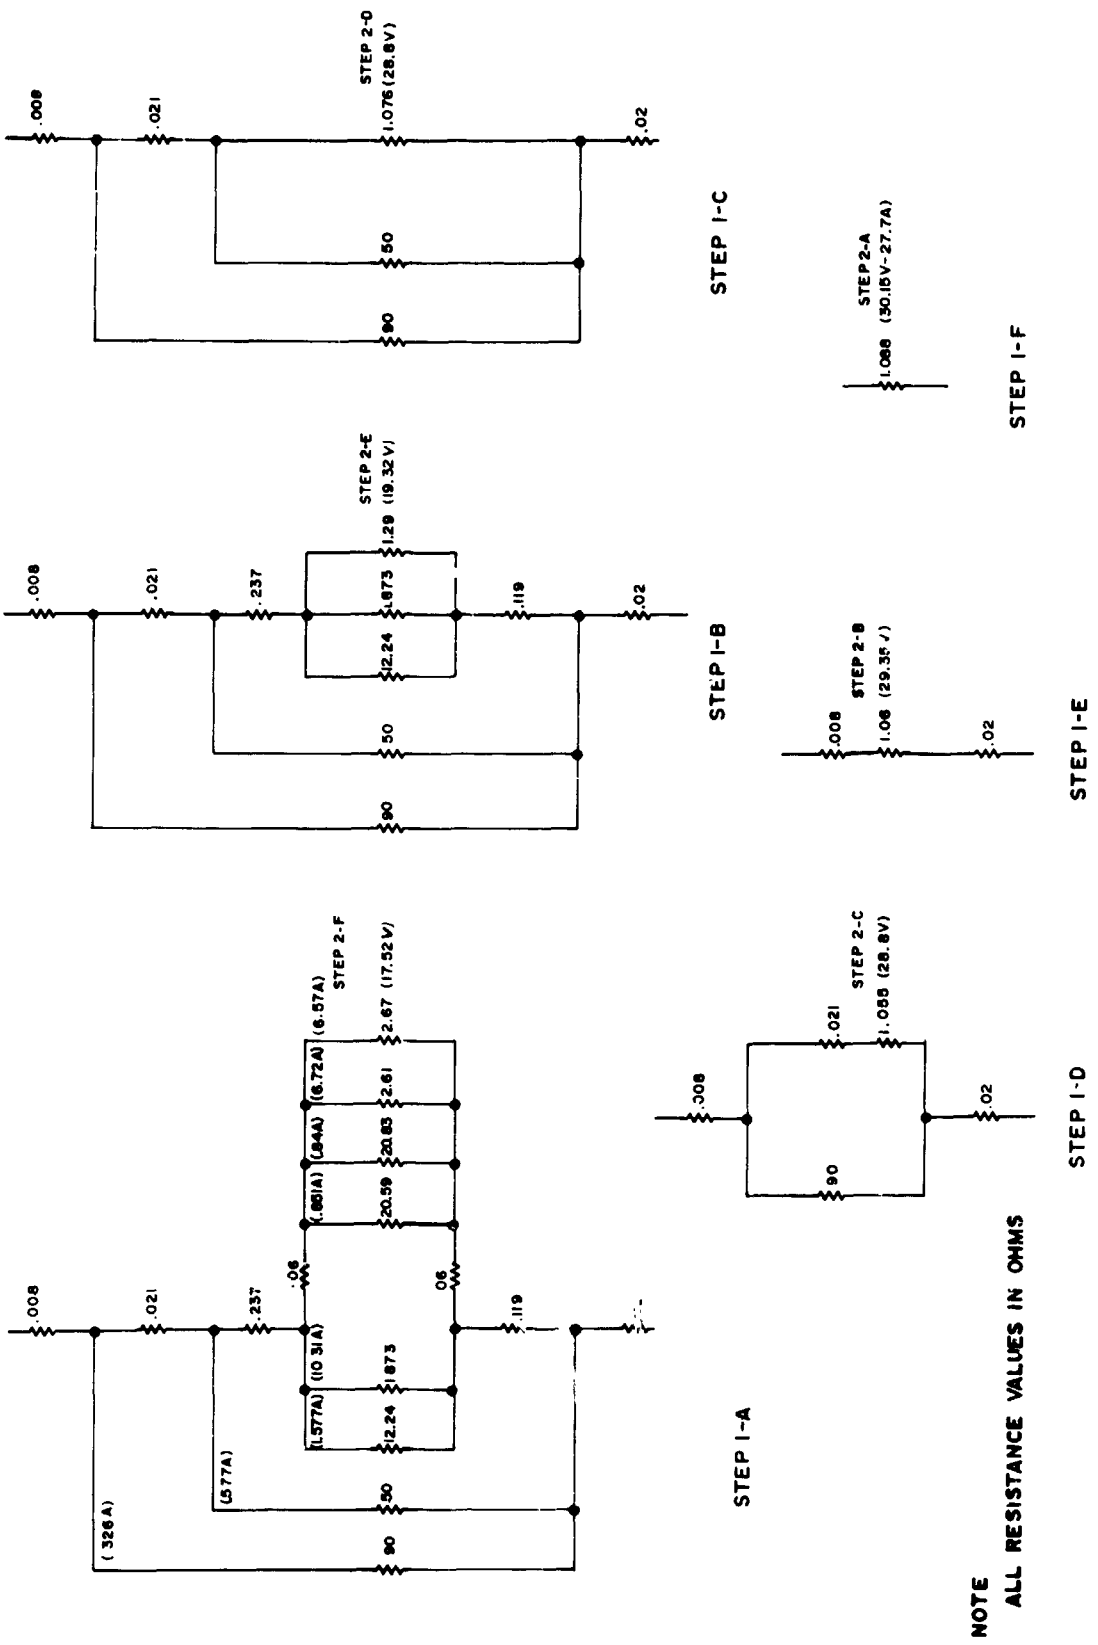
Figure C-12. Sequence 4 Current Flow if 1/2 of K703 Operates (Side A)

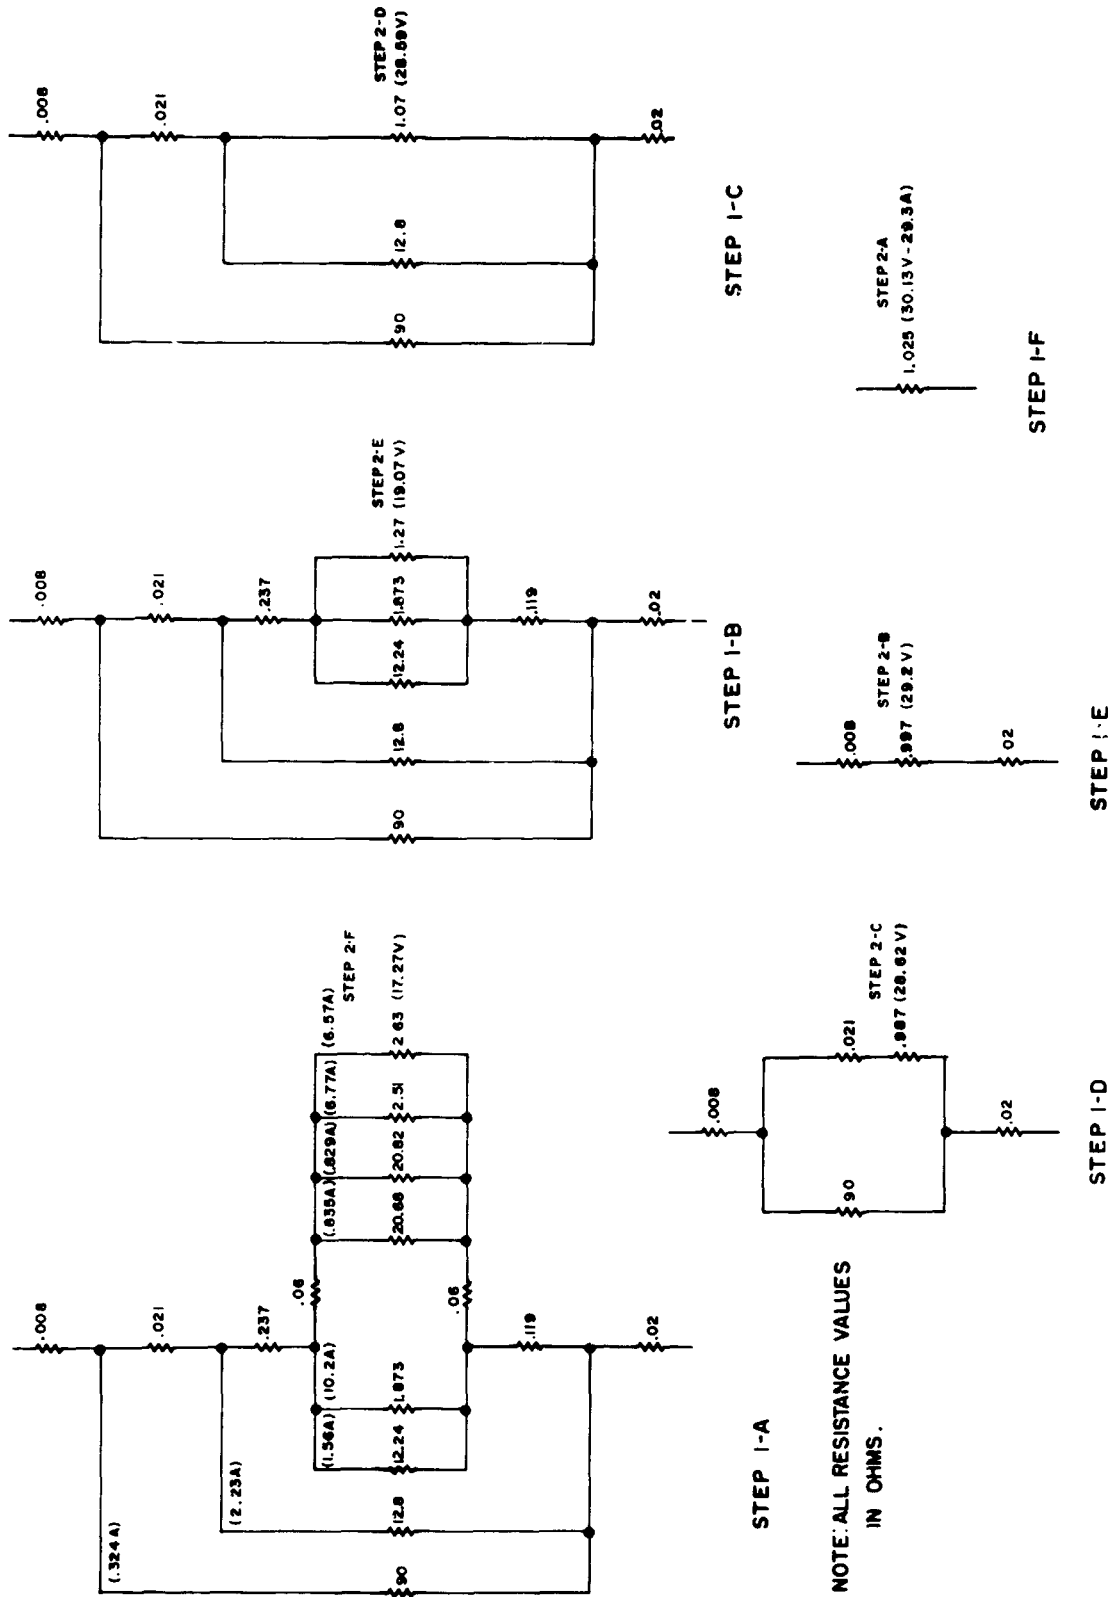
Figure C-13. Sequence 4 Current Flow 1/2 of K703 Operates Side B with S703

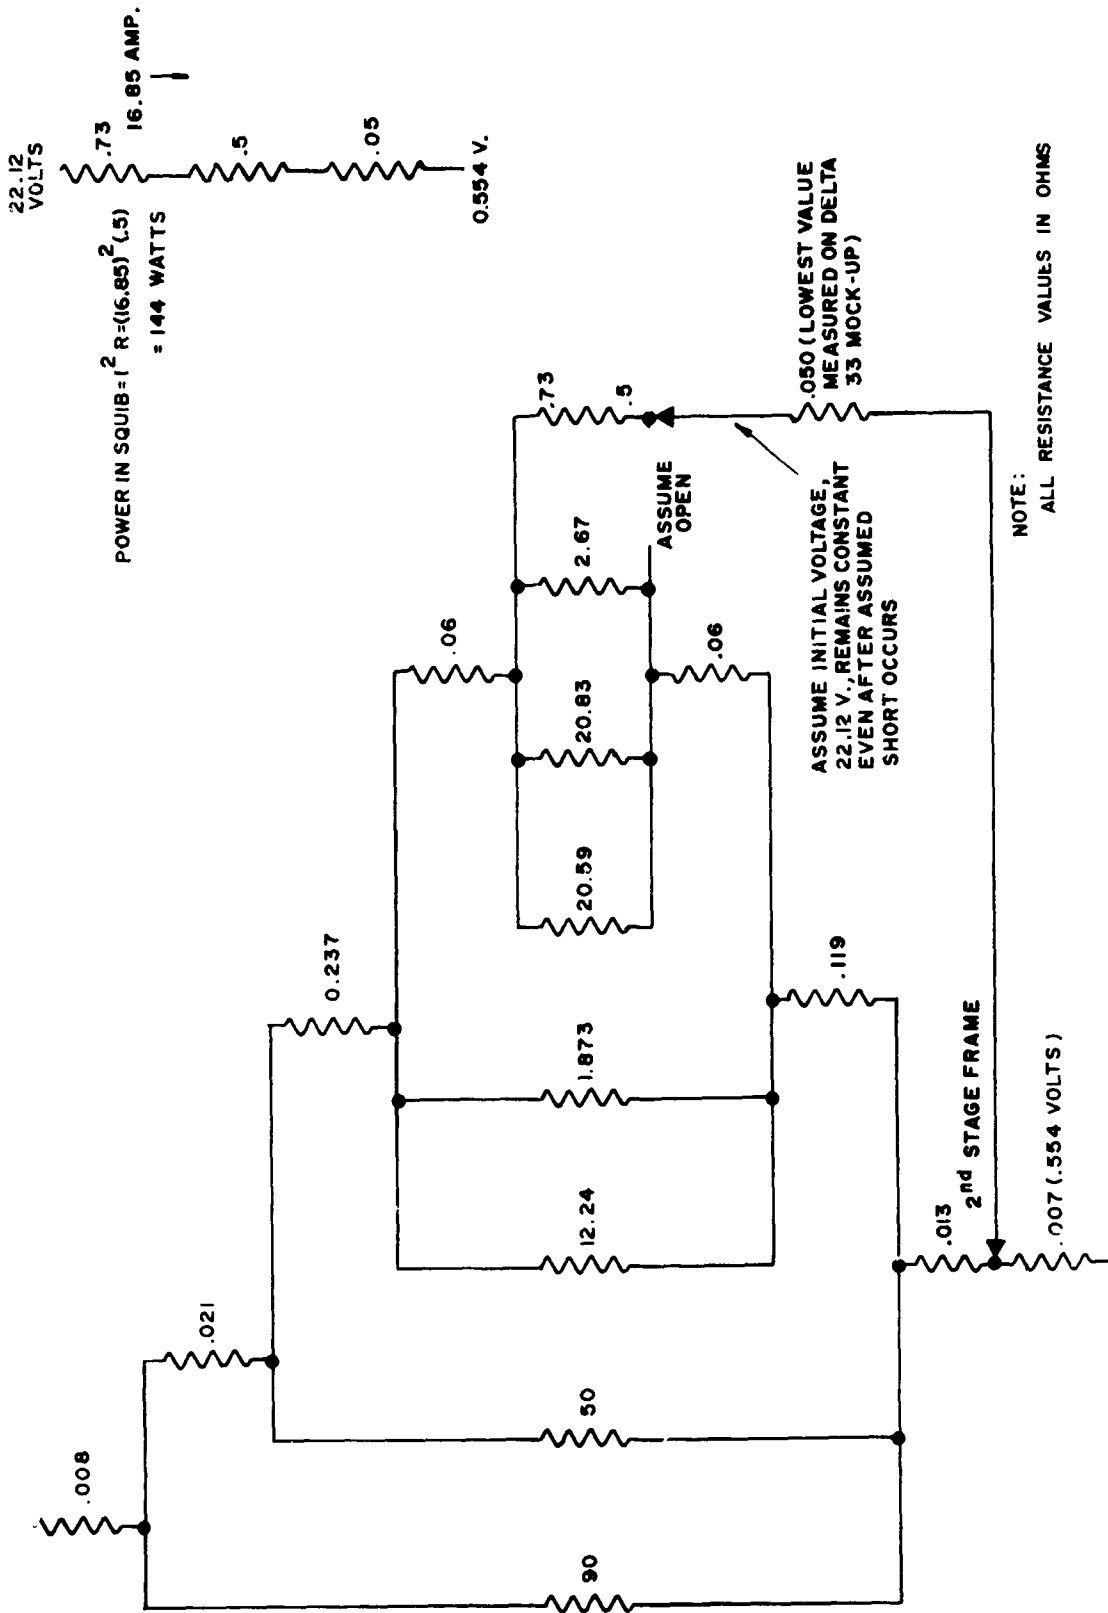
Three special conditions were considered to determine the power that might be dissipated in the SD60AO squib with various combinations of open and short circuits. Figures C-14, C-15 and C-16 show these connections.

Figure C-14. Special Condition (Assumed Short to 3rd Stage Ground at Squib)

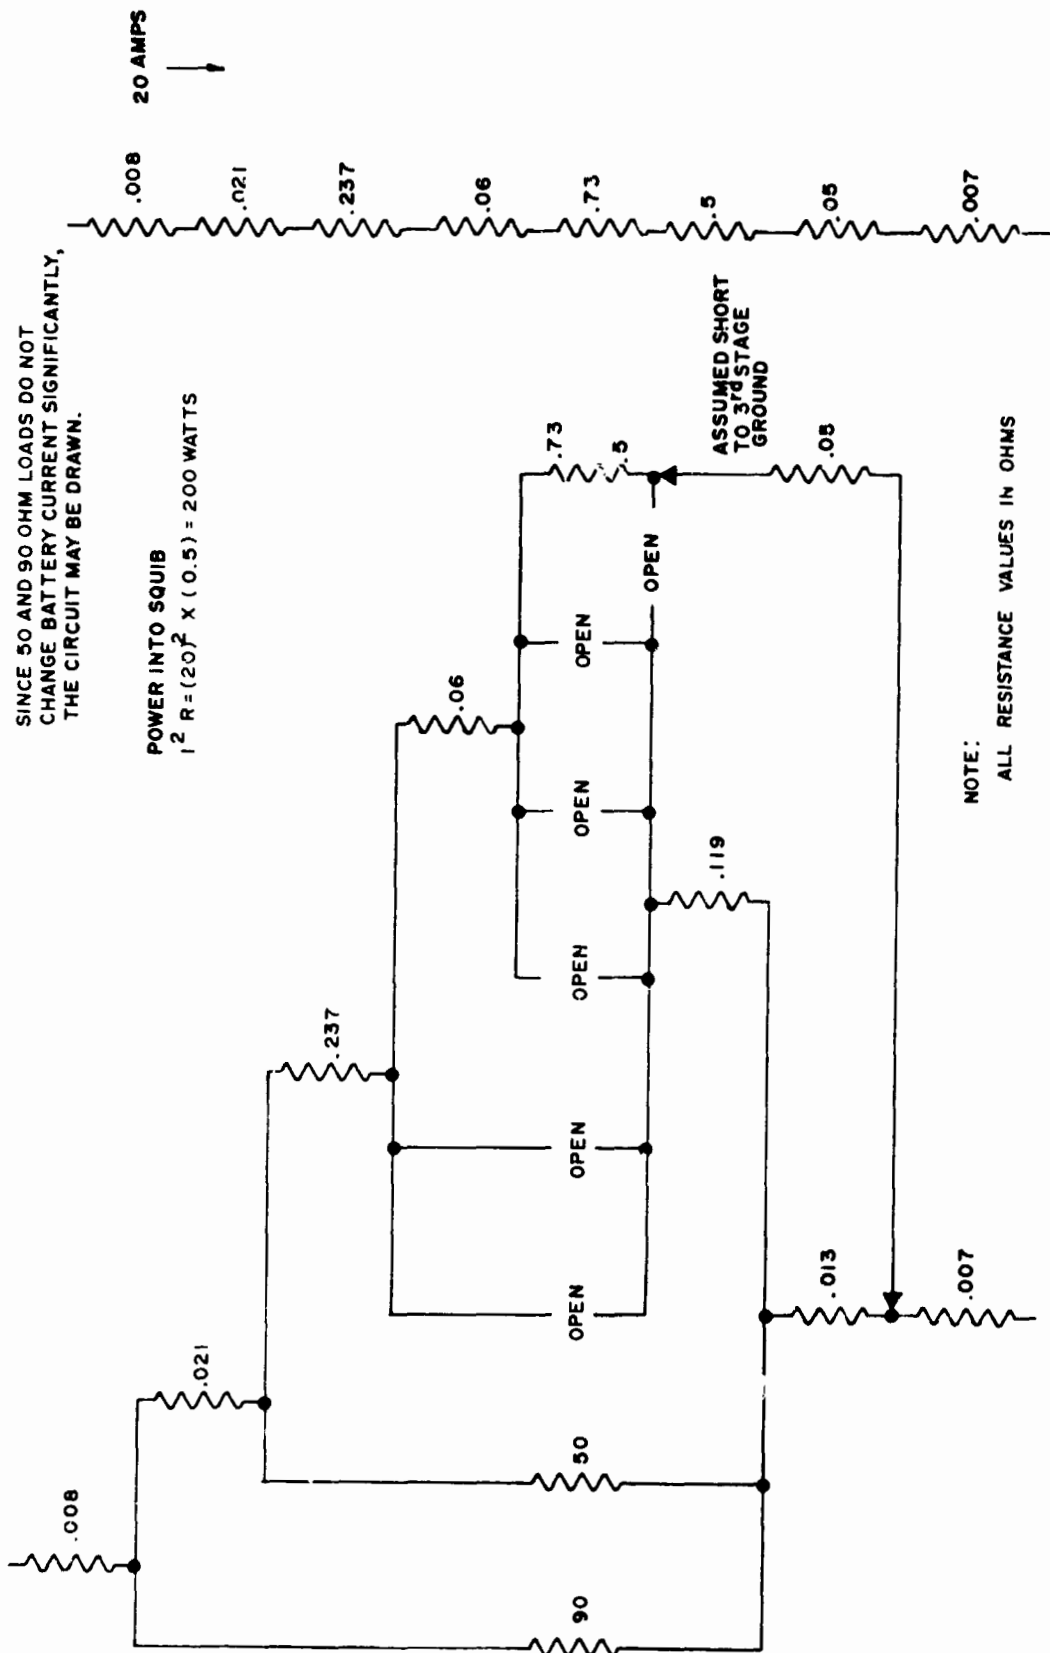
Figure C-15. Special Condition (Assume All Bridgewires Open After Initiation Except One SD60AO Bridgewire)

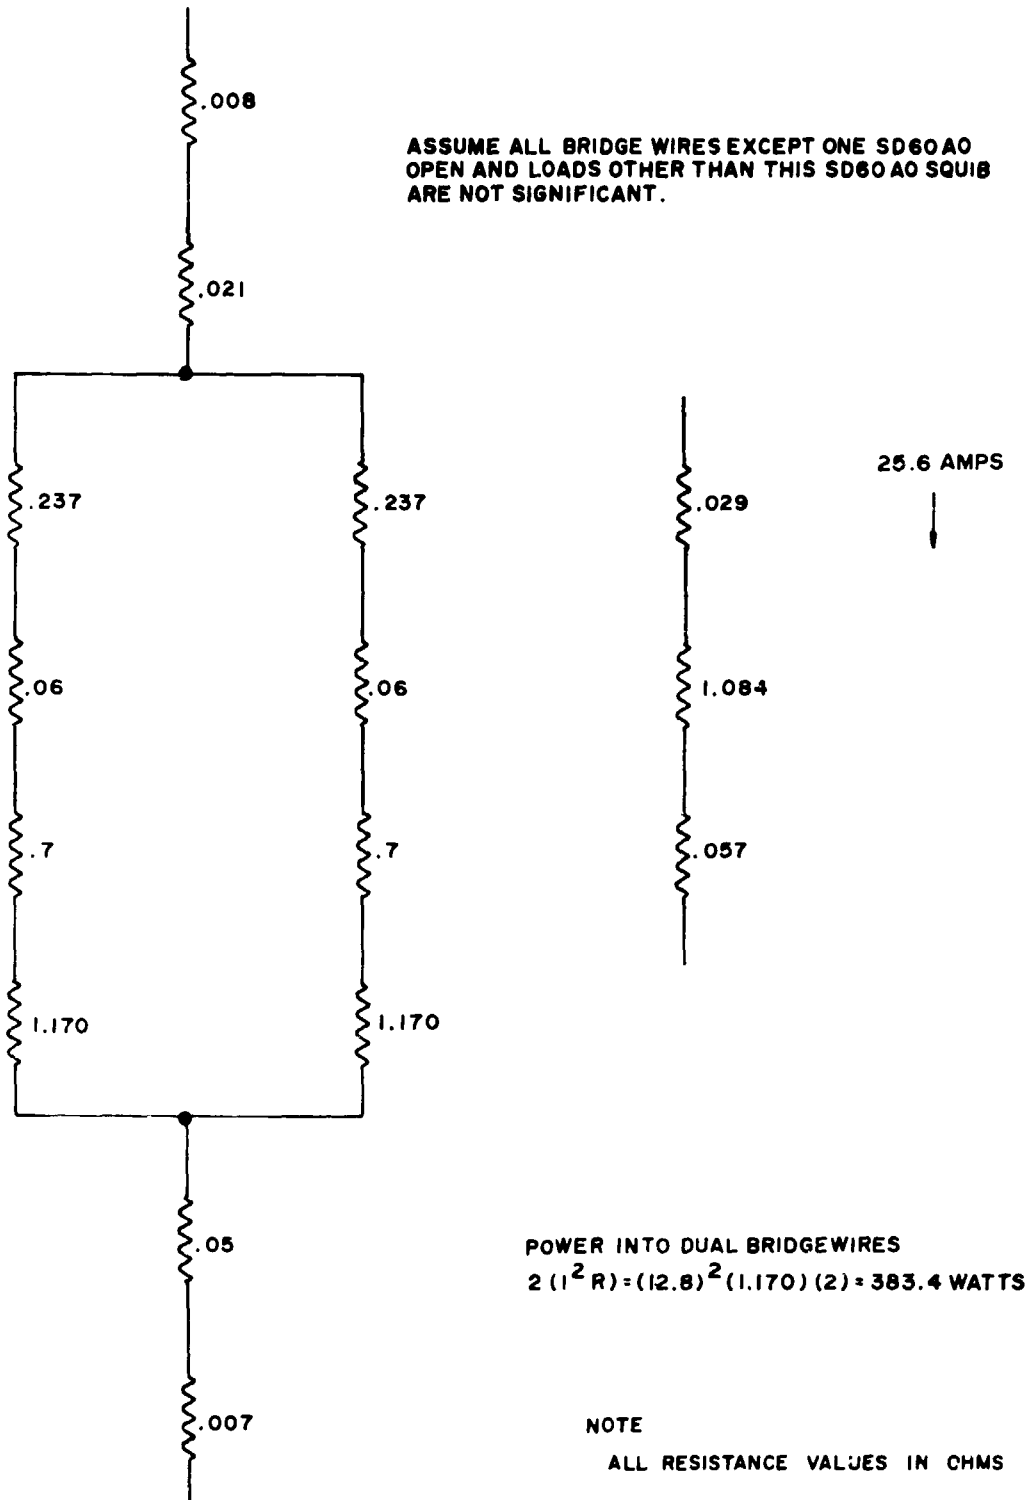
Figure C-16. Special Condition (Assume All Bridgewires Except One SD60AO Open and Loads Other Than This SD60AO Squib are not Significant)

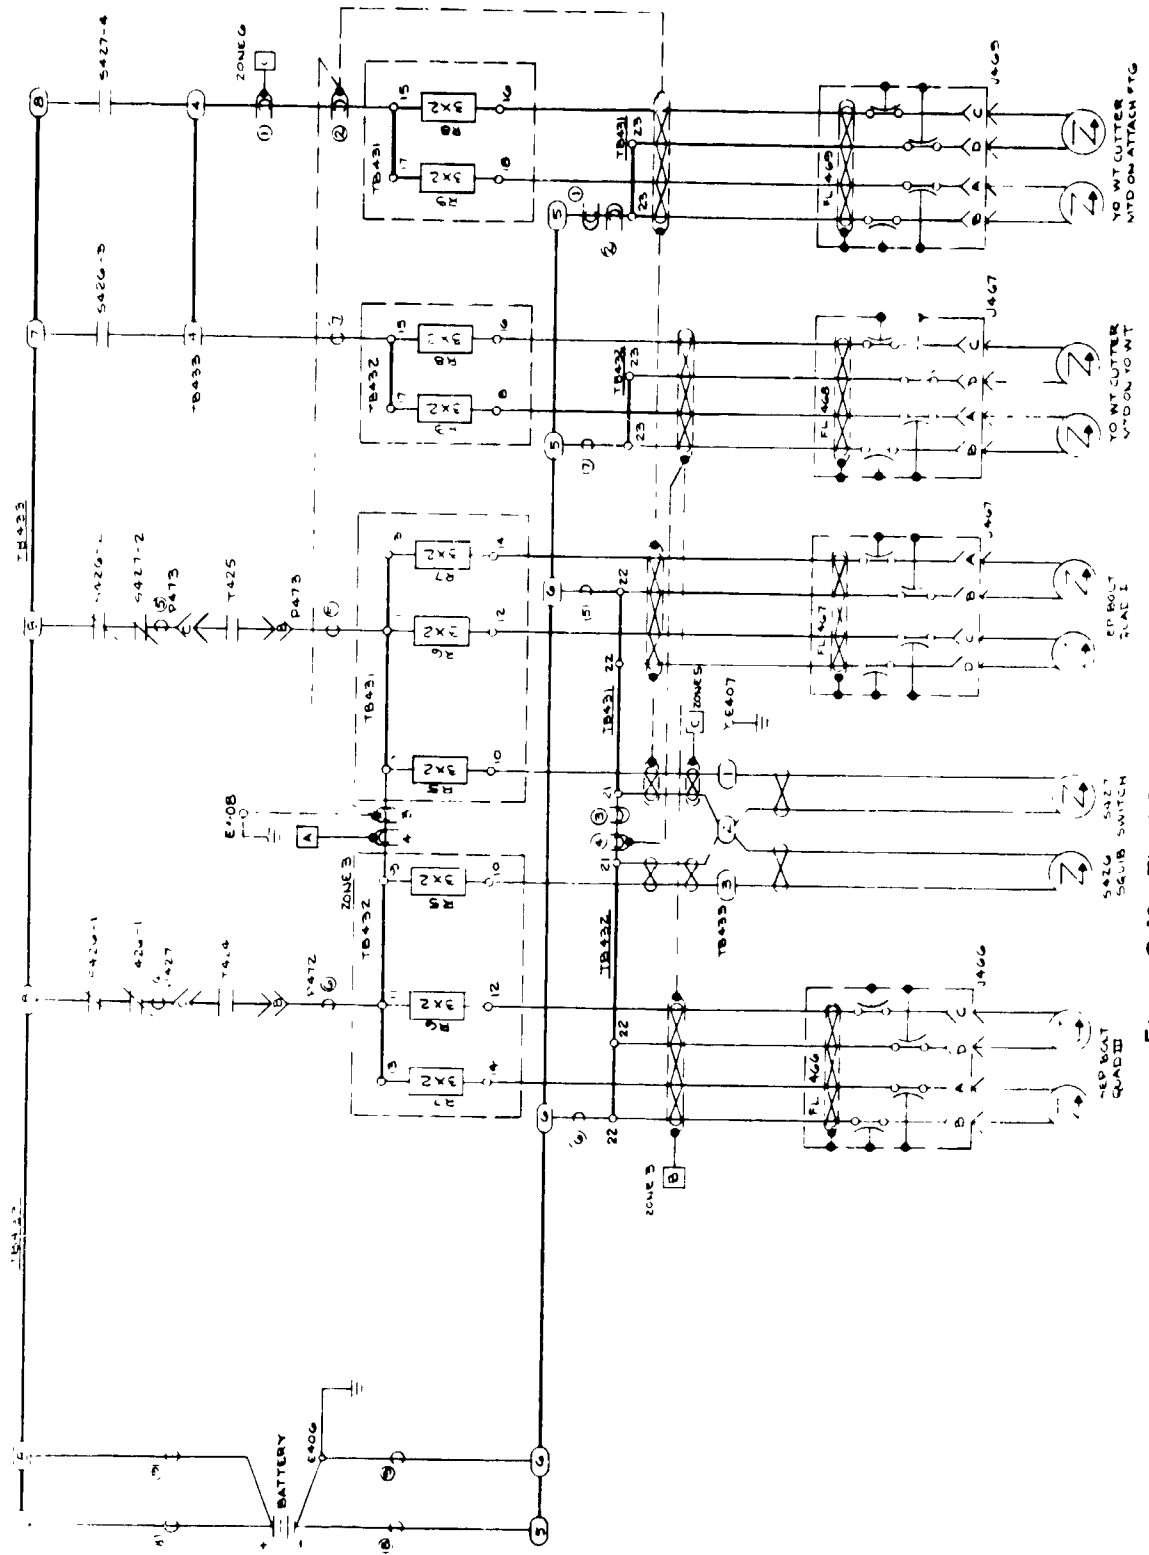
Figure C-18. Third Stage Schematic

A third phase in the examination of the electrical system was the distribution of current if the third stage battery should short to the sequence 4 circuit at some point on the attach fitting. The results are shown in Figure C-17, and indicate this to be an unlikely failure mode. The third stage schematic is provided as Figure C-18.
