AIRCRAFT ACCIDENT REPORT

ADOPTED: March 28, 1967**RELEASED:** April 4, 1967

AMERICAN FLYERS AIRLINE CORPORATION
L-188C, N183H,
NEAR ARDMORE MUNICIPAL AIRPORT
ARDMORE, OKLAHOMA
APRIL 22, 1966

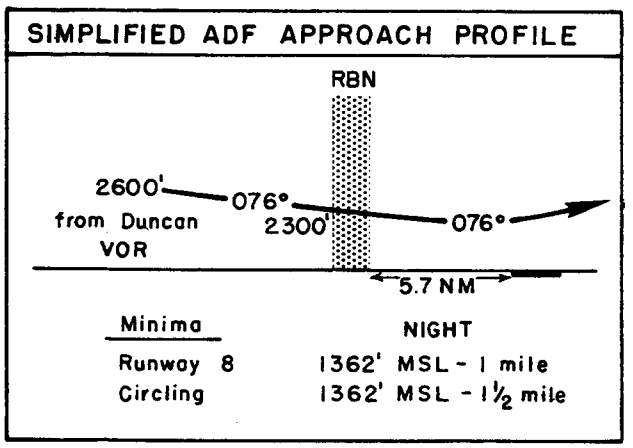
* These estimates were revised to approximately 1160 feet after observation of L-188 fly-bys.

MAG. N
APPROX.
9° E VAR.
TRUE
N
