HOAN BRIDGE FORENSIC INVESTIGATION FAILURE ANALYSIS FINAL REPORT

ATLSS Center
Lehigh University

Wisconsin Department of Transportation
and the
Federal Highway Administration

June 2001

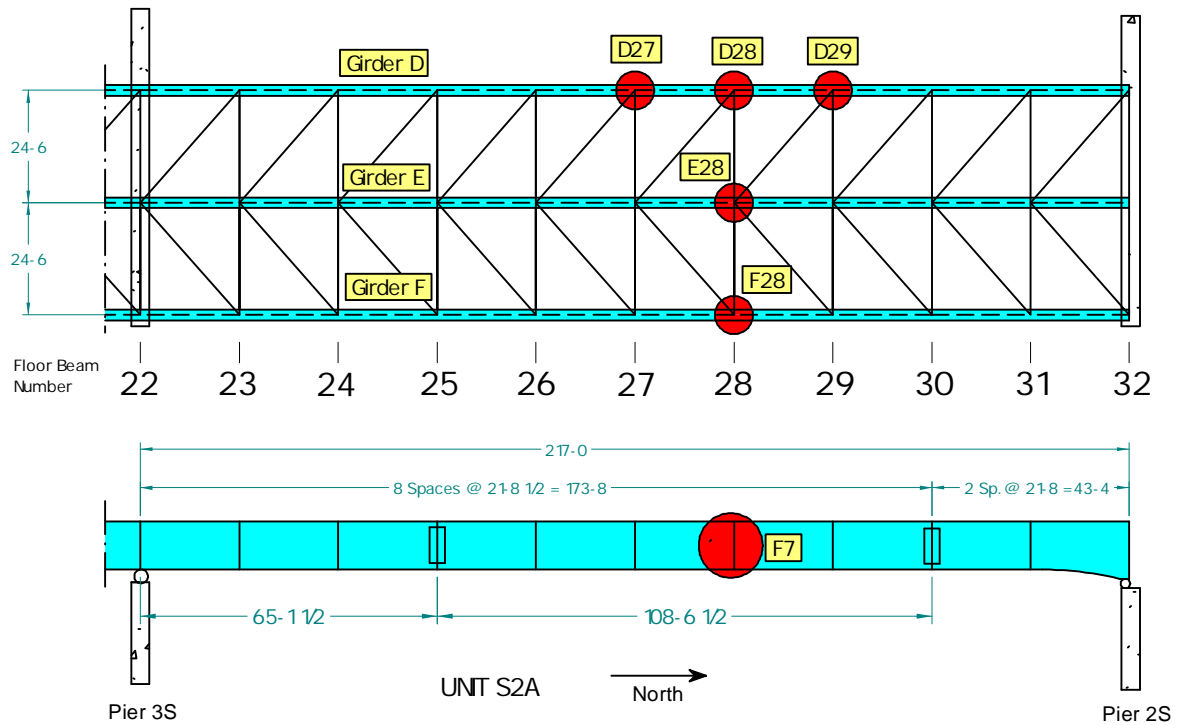
Figure 3 Framing Plan and Elevation of Fractured Span

The cross-section of the three-girder structure is shown in Figure 2. The framing plan and the elevations for the northern end span of Unit S2A is given in Figure 3 which also identifies the cracked girder locations at Panel Point 28.

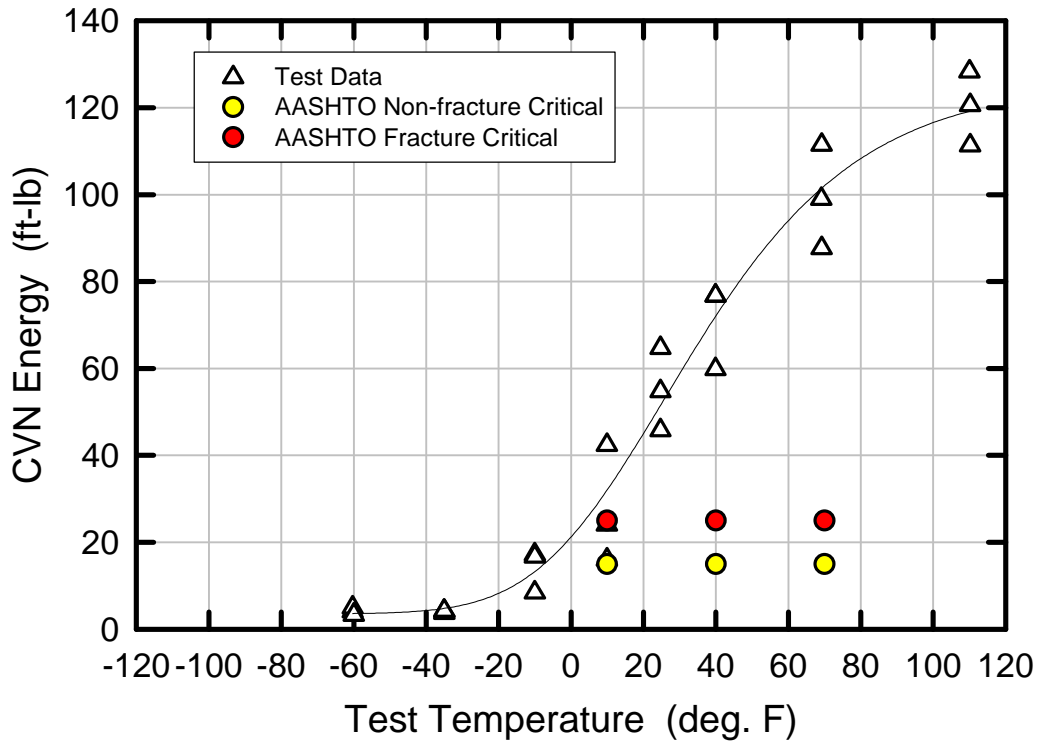
Figure 7: CVN Transition Curve for the Web Plate at D-28

Figures 7, 8, and 9 show the transition curves for the fracture locations on girders D-28, E-28, and F-28. All three locations have similar toughness and can be considered typical of data reported in the literature⁽¹²⁾. The AASHTO 1998 Specification requirements are plotted on the figures for reference. To meet the specification requirement, the average of three test results must exceed the specified minimum energy requirement and no individual test can fall below 2/3 of the requirement. The yellow circles show the requirements for non-fracture critical applications and the red circles show the higher toughness required for fracture critical applications. The test temperatures vary for each of the AASHTO temperature service zones. For A36 Steel, the test temperatures are +70, +40, and +10 °F for service zones 1, 2, and 3, respectively. The Hoan Bridge falls in temperature service zone 2 where the lowest anticipated service temperature is -30 °F. The modern specification requirements are presented for reference only, there were no such specifications in 1969 when the bridge was designed.

It can be concluded that the web in all three locations would be suitable for use in zone 2, fracture critical applications. For service in zone 3, the material would be marginal for non-fracture critical applications and it would not pass the fracture critical requirement. If built today, the Hoan Bridge would be classified as zone 2, non-fracture critical, therefore it can be concluded that the toughness of the web material would have met modern toughness requirements.

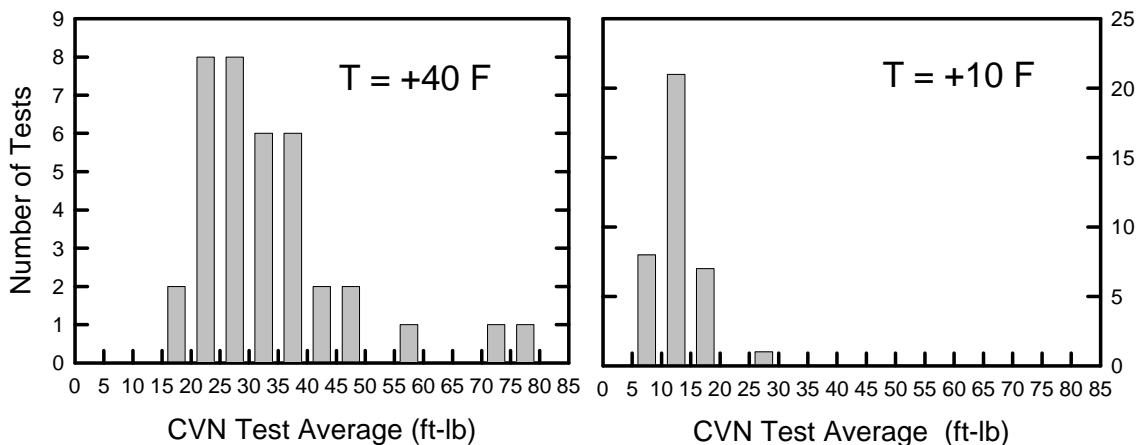
Figure 10: Histogram of CVN Tests From All Web Locations @ +10 °F and +40 °F

Compared to the 1998 AASHTO Specifications, All of the tests met the requirements for zone 2, non-fracture critical use. Seventy three percent of the tests met the zone 2 fracture critical requirement. For zone 3, only 27% of the tests met the non-fracture critical requirement. Again, it can be concluded that the web plate meets modern toughness requirements for zone 2, non-fracture critical use. The large number of sample locations gives a strong indication that the web plate properties are consistent throughout all of the three girder approach spans.

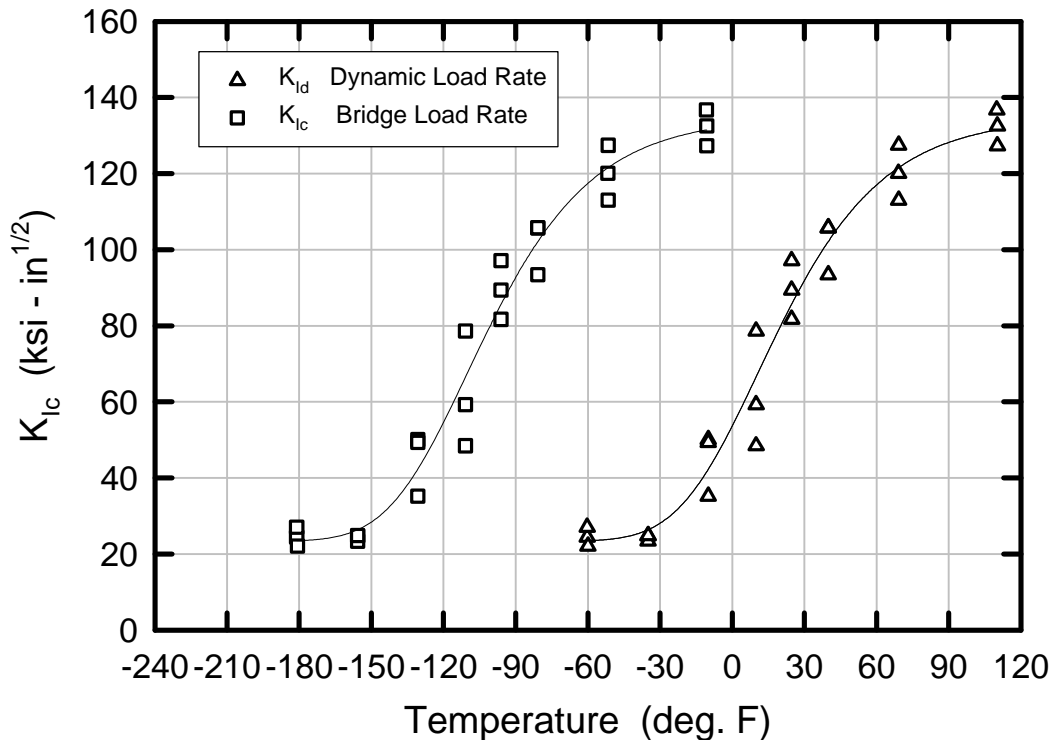
Figure 11: K_{Ic} Transition Curve for the Web at D- 28 Based on CVN Tests

Results show that the crack initiation resistance would be on the upper shelf at service temperatures encountered in the Hoan Bridge. The CVN correlation is technically not valid for upper shelf behavior, but the numbers give a relative indication of resistance to brittle fracture. The dynamic toughness is in the lower transition region, providing limited resistance to dynamic crack propagation.

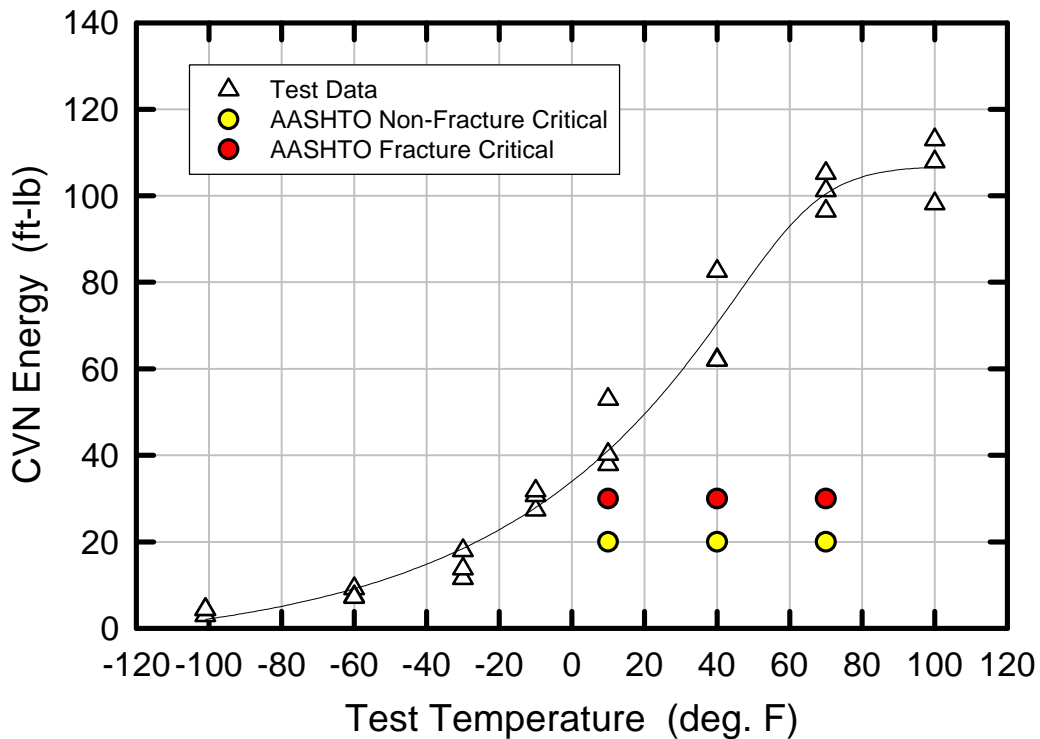
Figure 15: CVN Transition Curve for the Bottom Flange Plate at D-28

Figures 15, 16, and 17 show the transition curves for the bottom flange plates at the fracture locations on girders D-28, E-28, and F-28. Both 2-¼ in. plates (D-28 and F-28) have similar transition curves that show relatively good toughness and low variability. The transition curve was different for the 3 in. plate. There was a larger scatter band for the data and the transition temperature is shifted about +40 °F. The toughness of the 3 in. plate was significantly lower than the 2-¼ in plates.

meet specifications the first time. For this small sample size, the transition curve regression line provides a better indicator than re-tests since it helps average out variability. Based on the transition curve, the 2-¼ in. flange plates at D-28 and F-28 would have exceeded the 1998 requirement for zone 3, fracture critical service. The 3 in. flange plate at E-28 would generally meet the requirement for zone 2, non-fracture critical service. However, without regression analysis, two of the three specimens tested at +40°F would have fallen below the required 20 ft-lb and the plate would only have passed the requirement for service in zone 1.

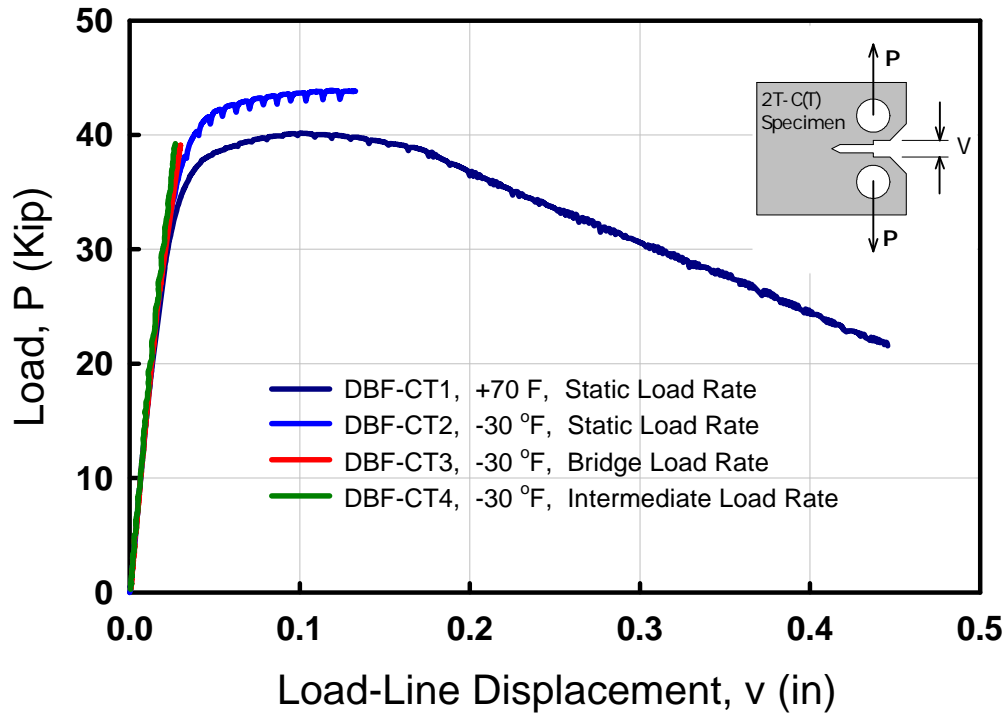
Figure 18: C(T) Test Data for the Bottom Flange at D-28

In figure 18, the static test at room temperature shows a large amount of ductility and the crack is extending through stable tearing instead of unstable fracture. When the temperature is reduced to -30°F , the ductility is reduced but the maximum load increases due to the elevated yield strength of the steel at low temperatures. This test ended in a ductile fracture, but there was a significant amount of plastic deformation prior to failure. The tests at the higher load rates show almost a total lack of ductility and there is very little plastic deformation prior to fracture. The failure mode is not ductile, but the relatively high load at fracture still indicates significant fracture resistance.

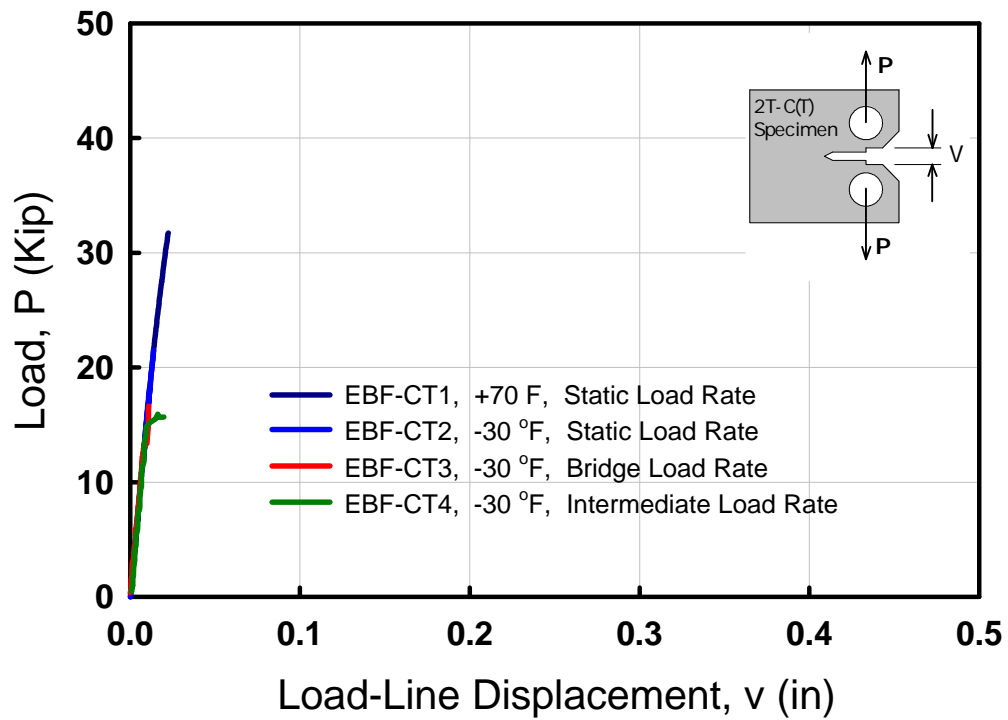
Figure 19: C(T) Test Data for the Bottom Flange at E-28

Figure 19 shows the same set of four curves for the 3 in. flange plate at location E-28. There is almost no ductility in any of the tests, even at high temperatures. At room temperature the steel has relatively good crack resistance, but there is a clear decrease in maximum load for the low temperature and high rate tests.

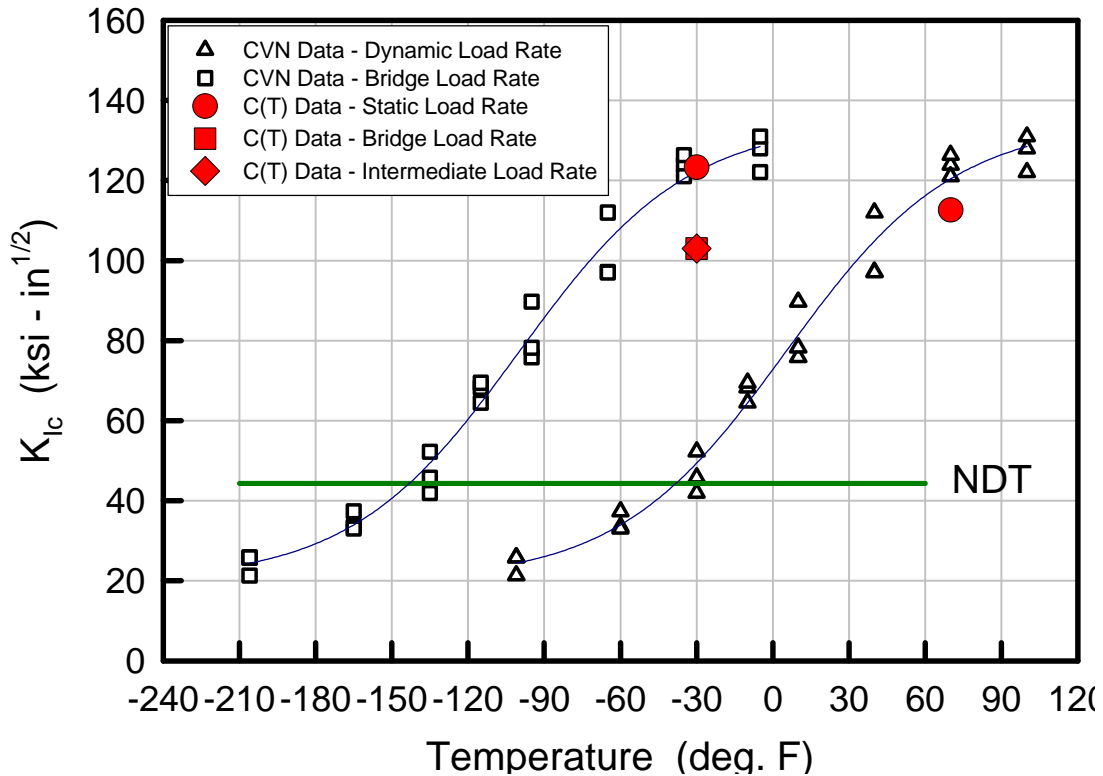
Figure 20: K_{Ic} Data for the Bottom Flange at Location D-28

Figure 20 shows the fracture toughness of the 2 ¼ in. bottom flange plate at location D-28. This is the flange where crack arrest was found to have occurred during the failure. The C(T) test results correlate well with the CVN data for the bridge-loading rate. There is little difference in the data between the bridge load rate and the intermediate load rate tests, but both show somewhat lower toughness than the static tests. At the lowest anticipated service temperature of -30°F , the fracture initiation toughness is expected to be close to upper shelf with $K > 100 \text{ ksi-in}^{1/2}$. Little variation in crack initiation toughness is expected within the range of bridge service temperatures. The toughness for crack arrest is lower, as expected. At -30°F , K is expected to be around $40 \text{ ksi-in}^{1/2}$, close to the point where brittle behavior is expected. The slope of the dynamic load rate curve indicates that toughness will be expected to increase rapidly as a function of temperature.

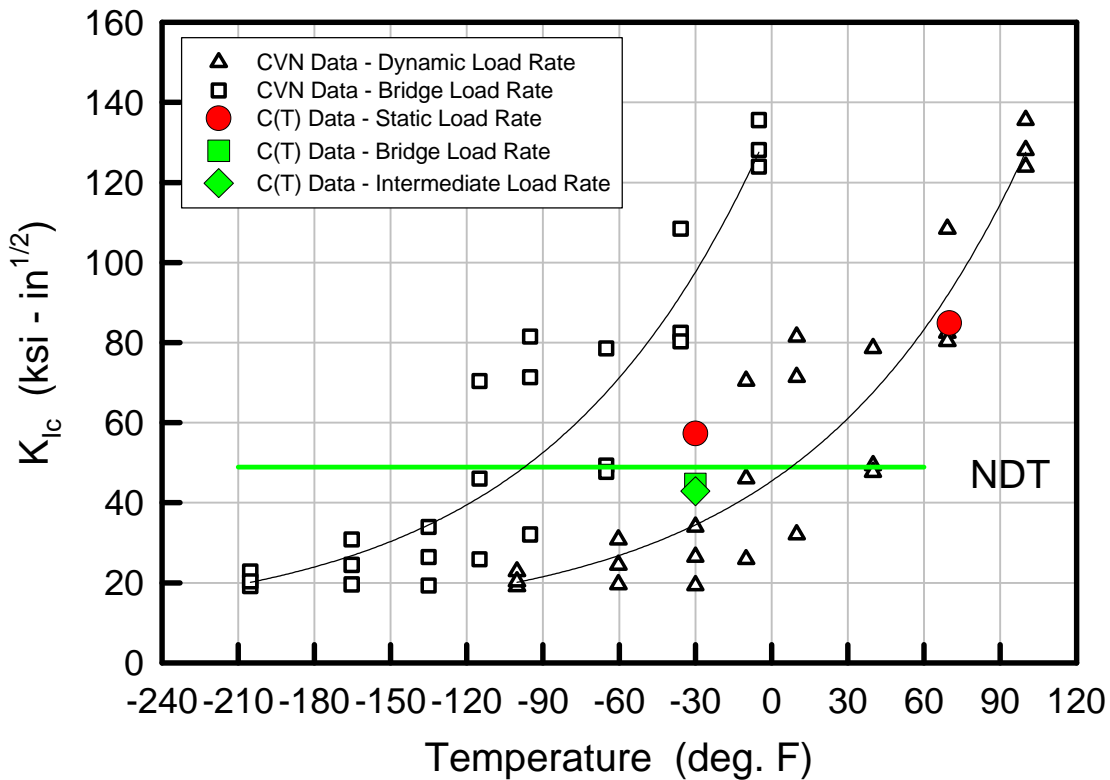
Figure 21: K_{Ic} Data for the Bottom Flange at Location E-28

Figure 21 shows the fracture toughness of the 3 in. flange plate at location E-28. For crack initiation at bridge load rates, the C(T) test data indicates lower toughness than the data derived from the CVN tests. The CVN data indicates that behavior would be in the upper transition region, while C(T) tests indicate lower transition region. At -30°F , the fracture initiation toughness from the C(T) tests is down around $40 \text{ ksi-in}^{1/2}$, compared to about $80 \text{ ksi-in}^{1/2}$ for the CVN data. Part of this difference can be explained by the specimen size of the C(T) tests. To get a 2 in. thick specimen from 3 in. thick material, 1/2 in. had to be machined off each surface. Because the material at the surface of plates is usually tougher than that at the center, the average toughness of the C(T)

The dynamic load rate curve indicates that the E-28 flange has very little resistance to fracture at high load rates. At $-30\text{ }^{\circ}\text{F}$, the dynamic toughness can be as low as $K = 20\text{ ksi-in}^{1/2}$, and little increase will be expected until the temperature increases above $0\text{ }^{\circ}\text{F}$.

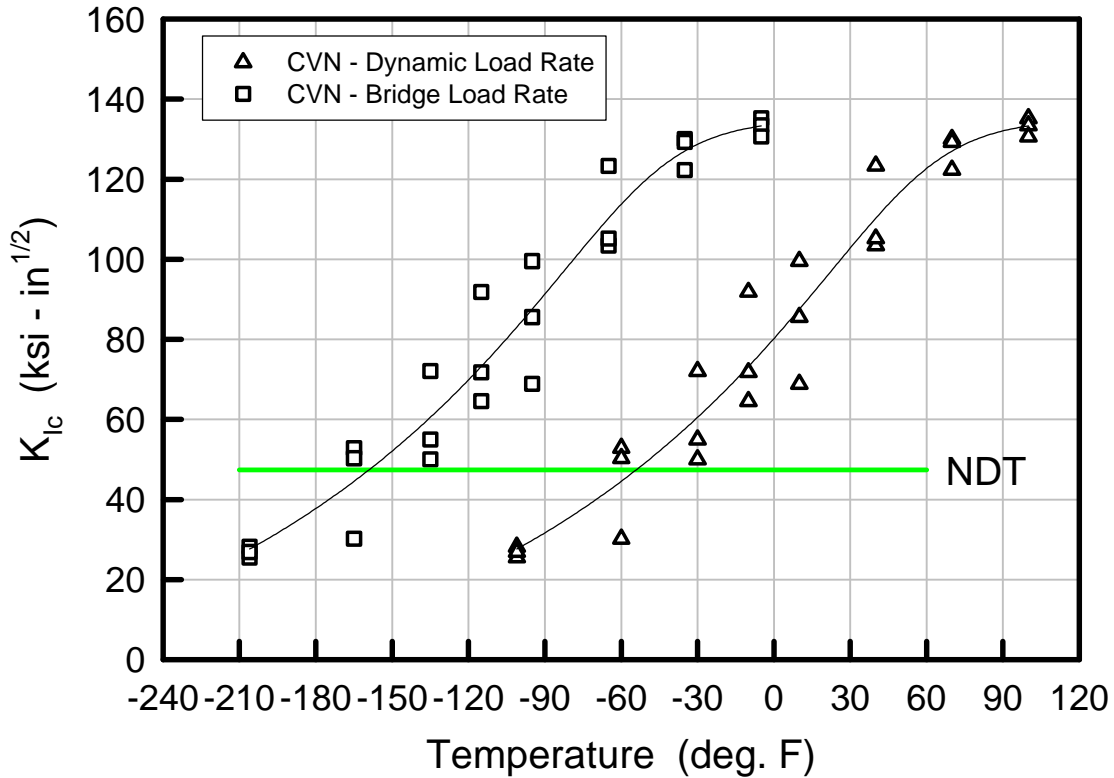
Figure 22: K_{Ic} Data for the Bottom Flange at Location F-28

Figure 22 shows the fracture toughness of the 2-1/4 in. bottom flange plate at location F-28. According to the fabrication records, the D-28 and F-28 flanges were both stripped from the same plate. Both the dynamic and bridge load rate curves are similar to those from location D-28, therefore the toughness of the two flanges can be considered similar.

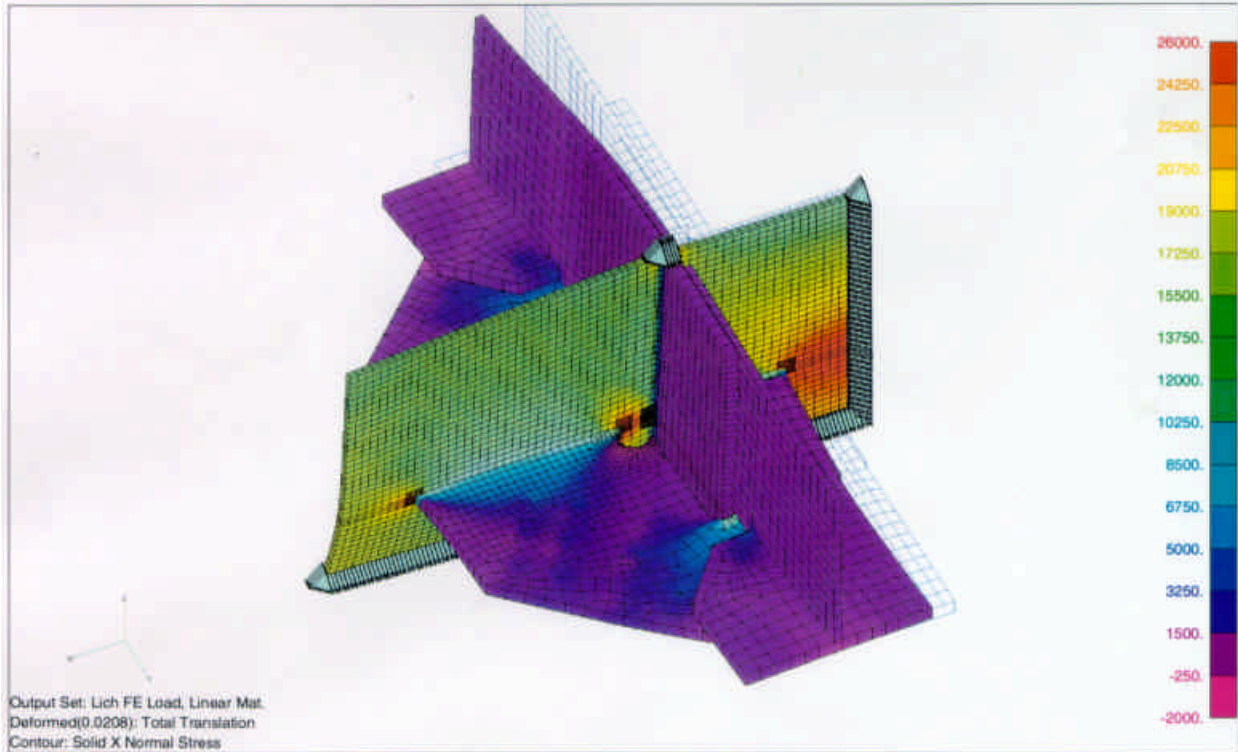
Figure 34: 3-D Solid Finite Element Model with Hole in Shelf Plate

Figure 34 shows a 3-dimensional view of the model with the hole in the west shelf plate. Note that the deflected shape is greatly exaggerated. The color contours show the magnitude of the stress in the X-direction along the axis of the girder.

The red areas clearly show stress concentrations that are occurring at the ends of the shelf plate and in the web gap areas. The size of the web plate is sufficient so the effect of stress concentrations is minimal at the edges of the plate.

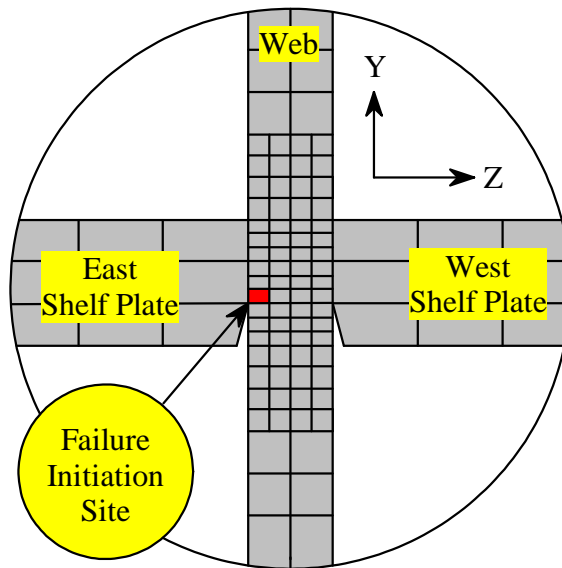
Figure 35: Section Through the F.E. Model Showing the Mesh Density and Location of the Failure Site

A refined mesh was used in the web gap area as shown in figure 35. There are four elements through the thickness of the ½ in. web plate in the vicinity of the web gap area. The bottom third of the shelf plate is not connected to the web to model the gap created by the partial penetration weld. Figure 35 also shows the direction of the Y and Z-axes used to define the stress components in the following sections. The X-direction represents the direction of normal bending stress in the girder web. The red square in figure 35 marks the element that corresponds to the failure initiation site identified by the fractographic investigation. The following stress plots all refer to elements with the same Y coordinate as the red square. All stress data points represent the average stress state at the center of an individual element. Therefore, the model is not capable of calculating the actual surface stress in the web. The elements on the surface of the web plate give the average stress state 1/16 in. away from the surface. Because of the large through-thickness stress gradient occurring in the web gap areas, the actual surface stress will be higher than those reported by the element average stress.

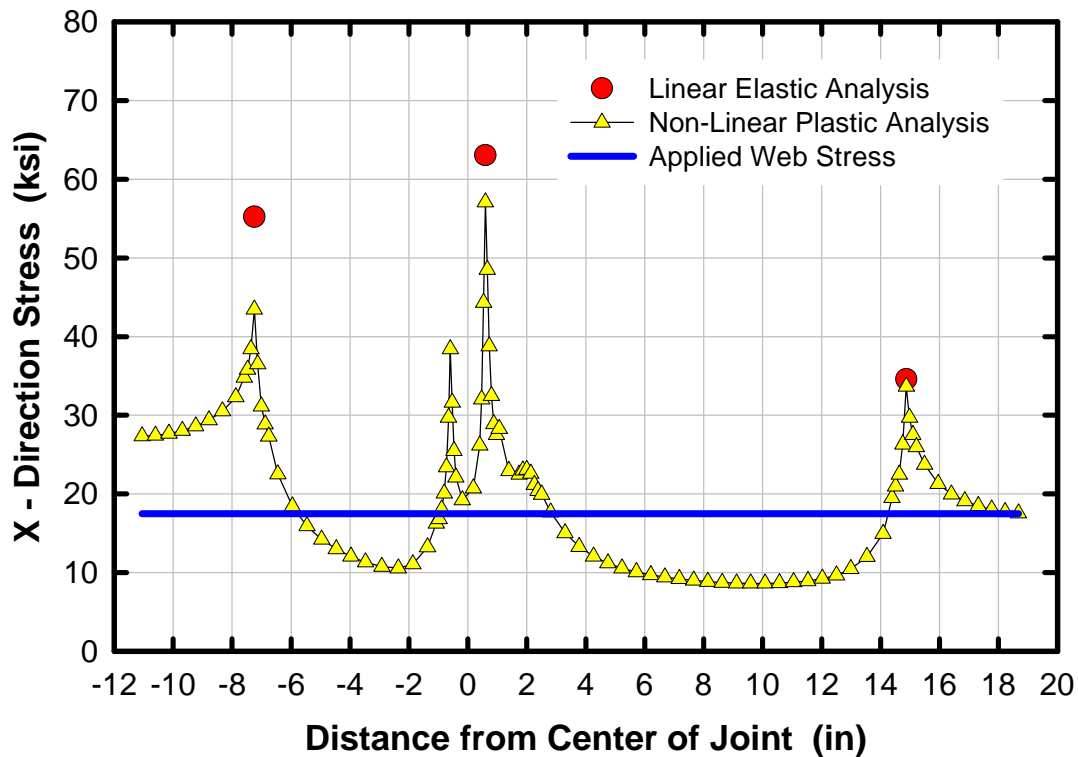
Figure 37: Variation in Bending Stress (σ_x) in the Web Along the Length of the Shelf Plate

Figure 37 shows the variation in bending stress (σ_x) that occurs along the length of the shelf plate detail due to the applied loading shown in figure 36. There is no hole in the shelf plate and the web gap is $\frac{1}{4}$ in., simulating the as-built conditions in the bridge. The horizontal axis shows the location relative to the center of the floor beam connection plate with positive numbers increasing in the north direction. The horizontal blue line at 17.5 ksi shows the applied bending stress that would exist without the geometric stress concentrations and the effect of the lateral brace forces.

The stress concentration occurring at the two shelf plate ends and in the web gap area is clearly visible in this figure. The yellow symbols show the results of the non-linear analysis where yielding is allowed to occur. For comparison, the red symbols show the peak elastic stress concentration that was calculated without yielding. At the south end of the shelf plate ($X = -7.2$ in.), yielding caused a 27 percent reduction in the stress from 55.2 ksi down to 43.5 ksi. This shows the effect of yielding when the web plate has a relatively low level of triaxial constraint. At the failure location ($X = 0.59$ in.), there is clearly less yielding and the initial stress concentration of 63 ksi is only reduced 10 percent to 57.1 ksi. This shows that an increased triaxiality in the web gap area is preventing yielding.

The effect of the forces in the lateral braces can be seen at the south end of the plot ($X = -11$ in.). On the north end ($X = 19$ in.) the stress converges to the applied bending stress level at about 4 in. past the end of the shelf plate. However at the south end, the stress is elevated. This elevation in stress is the result of the forces in the lateral bracing system. The asymmetric “K” pattern of the lateral bracing requires an additional axial stress in the girder to satisfy equilibrium in the joint assembly. This effect can help explain why several fatigue cracks were found at this end of the shelf plate at other locations in the structure.

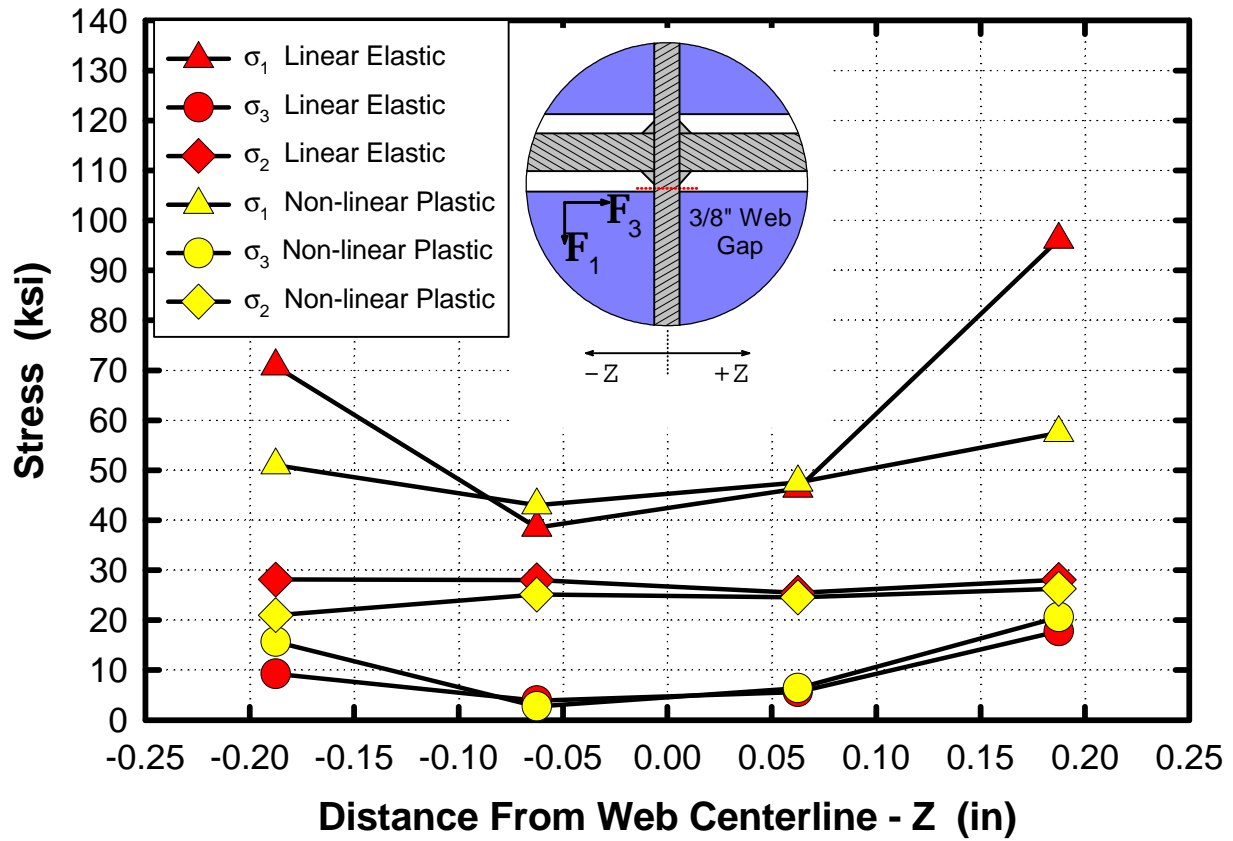
Figure 38: Variation in Principal Stress Through the Web Thickness with the Symmetric Web Gap

The result of the model with the symmetric web gap (3/8 in. – 3/8 in.) is shown in figure 37. Under elastic conditions, there is a large elevation in the σ_1 stress component toward the surface of the web, but this decreases toward the middle of the plate. Yielding allows stress relaxation to occur and the σ_1 stress component becomes relatively constant through the web thickness. The σ_3 stress component is low in the middle of the web resulting in a biaxial stress state. Toward the surfaces, σ_3 increases changing the stress state to a more triaxial condition. This triaxiality is the reason the maximum principal stress is still well above the yield strength of the material, even after yielding occurs.

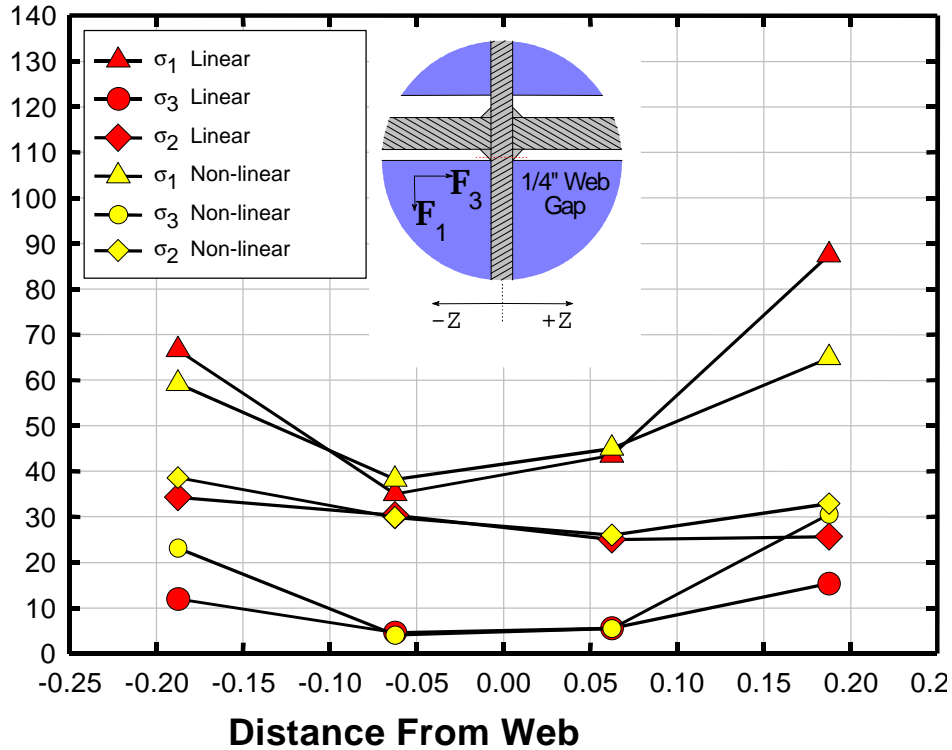
Figure 39: Variation in Principal Stress Through the Web Thickness with the Offset Web Gap

Figure 38 shows the model with the offset web gap (1/4 in. – 1/2 in.). The reduced gap causes an increase in the σ_3 stress component towards the surface of the web indicating an increase in the amount of triaxiality. This increased triaxiality causes about a 13% increase in the maximum principal stress compared to the symmetric web gap. Table 3.8 shows a summary of the effect of decreasing the web gap for the west surface of the web at $Z = 0.1875$ in.

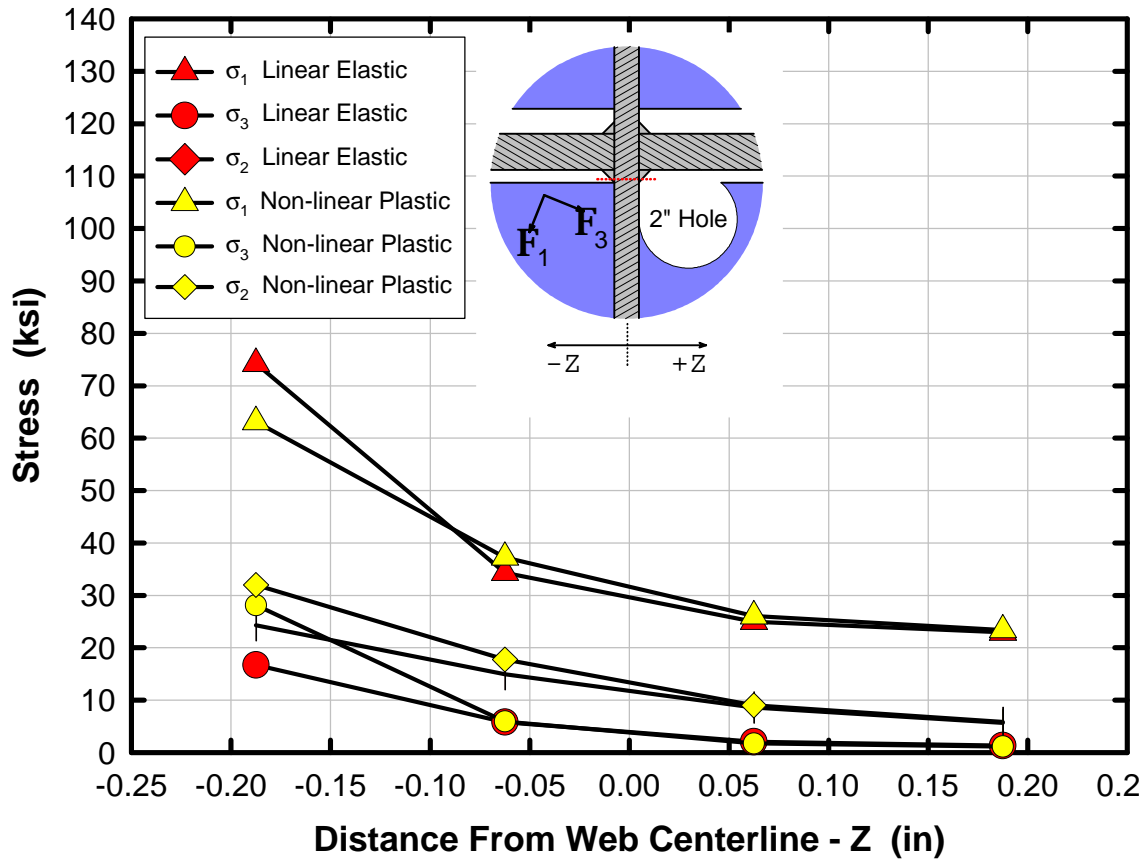
Figure 40: Variation in Principal Stress Through the Web Thickness with a 2 in. Hole in the West Shelf Plate

The model with the offset web gap was modified to introduce a 2 in. diameter hole in the shelf plate on the west side of the connection. This simulates as closely as possible the geometry present at the failure location in the bridge. Results in figure 40 can be compared to figure 39 to show the effect of adding the hole. On the west side at $Z = 0.1875$, there is almost a total elimination in triaxiality resulting in a sharp decrease in the maximum principal stress. On the east side, however, there is an increase in triaxiality resulting in an 7 % increase in the maximum principal stress compared to the model without the hole. Table 3.9 summarizes this effect for the east surface of the web at $Z = -0.1875$.

Because the 2 in. hole is only present in one side of the shelf plate connection, the principal stress axes are no longer in the same direction as the global coordinate system. As shown in the inset in figure 39, the axis of maximum principal stress is rotated about 23 degrees relative to the global x axis. This correlates with observations of the fracture initiation site at location E-28. The fracture plane in the web gap was oriented approximately perpendicular to the σ_1 axis shown in figure 40.

- The 2 in. retrofit hole in the west shelf plate reduced the stress concentration and constraint on the side of the web with the hole, but increased the stress concentration on the opposite side by about 7% compared to the joint without the hole. Because plastic constraint was high in both cases, the presence of the hole has only a minor effect on the fracture vulnerability of the joint at E-28.

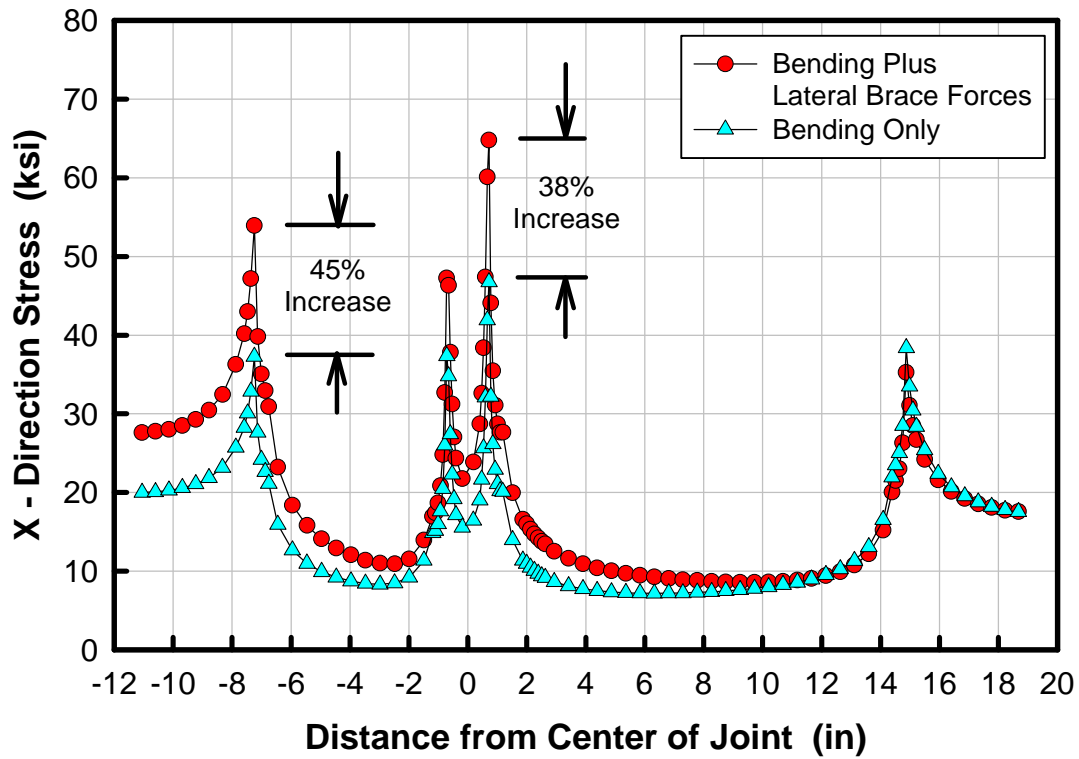
Figure 41: Change in Elastic Bending Stress (s_x) in the Web Due to Lateral Brace Forces

The model with the symmetric web gap was run with and without the lateral bracing forces shown in Figure 36. Both models had the same applied bending stress of 17.5 ksi. The non-linear plastic model was not run for the case without the bracing force, therefore only elastic analysis is used as the basis for comparison. The results, shown in figure 41, show a significant increase in stress concentration in the web gap and at the south end ($X = -7.5$) of the shelf plate. The change in the 3-dimensional stress state in the web gap is shown in table 3.10. The stress components in the x and y direction both increase, but there is little change in the Z direction.

The increase in stress concentration in Figure 41 is primarily due to a rigid twisting of the joint assembly due to the asymmetric nature of the lateral brace forces. The stress pattern shows there is very little out-of-plane distortion occurring in the web gap area.

- Tensile forces in the lower lateral bracing cause an increase in stress concentration at the shelf plate ends, but have only a minor effect in the web gap area. There is no significant evidence of out-of-plane web gap distortion due to forces on the lateral braces.

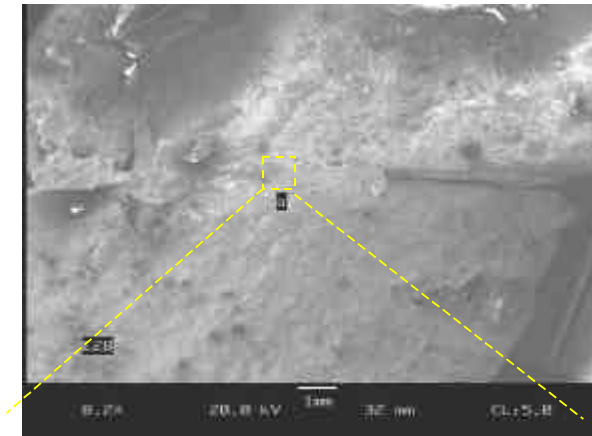
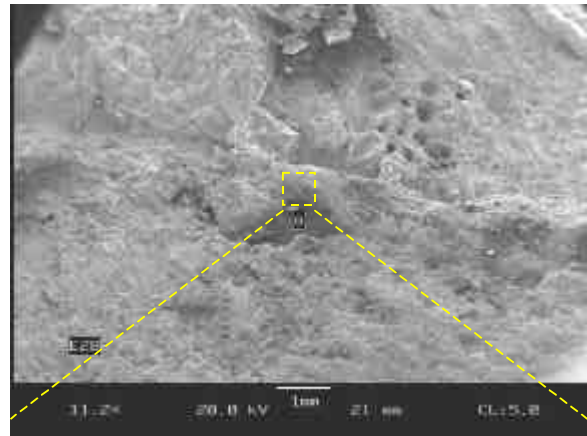
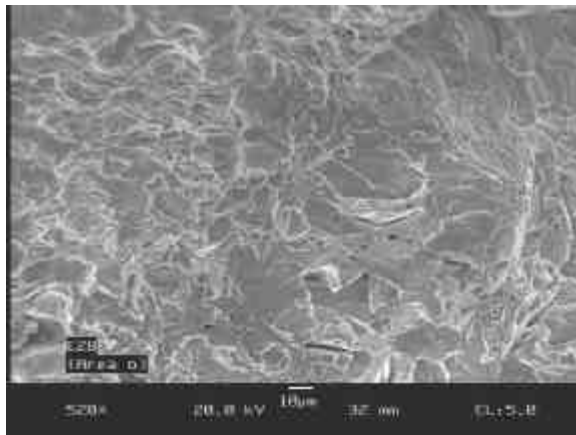
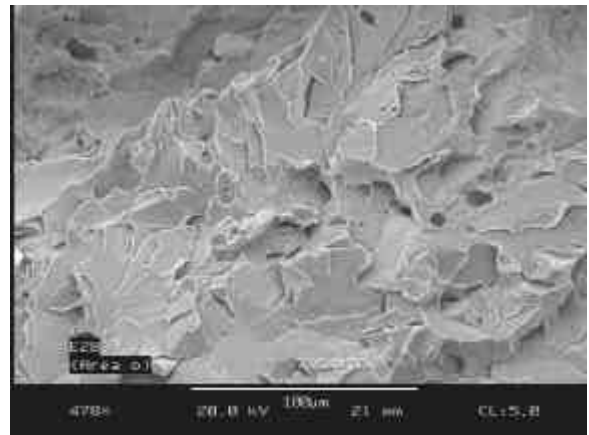
Figure 51: SEM Micrographs Obtained From Opposing Sides of the Fracture Showing Cleavage at the Fracture Origin (Girder E P.P. 28)

Visual examination of the fracture origin area of both sides of the fracture showed no indication of a base metal or weld defect in this area. Microscopic examination with the SEM (see Figure 51) showed the presence of cleavage fracture as close to the fracture origin as could be discerned. Corrosion product not removed during cleaning of the surfaces obscured some areas at the origin, however, no indication of stable crack growth processes such as fatigue or ductile tearing was observed in corrosion free areas within 1mm of the origin. Without the presence of a macroscopic defect cleavage likely initiated from a microscopic discontinuity which may have sharpened by fatigue over time. Fracture initiation from a microscopic defect is not inconsistent with the high triaxial stress state believed to exist in this area.

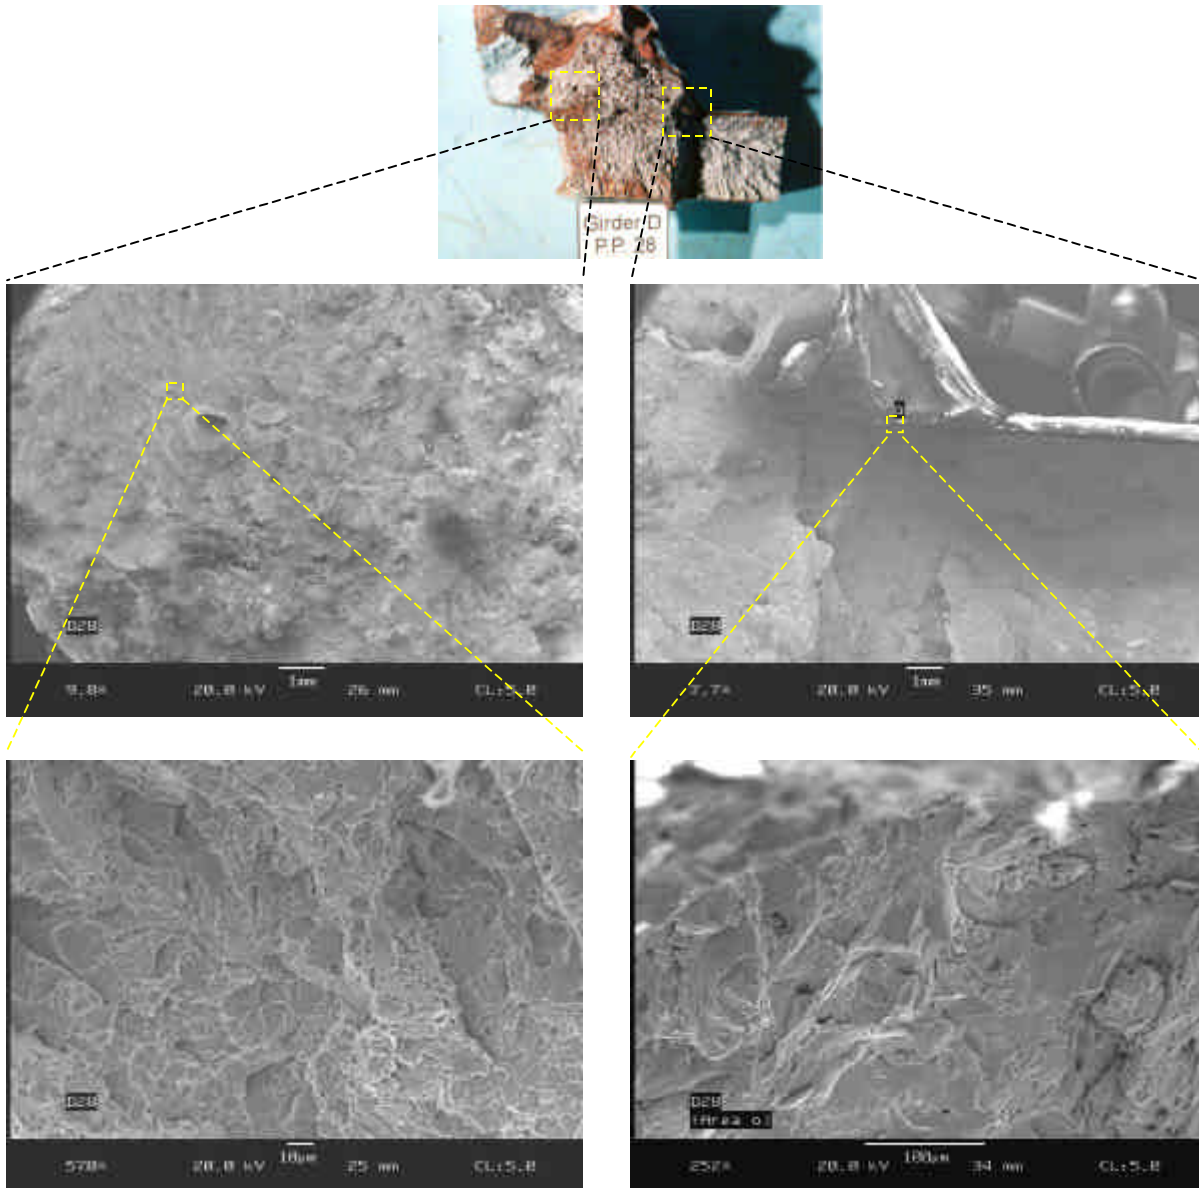
Figure 54: SEM Micrographs of the Fracture Origin Areas Showing Cleavage Fracture (Girder D P.P. 28)

Figure 54 shows low magnification SEM micrographs of the two origin areas and higher magnification micrographs revealing the mechanism of fracture in these areas. The weld toe fracture origin showed evidence of cleavage fracture at all areas near the origin from the web surface inward. The fracture mechanism at the weld root fracture origin was not as clear since corrosion product and corrosion damage to the underlying crack surface in this area was more severe. Evidence of cleavage fracture was observed at all areas which could be examined and no evidence of stable crack growth was observed, as was also found at the fracture origin in Girder E. The fractures did not provide any clear indication of the sequence of fracture, however, it is likely that the two cleavage instabilities occurred at a very short time interval.
