HOAN BRIDGE FORENSIC INVESTIGATION FAILURE ANALYSIS FINAL REPORT

ATLSS Center
Lehigh University

Wisconsin Department of Transportation
and the
Federal Highway Administration

June 2001

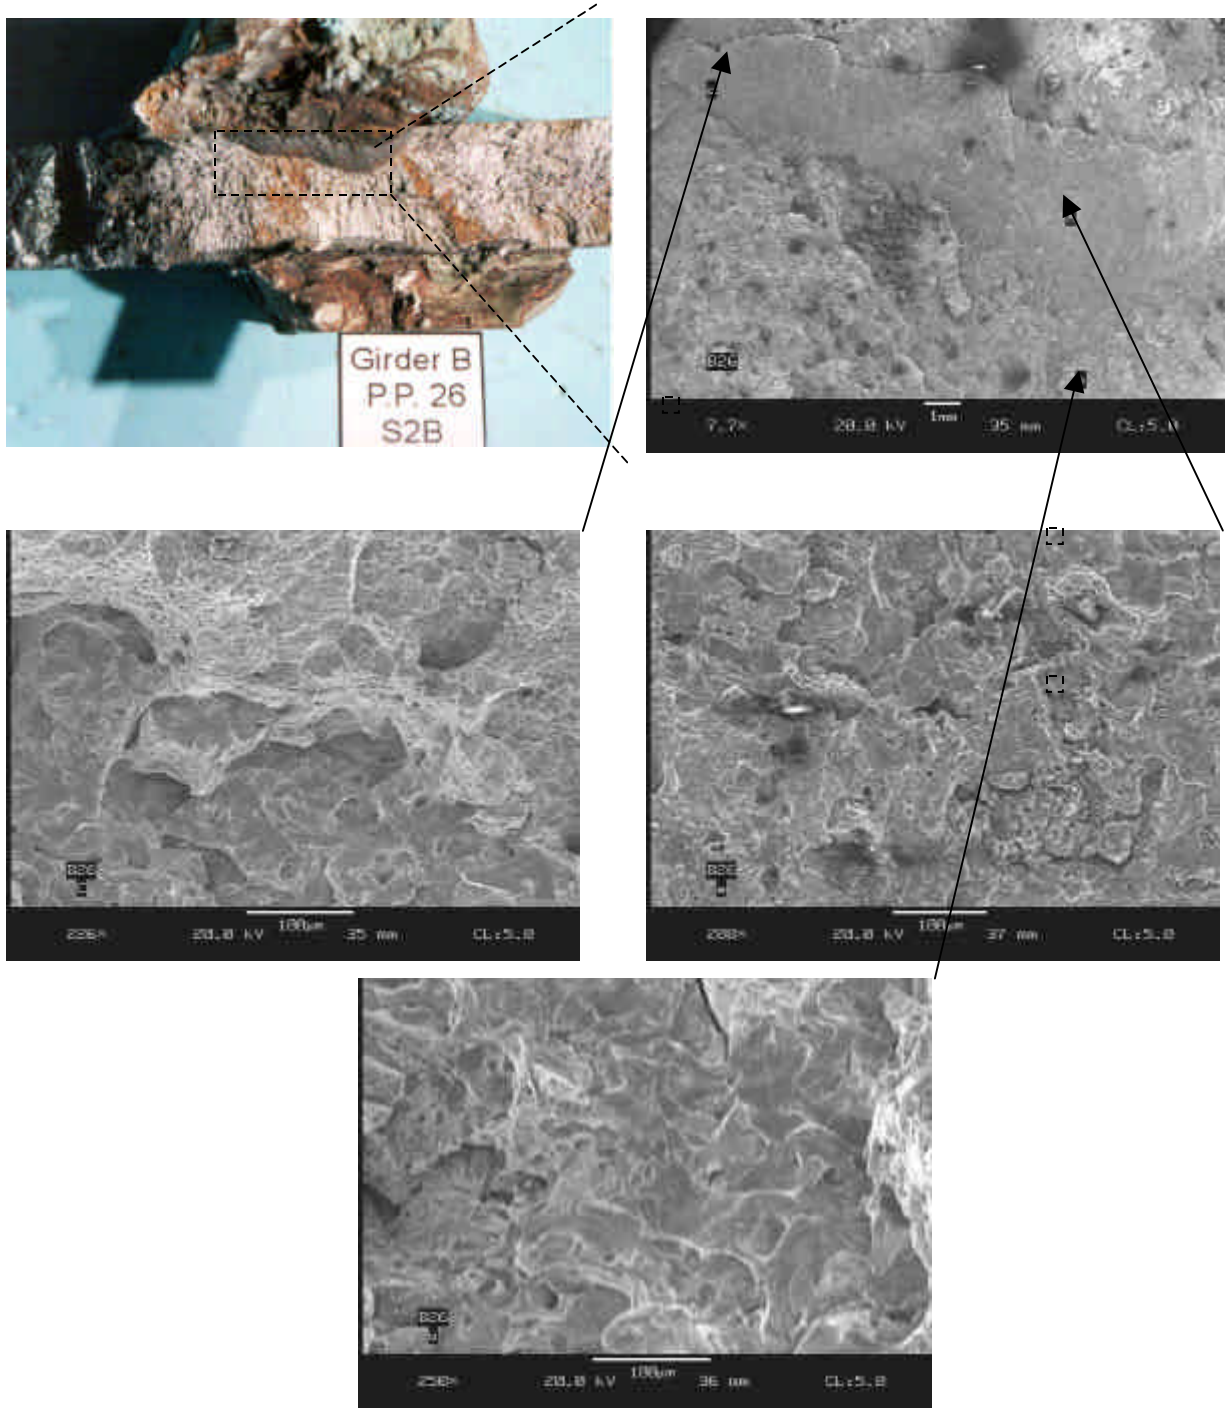
Figure 61: SEM Micrographs Showing the Oxide Layer Covering the Thumbnail Defect and Cleavage and Mixed Mode Fracture Near the Fracture Origin. (Girder B P.P.26)

Another web crack at a lateral bracing connection found in Girder B of the adjacent span a P.P. 26 was also removed for examination (see Figure 59). The crack origin again appeared to be located at the shelf plate weld termination, however, in this case an unusual blackened thumbnail feature was seen penetrating the web surface adjacent to the weld from which cleavage fracture clearly initiated. The size and appearance of the thumbnail is enhanced in the photograph shown in Figure 60 after cleaning the crack surface. The blackened thumbnail extended into the web to a maximum depth of about 3/16" and remained fully covered with an oxide layer despite cleaning attempts. The oxide layer appeared slag-like, however, it was unusually adherent for weld slag. It would also be unusual for weld slag to be able to penetrate to this depth in the web plate. Viewed at higher magnifications (see Figure 54) the oxide covering the surface of the thumbnail area completely obscured the underlying fracture surface. At the boundary of the thumbnail some indications of mixed mode fracture (cleavage and ductile fracture) was observed. Beyond this area the fracture was entirely cleavage in appearance.

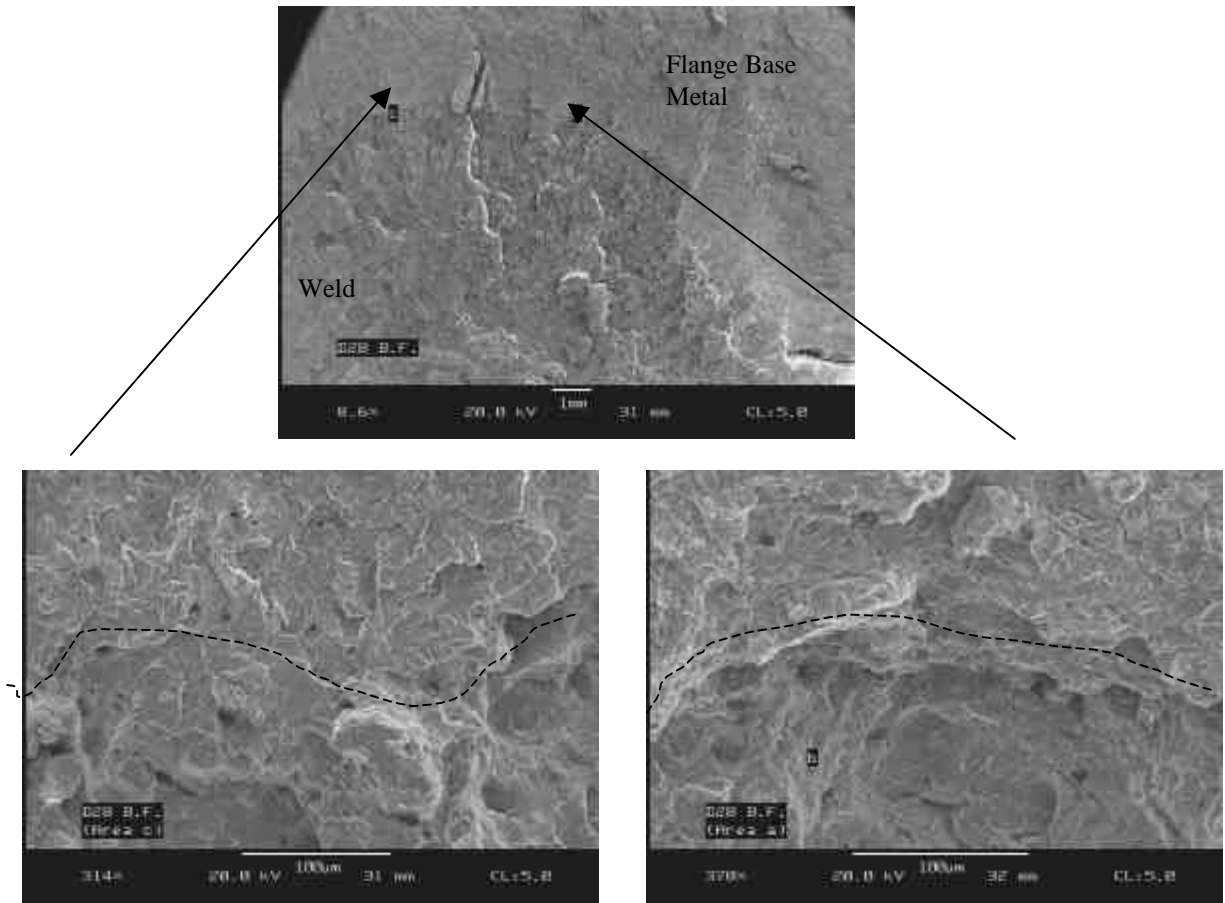
The crack surface was examined microscopically in the crack arrest region to detect changes in fracture mechanism during arrest. Figure 64 shows SEM micrographs at locations along the crack arrest boundary. The fresh cleavage fracture developed at cryogenic temperatures to expose the crack surface is readily distinguishable from the oxidized original fracture. Interestingly, little change in fracture mechanism was detected along the crack arrest boundary. Some evidence of mixed mode fracture was observed at some locations, however, other locations showed all cleavage fracture up to the crack arrest boundary.

Figure 64: SEM Micrographs of the Crack Arrest Boundary Showing Cleavage and Ductile Fracture. Dashed Line Denotes Crack Arrest Boundary. (Girder D P.P.28)

The crack in Girder D arrested in the fine grain heat affect zone, as was illustrated in Figures 63 and 64. The lower bound dynamic crack arrest capability of Girder D is about the same as Girder F, as seen in Section 2.2.4 Table 2.9. It was estimated to be 60 ksi $\sqrt{\text{in.}}$ at -10E F. Another difference between the two girders is the truckloads that were on the span when the fractures occurred. The truck(s) were likely in the east or center lanes which results in about 40% of the live load stress in West Girder D compared with the east Girder F and center Girder E during passage of the vehicles, as illustrated in Section 3.

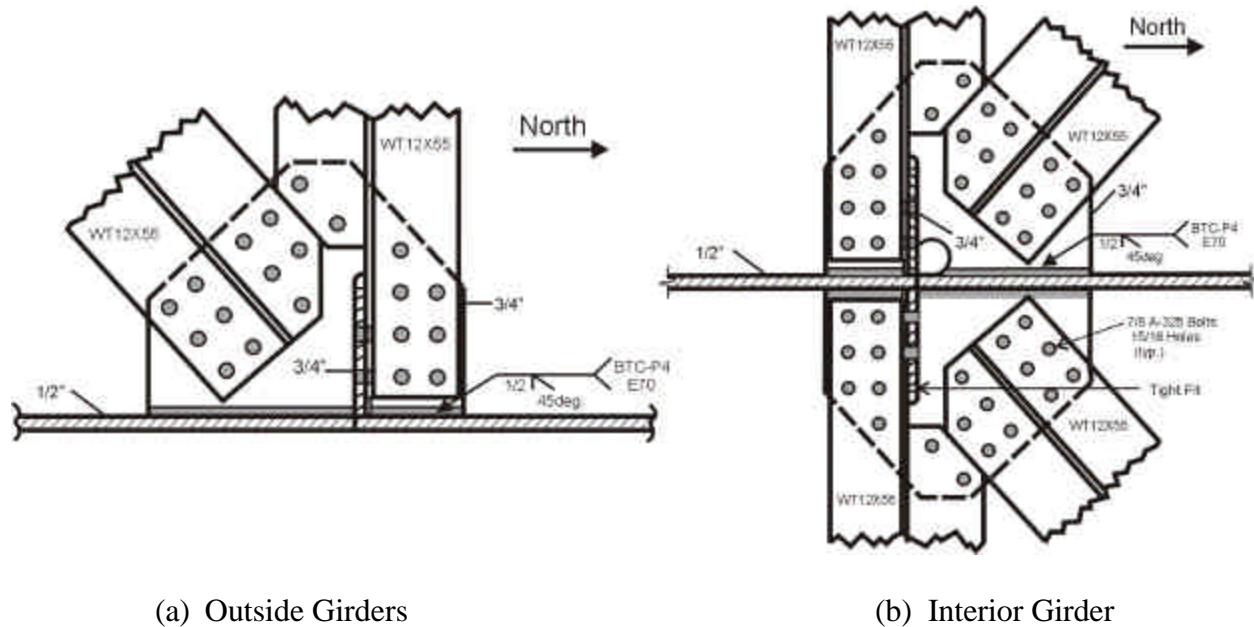
The fractographic studies have demonstrated that crack instability developed in all lateral gusset connections examined as cleavage fracture that extended from the web plate surface. The intersection of the transverse connection plate fillet welds and the longitudinal shelf plate partial penetration weld created a crack-like condition. In most of the joints, the slotted shelf plate had been pushed against the transverse connection plate at the time of fabrication, as illustrated in Fig. 71. As the 1/2 in. beveled joint in the 3/4 in. thick shelf plate was welded to the girder web, a condition of high triaxiality was formed. With the tight fit of the shelf plate against the transverse stiffener, the intersecting welds created a crack-like condition in the small gap.

Figure 71: Geometric Condition Providing a Crack-Like Plane When Shelf Plate is Touching Transverse Connection Plate

During service, the cyclic stress in the small gap served to sharpen the crack tip which was at or near to the web plate. No evidence of fatigue crack growth was observed at any of the five joints that were examined. In cases where there was entrapped slag or cold laps between the two welds any crack extension evidence was destroyed by corrosion or was sharpened at such low levels of crack growth that striations were not detectable. All that was observed in the fractographs seen in Figures 51 to 61 were cleavage facets.

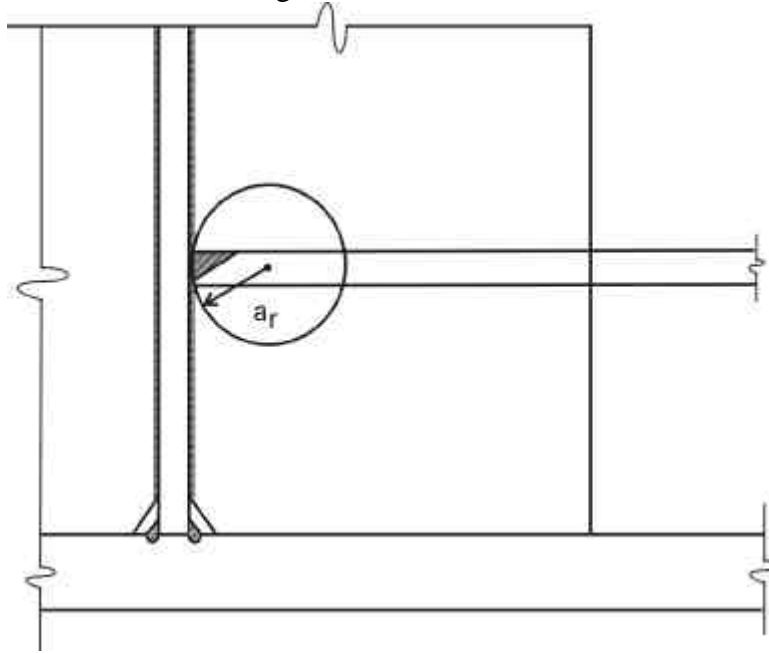
The finite element 3D model suggests that the stress field in the shelf plate is mainly compatible with the web for an effective width of 3 to 4 inches. To account for the three-dimensional nature of the stressed crack-like shelf plate connection, an effective crack width of 3 inches was assumed. Experience with fatigue crack extension has demonstrated that the crack extends into the web plate as an elliptical surface crack (9,10). A suitable 3D model that

accounts for the geometric condition of the crack-like plane and its extension into the web plate is a penny-shaped crack, as shown in Fig. 72.

**Figure 72: Idealized Circular 3D Crack Model at Shelf Plate
- Transverse Connection Plate Intersection**

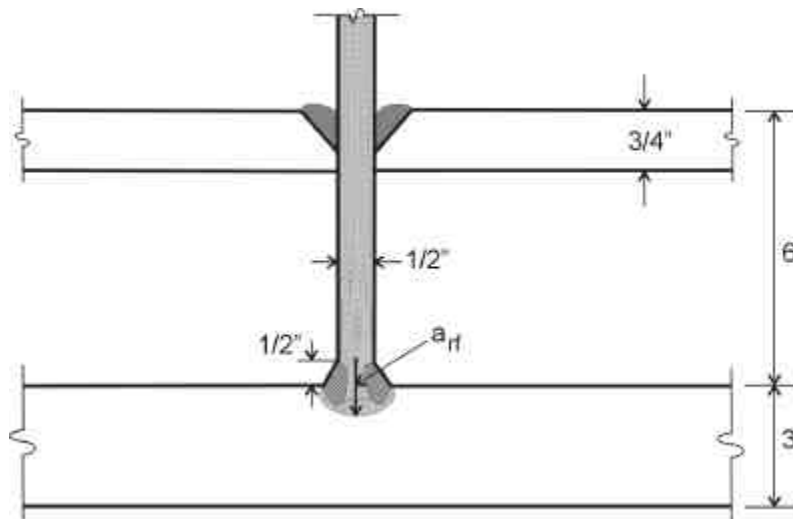
Once initiated, the crack extended in the web dynamically and entered into the bottom flange through the two longitudinal fillet welds that connected the web to the flange plate. However, the crack shape changes as it extends into the flange through the submerged arc welds. These welds have a higher toughness than the web or flange plates. One possible model is to consider the crack as another penny-shaped crack, with a radius that is in the web near the toe of the web-flange weld, as shown in Figure 73.

Fatigue cracks that have developed in the web plate at stiffeners or gusset plates have been observed to propagate into the flange plate like a circular-shaped crack with its origin in the web near the flange (9,10,11). The crack front seen in Fig. 63 for Girder D confirms this characteristic shape at crack arrest. The effective radius, a_{rf} , is about 0.75 in. for the arrested crack.

Figure 73: Idealized Circular 3D Crack Arrested in Web-Flange Weld Zone
