AIRCRAFT ACCIDENT REPORT

North Central Airlines, Inc..
Allison Convair **340/440(CV-580)**, N90858
and
Air ,Wisconsin Inc., DHC-6, N4043B
near Appleton, Wisconsin
June 29, 1972

NATIONAL TRANSPORTATION SAFETY BOARD
Washington, D.C. 20591
Report Number: **NTSB-AAR-73-9**

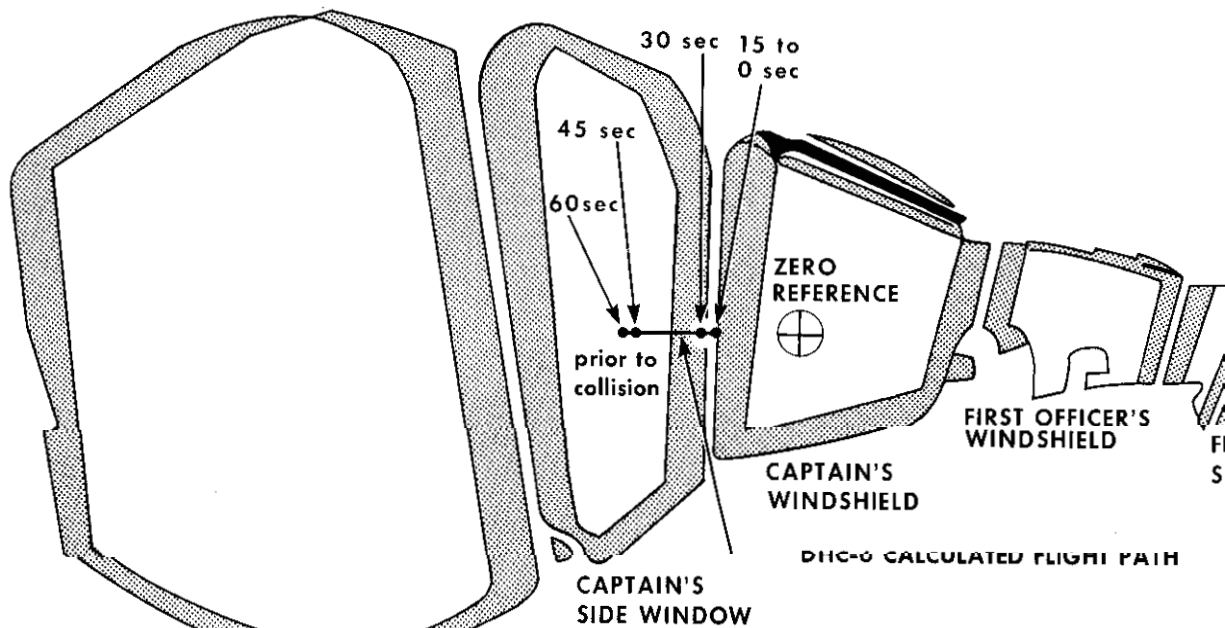
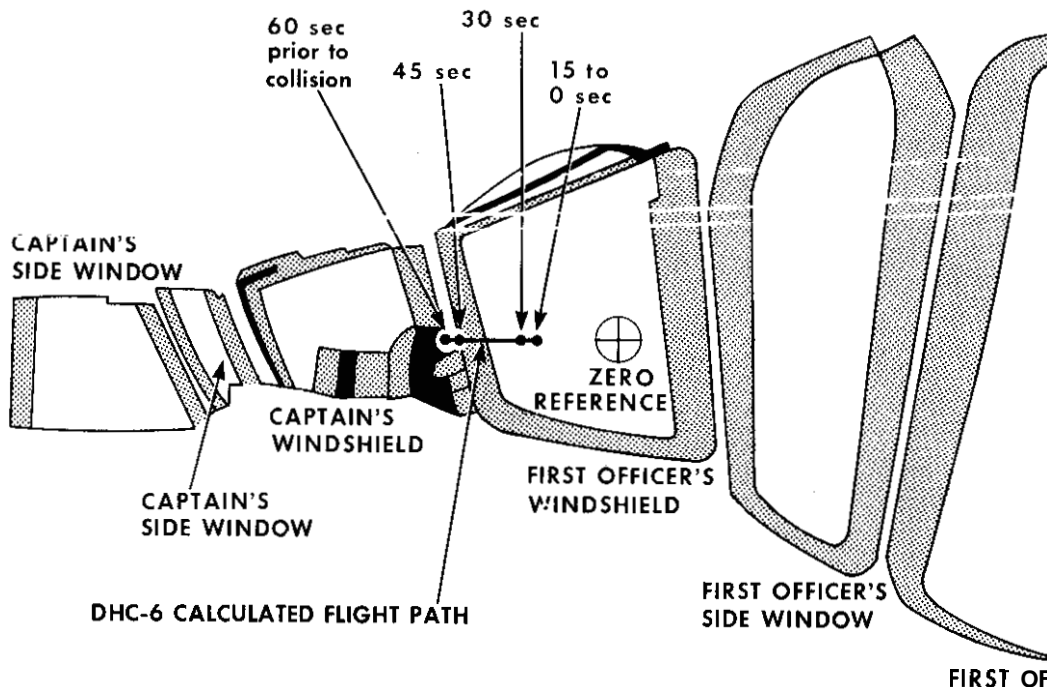
LATERAL VISIBILITY ANGLE - DEGREES
 403530252015 10 5 0 5 10152025303540
 LEFT RIGHT

CAPTAIN'S SIDE WINDOW

VERTICAL VISIBILITY ANGLE - DEGREES

DHC-6 CALCULATED FLIGHT PATH

FIRST OFFICER'S SIDE WINDOW

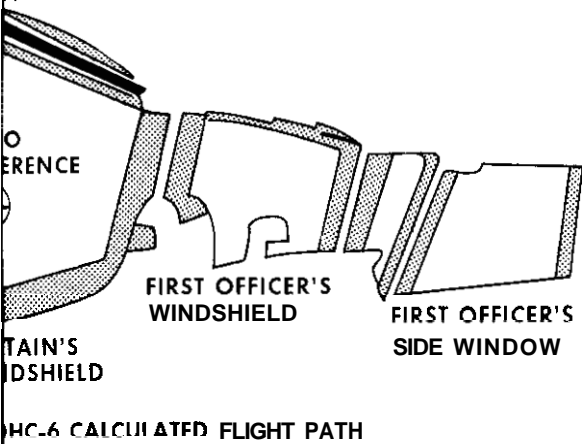
CV-580 LEFT SEAT

ANGLE - DEGREES
5 10 15 20 25 30 35 40
RIGHT

VISIBILITY FROM CAPTAIN'S DESIGN EYE
REFERENCE POINT

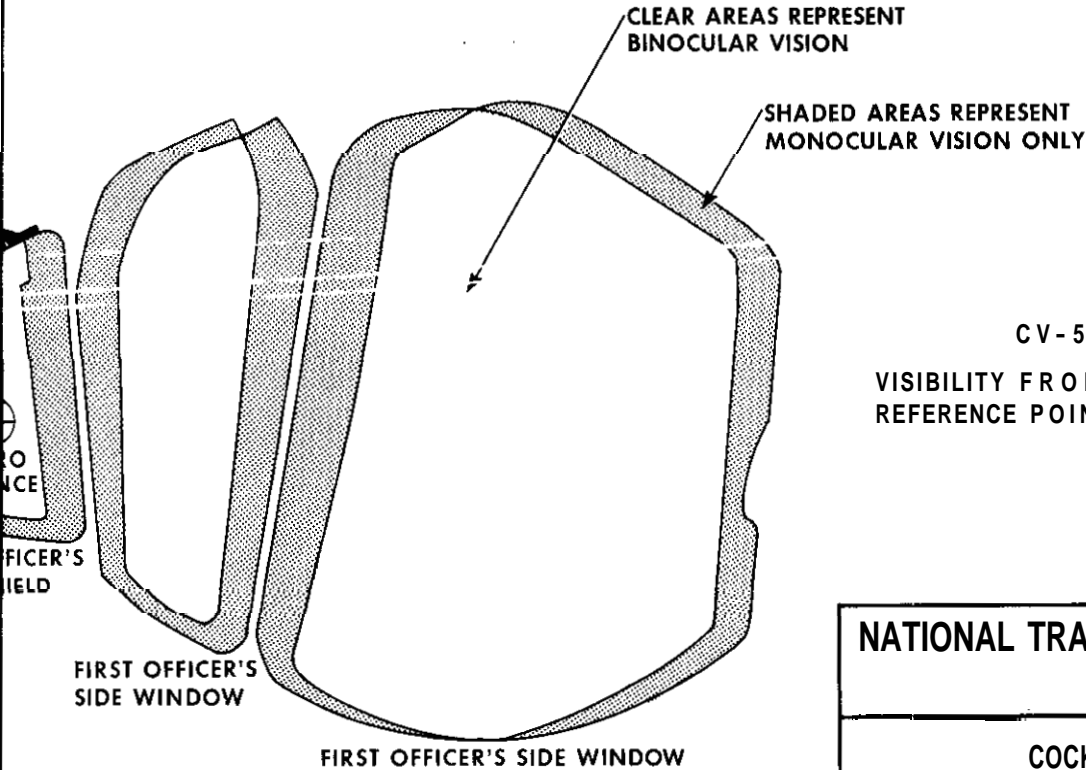
CV-580 RIGHT SEAT

VISIBILITY FROM FIRST OFFICER'S DESIGN EYE
REFERENCE POINT

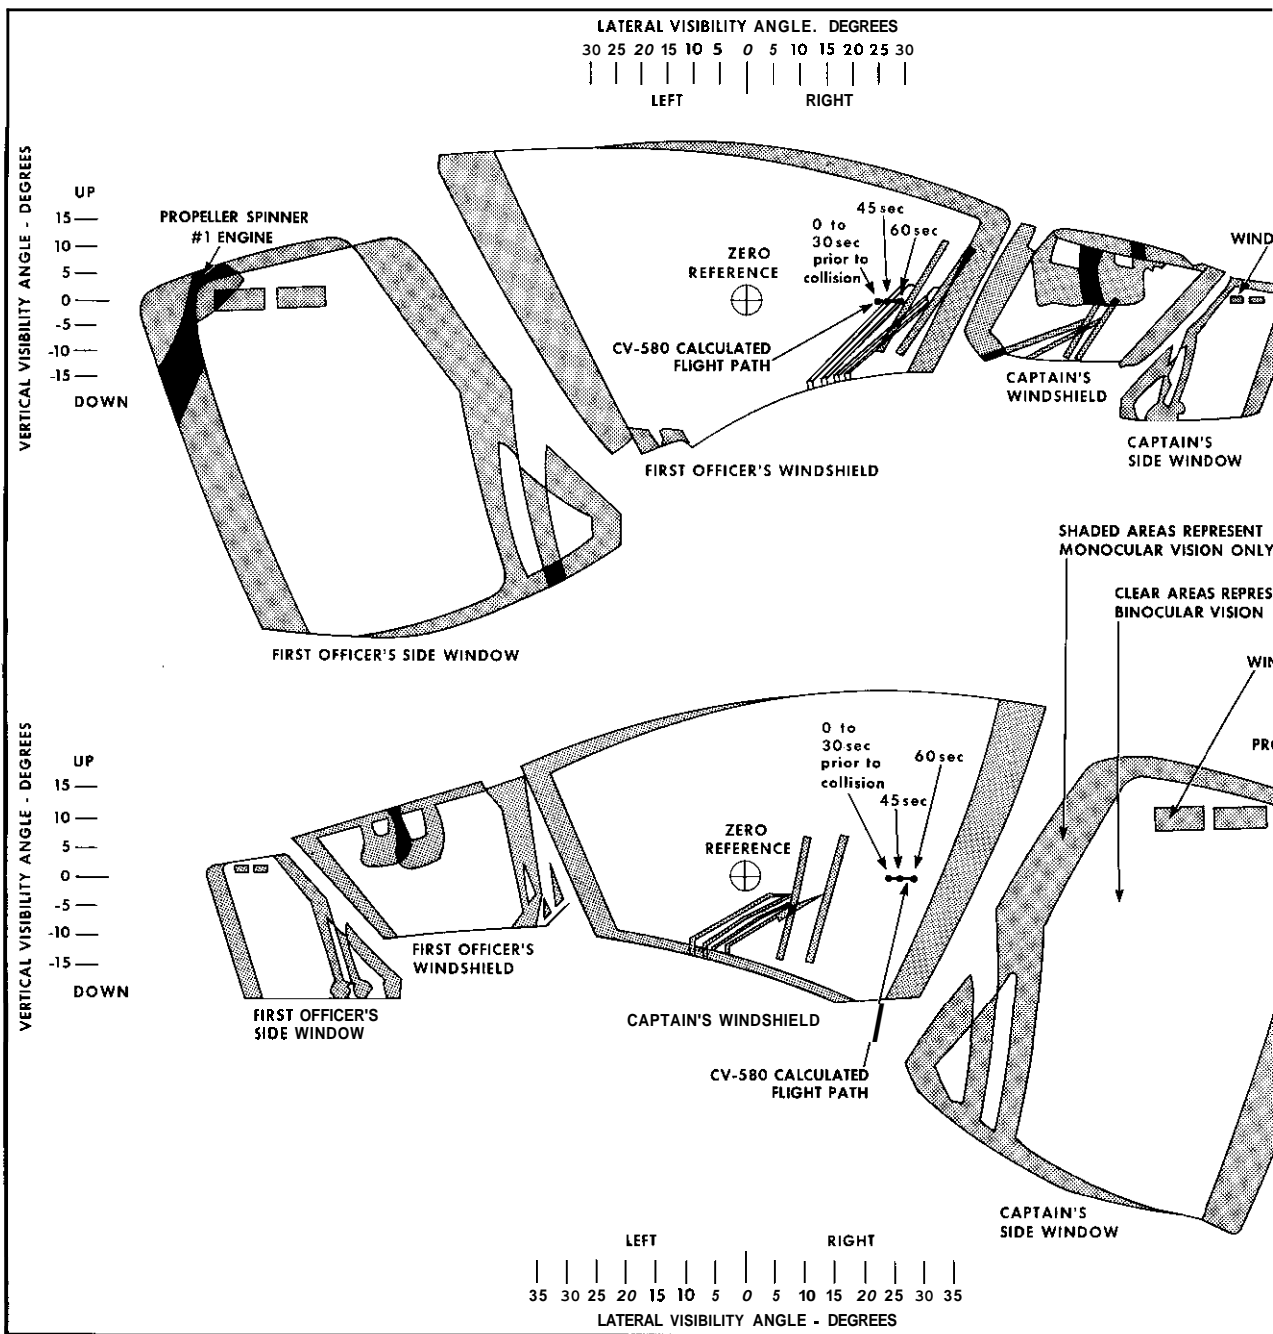
COCKPIT VISIBILITY - CV-580
NORTH CENTRAL CV-580 AND AIR WISCONSIN DHC-6
NEAR APPLETDN, WISCONSIN
JUNE 29, 1972

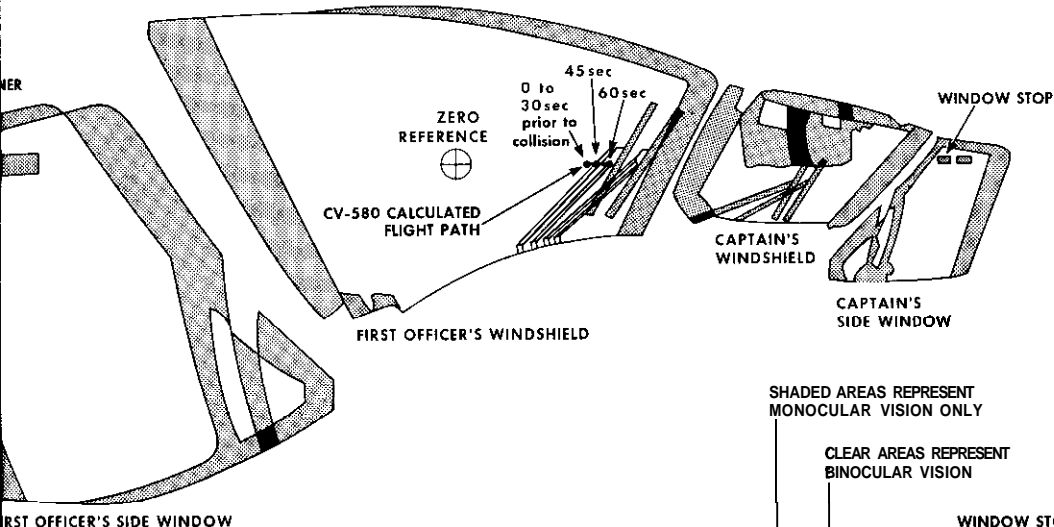
DHC-6 LEFT SEAT
 VISIBILITY FROM FIRST OFFICER'S PROBABLE
 EYE REFERENCE POINT
 FIRST OFFICER OCCUPIED LEFT SEAT

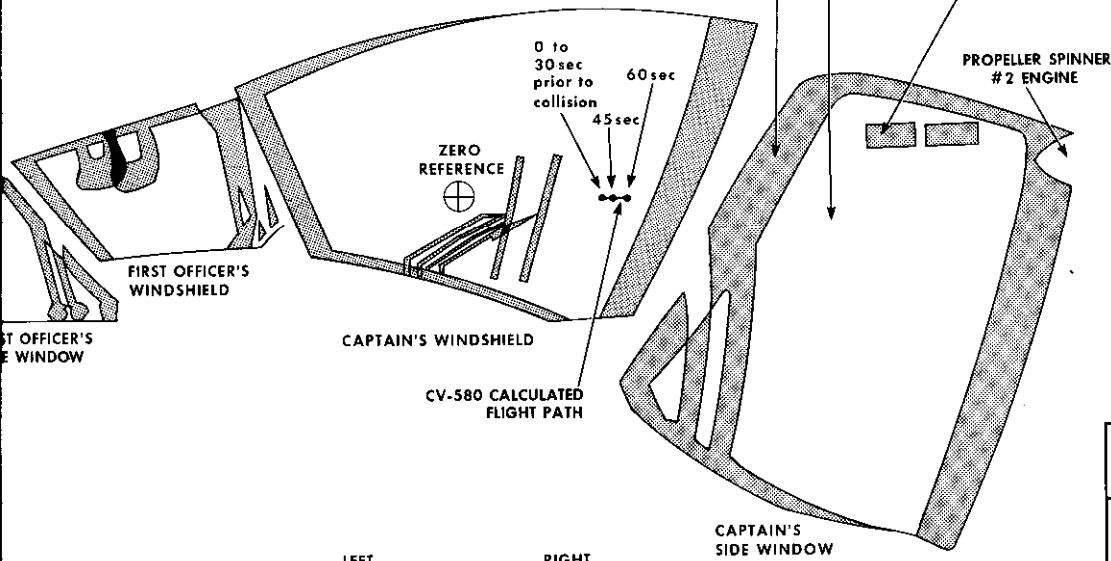
DHC-6 RIGHT SEAT
 VISIBILITY FROM CAPTAIN'S PROBABLE
 EYE REFERENCE POINT
 CAPTAIN OCCUPIED RIGHT SEAT

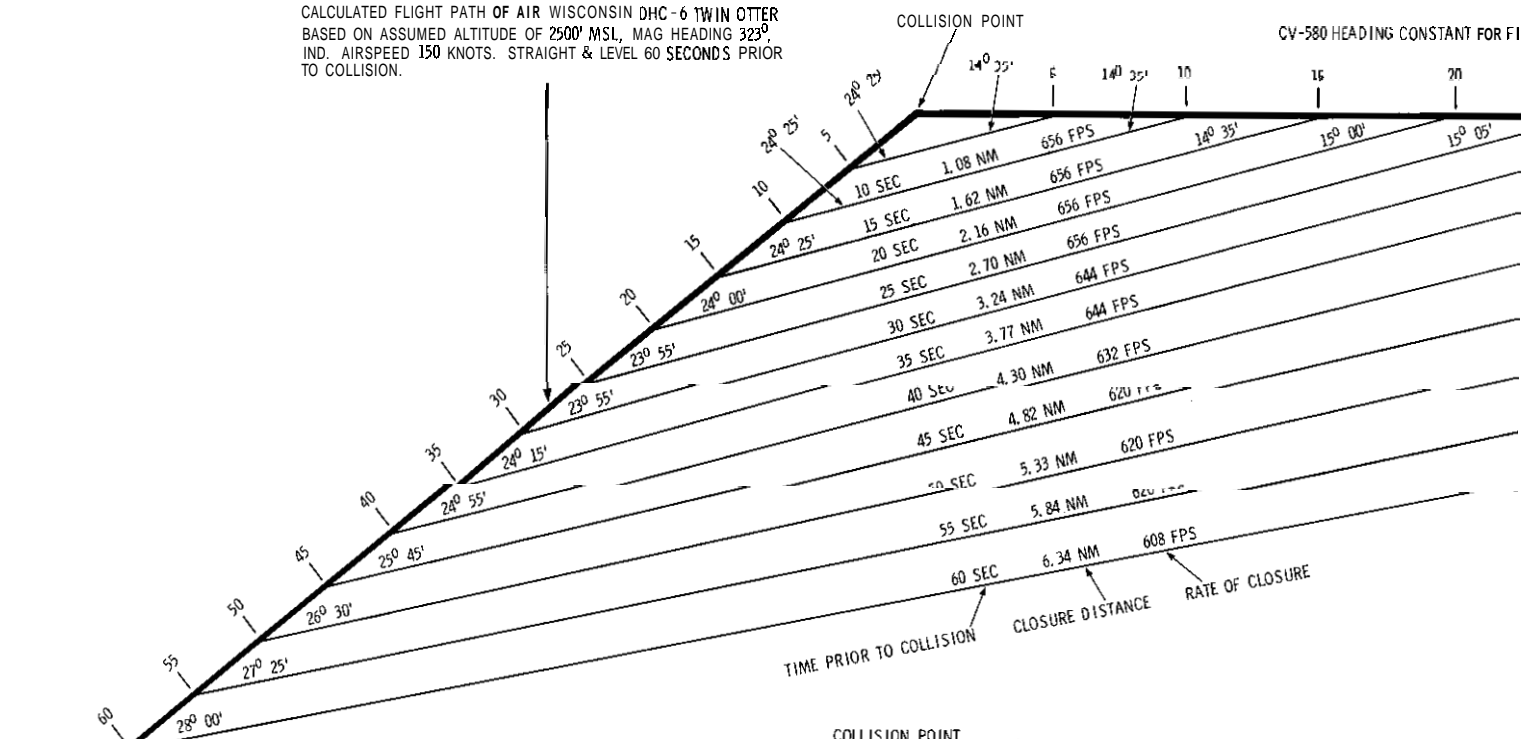
CALCULATED FLIGHT PATHS FOR 60 SECONDS PRIOR TO COLLISION

CALCULATED FLIGHT PATH OF AIR WISCONSIN DHC-6 TWIN OTTER
 BASED ON ASSUMED ALTITUDE OF 2500' MSL, MAG HEADING 323°
 IND. AIRSPEED 150 KNOTS. STRAIGHT & LEVEL 60 SECONDS PRIOR
 TO COLLISION.

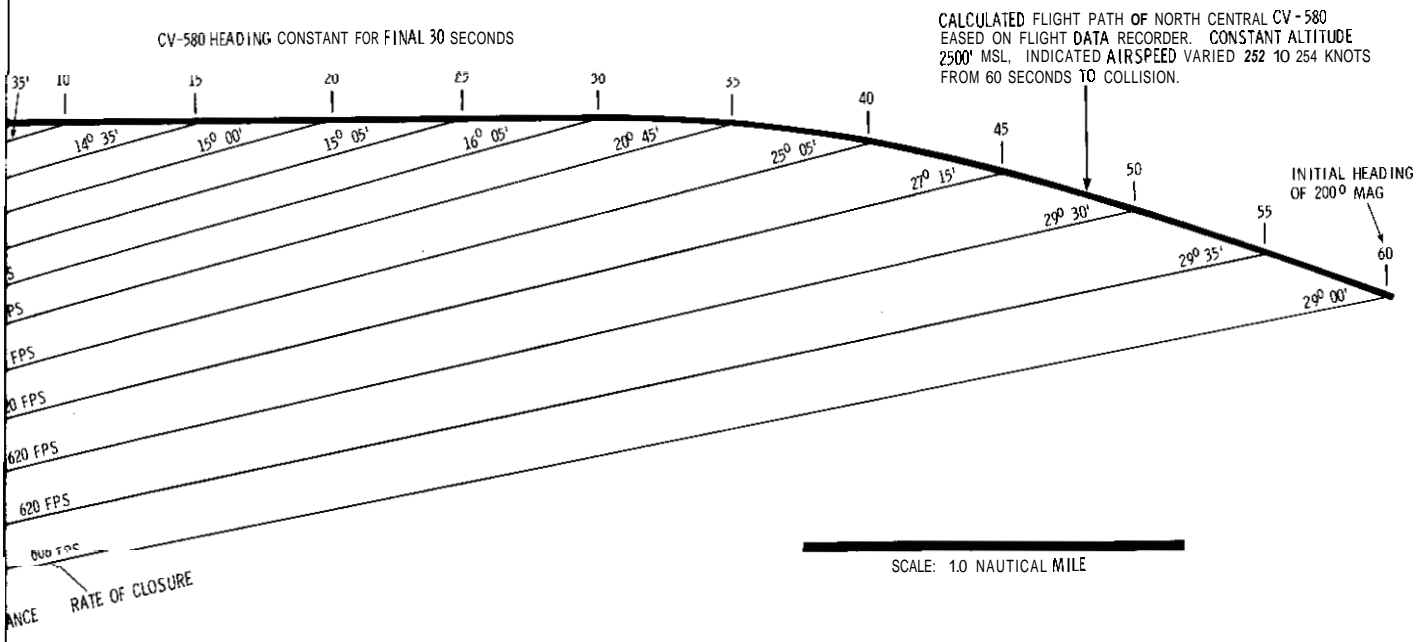
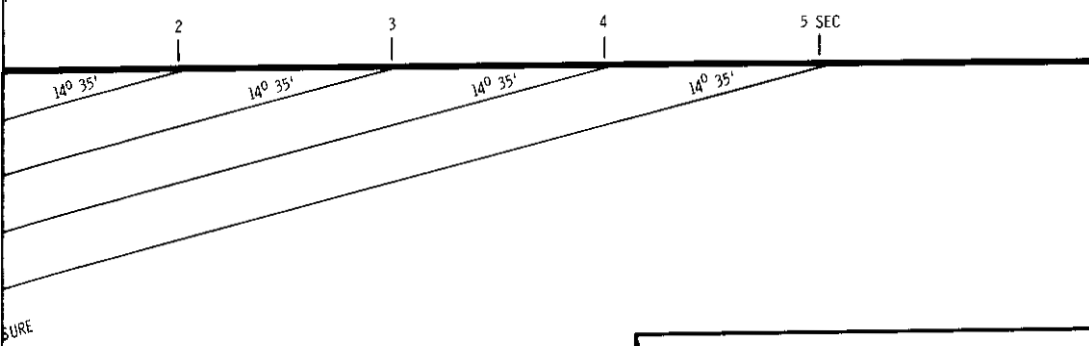
30 SECONDS PRIOR TO COLLISION

CALCULATED FLIGHT PATH
NORTH CENTRAL CV-580 AND
AIR WISCONSIN DHC-6
NEAR APPLETON, WISCONSIN
JUNE 29, 1972
